### CORVALLIS, BENTON COUNTY, OREGON BUILDING AND STRUCTURE INVENTORY FORM

CORVALLIS PRESERVATION SOCIETY, INC. CULTURAL RESOURCE SURVEY 1983-1984 INVENTORY NO: 782B

Willamette River, COMMON NAME: Van Buren Street Bridge HISTORIC NAME:

Steel swing-span truss bridge

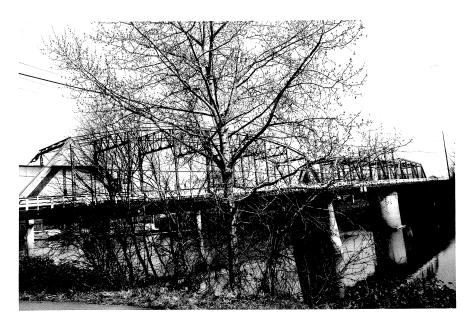
VIEW TO: Northeast

The 708 foot long bridge spanning the Willamette River at the foot of Van Buren Street is a three span steel bridge consisting of one steel through truss swing span, a 171 foot steel through truss (secondary span), a 57 foot steel pony truss at the east end, and nine 19-foot timber spans at the west end, which replaced the original west end 57 foot steel pony truss. The swing span truss is of Pratt configuration; the large through truss is a Parker; and the pony truss is a Warren, with polyginal upper chords. The individual truss members are connected together with steel pins.
