Cultural Resource Survey Form:

CLACKAMAS COUNTY

COMMON/HISTORICAL NAME: SANDERS RESIDENCE

ADDRESS: 1007 N. Molalla Avenue

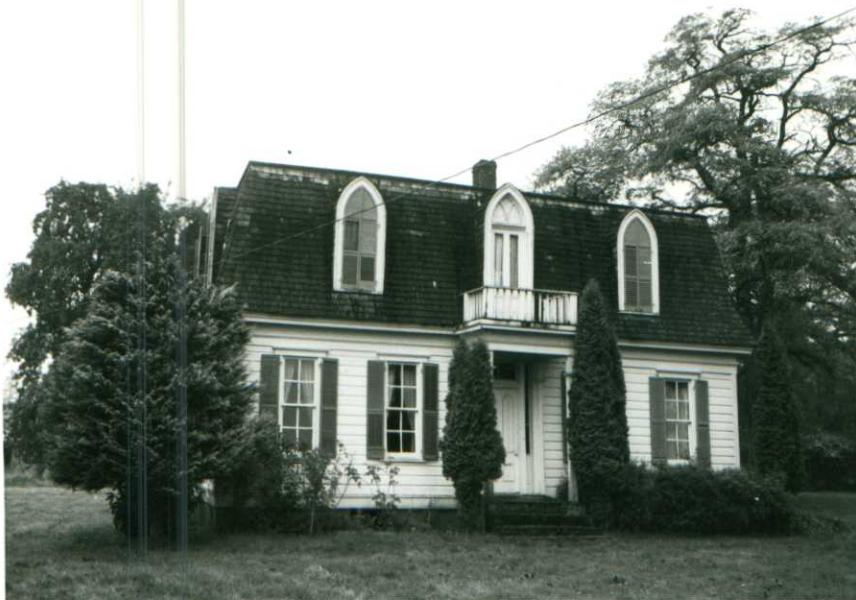
STYLE: Second Empire

CONDITION: Good

SIDING: Wide shiplap with frieze, corner boards and water table.

ROOF: Bell-shaped mansard with pointed arch dormers on all elevations.

DOORS: Rounded panels with modified chamfered pilasters

WINDOWS: 4/4 double-hung sash with architrave molding and shutters, pointed-arch transomed windows, louvered shutters.

MAIN ENTRANCE: Brick steps replace original decking. Balcony above entrance with plain balustrade. Sidelights and transom light flank front door.

NOTES: Side porch with chamfered posts. Enclosed balustrade replaces jigsaw balustrade posts. Barn with gambrel roof, hay hood (ca. 1910), board and batten, pear tree, fruit trees and locust tree contemporary with house.

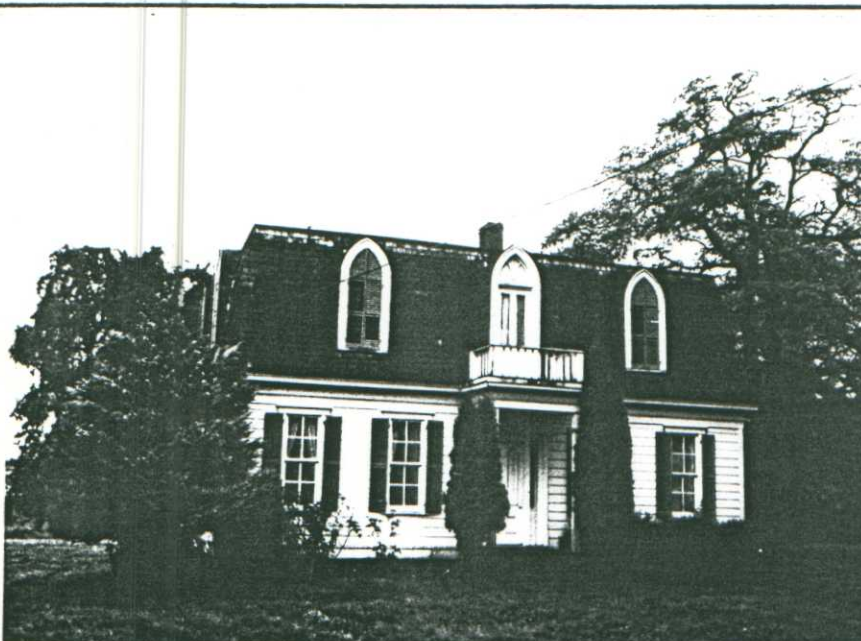
STYLE: Second Empire

CONDITION: Good

SIDING: Wide shiplap with frieze, corner boards and water table.

ROOF: Bell-shaped mansard with pointed arch dormers on all elevations.

DOORS: Rounded panels with modified chamfered pilasters

WINDOWS: 4/4 double-hung sash with architrave molding and shutters, pointed-arch transomed windows, louvered shutters.

MAIN ENTRANCE: Brick steps replace original decking. Balcony above entrance with plain balustrade. Sidelights and transom light flank front door.

NOTES: Side porch with chamfered posts. Enclosed balustrade replaces jigsawn balustrade posts. Barn with gambrel roof, hay hood (ca. 1910), board and batten, pear tree, fruit trees and locust tree contemporary with house.

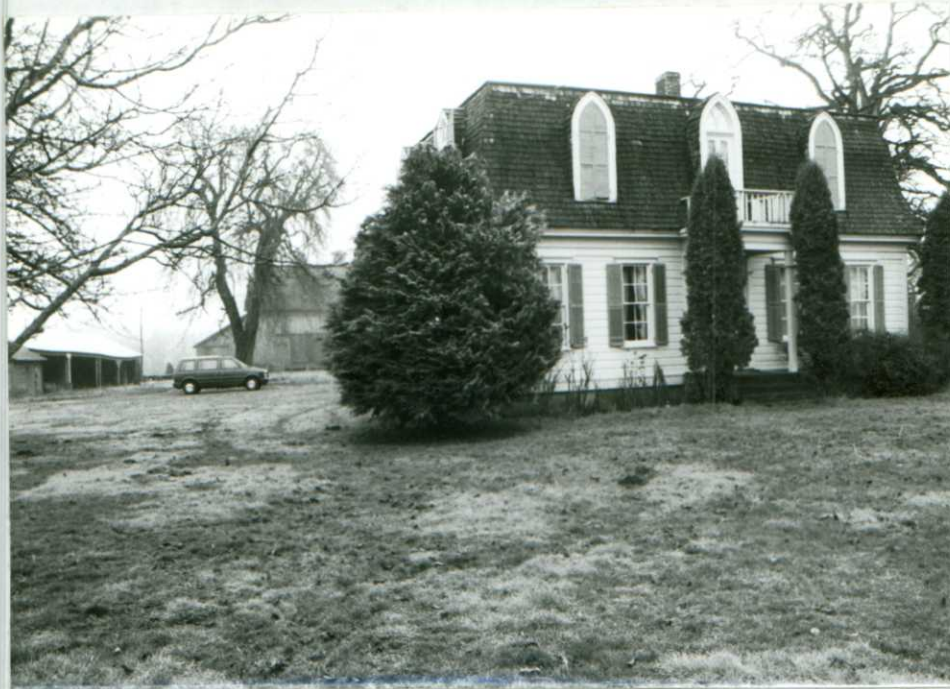
HOUSE

DATE BUILT: 1878
STYLE: Second Empire
PLAN TYPE/SHAPE: T-plan
NO. OF STORIES: 1 1/2
FOUNDATION MATERIAL: Brick
BASEMENT: No
ROOF FORM AND MATERIALS: Mansard w/ wood shingles
WALL CONSTRUCTION/STRUCTURAL FRAME: Wood/unknown
PRIMARY WINDOW TYPE: Four-over-four double-hung sash
EXTERIOR SURFACING MATERIALS: Wide dropped siding w/ corner boards
DECORATIVE FEATURES: Pointed arch dormers; four paneled door w/ side lights and transom; shutters
OTHER: Single bay porch w/ champfered posts; interior chimney; porch w/ champfered posts, n. elev.
CONDITION: Good
EXTERIOR ALTERATIONS (DATE): Addition (c. 1940)

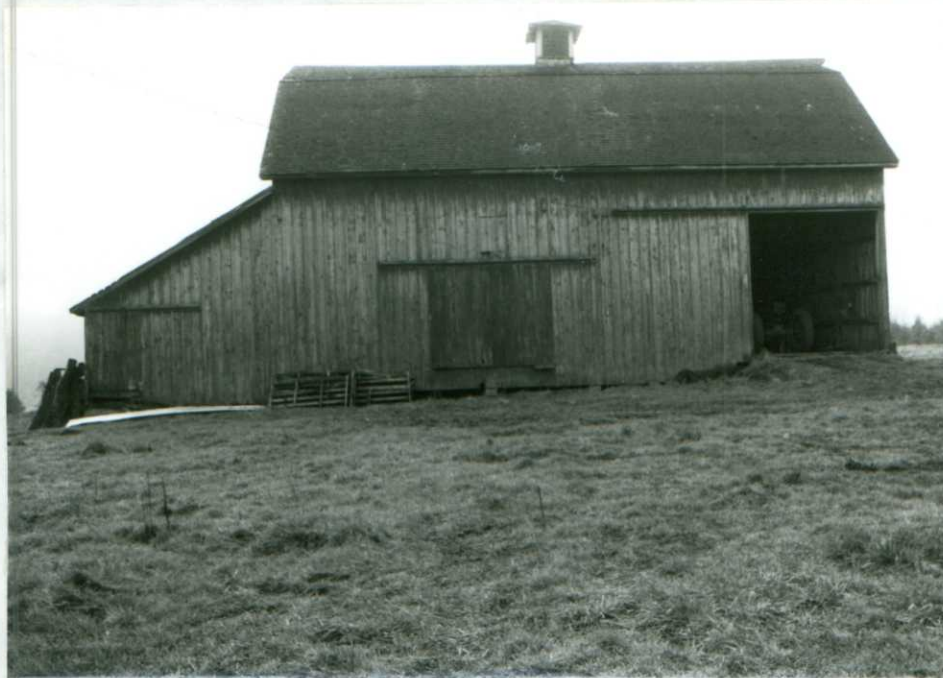
BARN

DATE BUILT: Unknown
STYLE: Gambrel
PLAN TYPE/SHAPE: Asymmetrical
NO. OF STORIES: 2
FOUNDATION MATERIAL: Post-and-beam
BASEMENT: No
ROOF FORM AND MATERIALS: Gambrel w/ wood shingles
WALL CONSTRUCTION/STRUCTURAL FRAME: Wood/unknown
PRIMARY WINDOW TYPE: None
EXTERIOR SURFACING MATERIALS: Board-and-batten
DECORATIVE FEATURES: None
OTHER: Lean-tos on n. and e. elevs.; hipped cupola
CONDITION: Fair
EXTERIOR ALTERATIONS (DATE): Lean-tos added (n.d.)

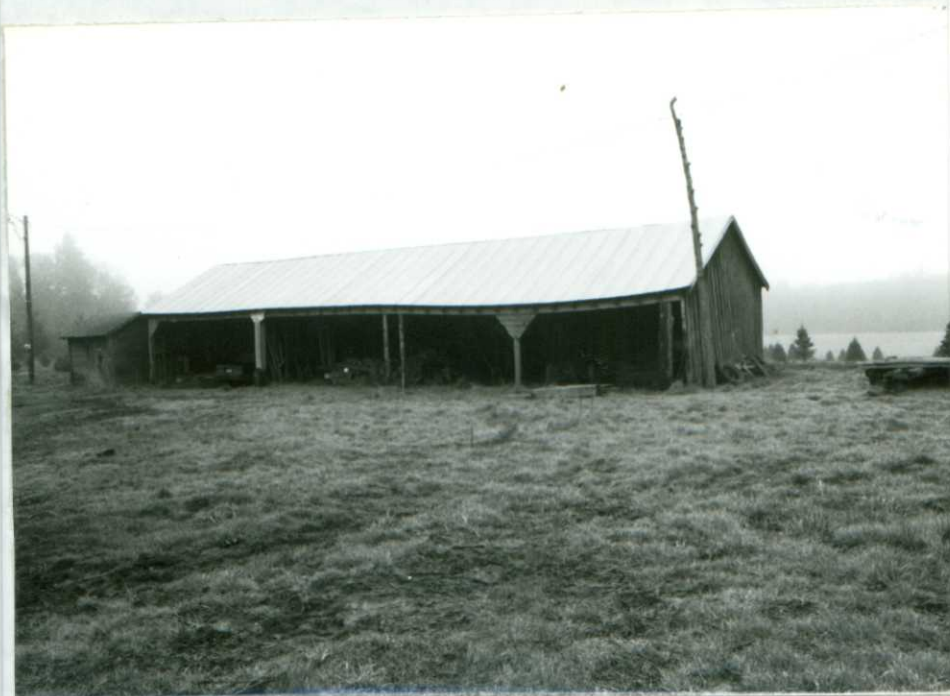
MACHINE SHED

DATE BUILT: Unknown
STYLE: Vernacular
PLAN TYPE/SHAPE: Rectangular
NO. OF STORIES: 1
FOUNDATION MATERIAL: Post-and-beam
BASEMENT: No
ROOF FORM AND MATERIALS: Gable w/ sheet metal
WALL CONSTRUCTION/STRUCTURAL FRAME: Wood/stud
PRIMARY WINDOW TYPE: None
EXTERIOR SURFACING MATERIALS: Board-and-batten
DECORATIVE FEATURES: None
OTHER: None
CONDITION: Poor
EXTERIOR ALTERATIONS (DATE): Unknown
