**National Register of Historic Places
Inventory—Nomination Form**

historic ST. JOHN THE EVANGELIST ROMAN CATHOLIC CHURCH

street & number SW of Zigzag on Truman Road not for publication

city, town Zigzag vicinity of congressional district Second

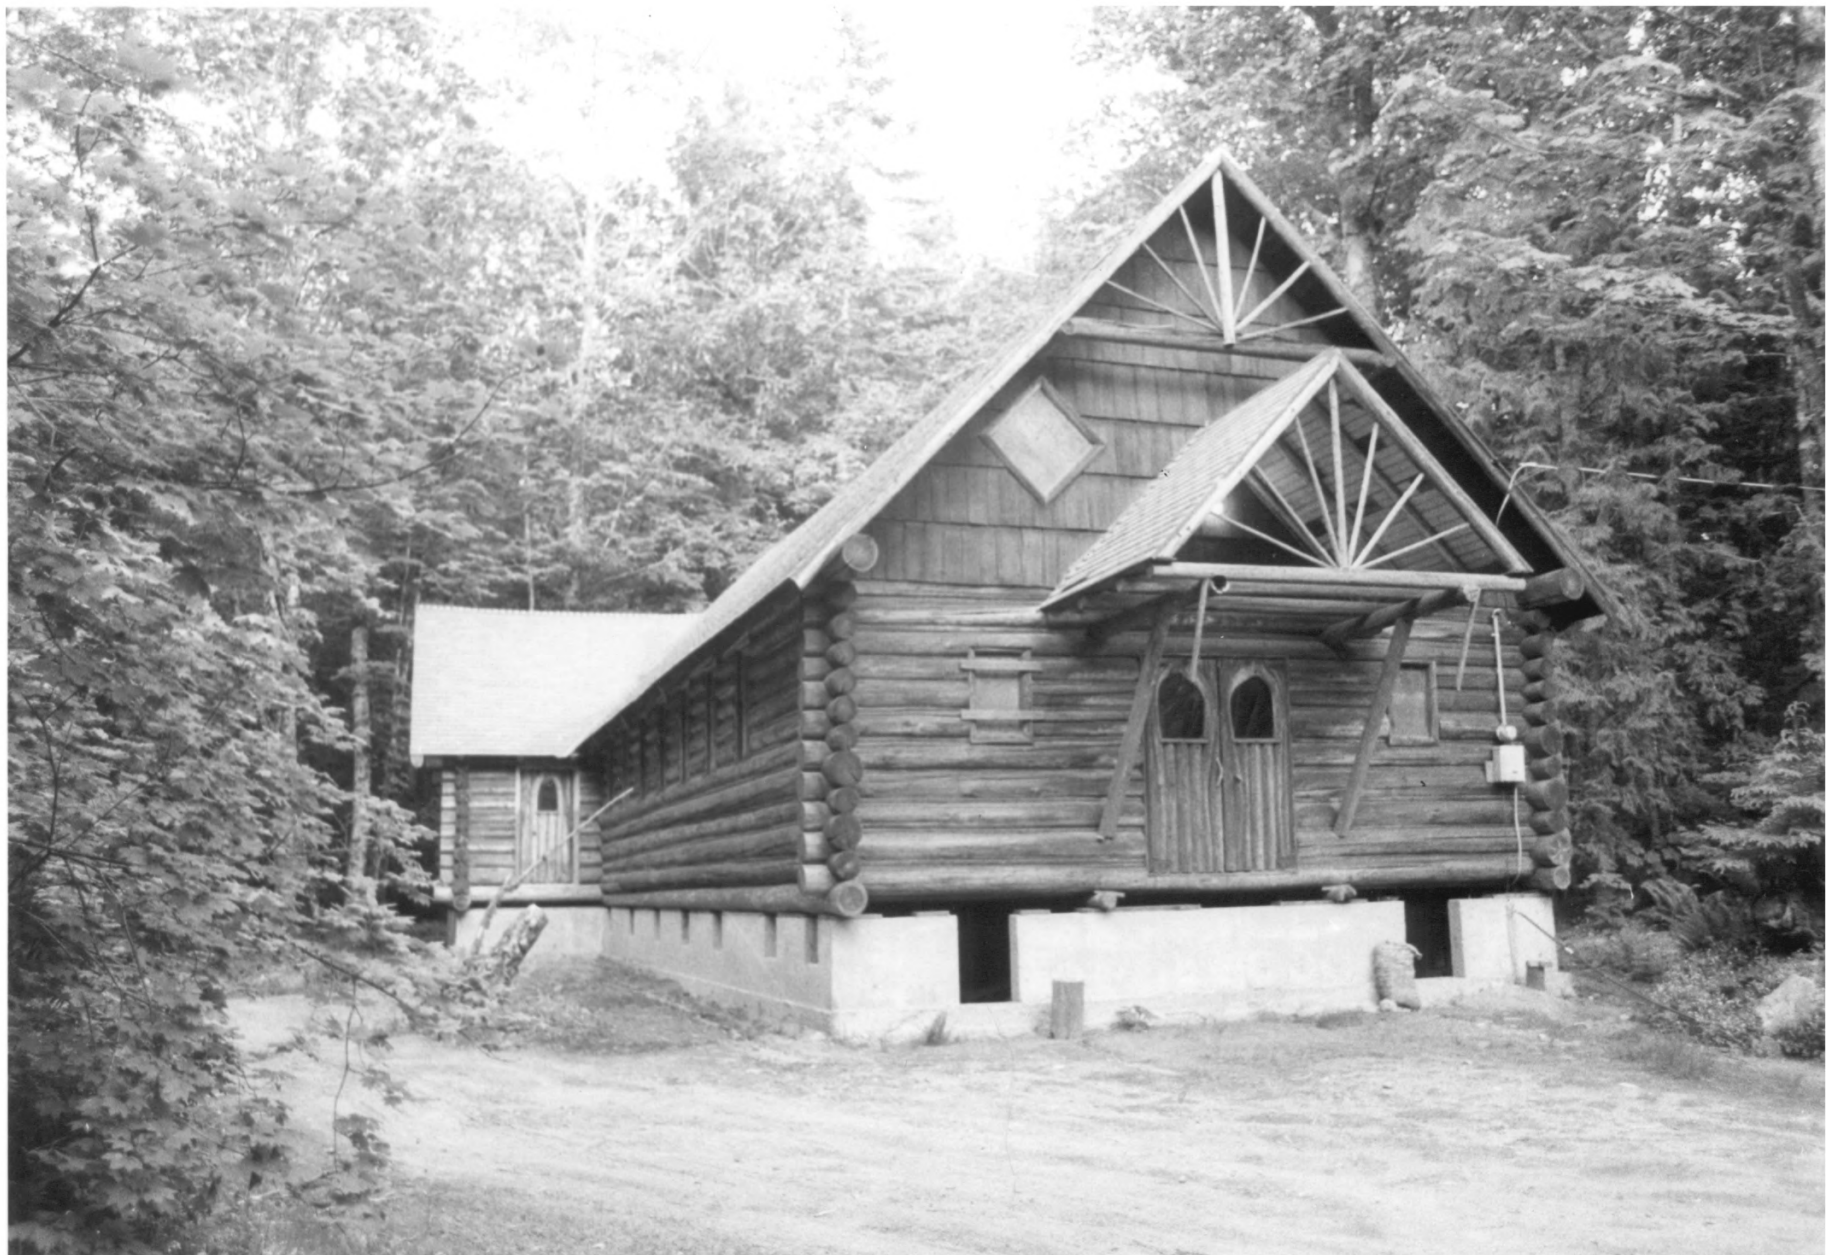
1 of 12 North and west elevations of
building as relocated within a mile of
original site. Original east-west ori-
entation recreated. Concrete foundation
to be covered with back-fill.

The original site of the church was a parcel of 0.36 acres on the north side of Highway 26 (Mt. Hood Loop Highway) at Zigzag. The parcel was level and wooded. The nominated property of 2.50 acres also is level and forested terrain in a residential zone less than a mile from the original setting. The current owner is acquiring several additional acres surrounding the two-acre parcel to buffer the property. On its original site, the church rested directly on the ground without foundation. First course logs incurred moisture damage as a result. Today, the building is on a peripheral foundation of reinforced concrete with 4x4" posts and piers as secondary reinforcement. The damaged lowermost course of logs has been replaced. The concrete foundation will be covered by back-fill upon completion of the restoration.

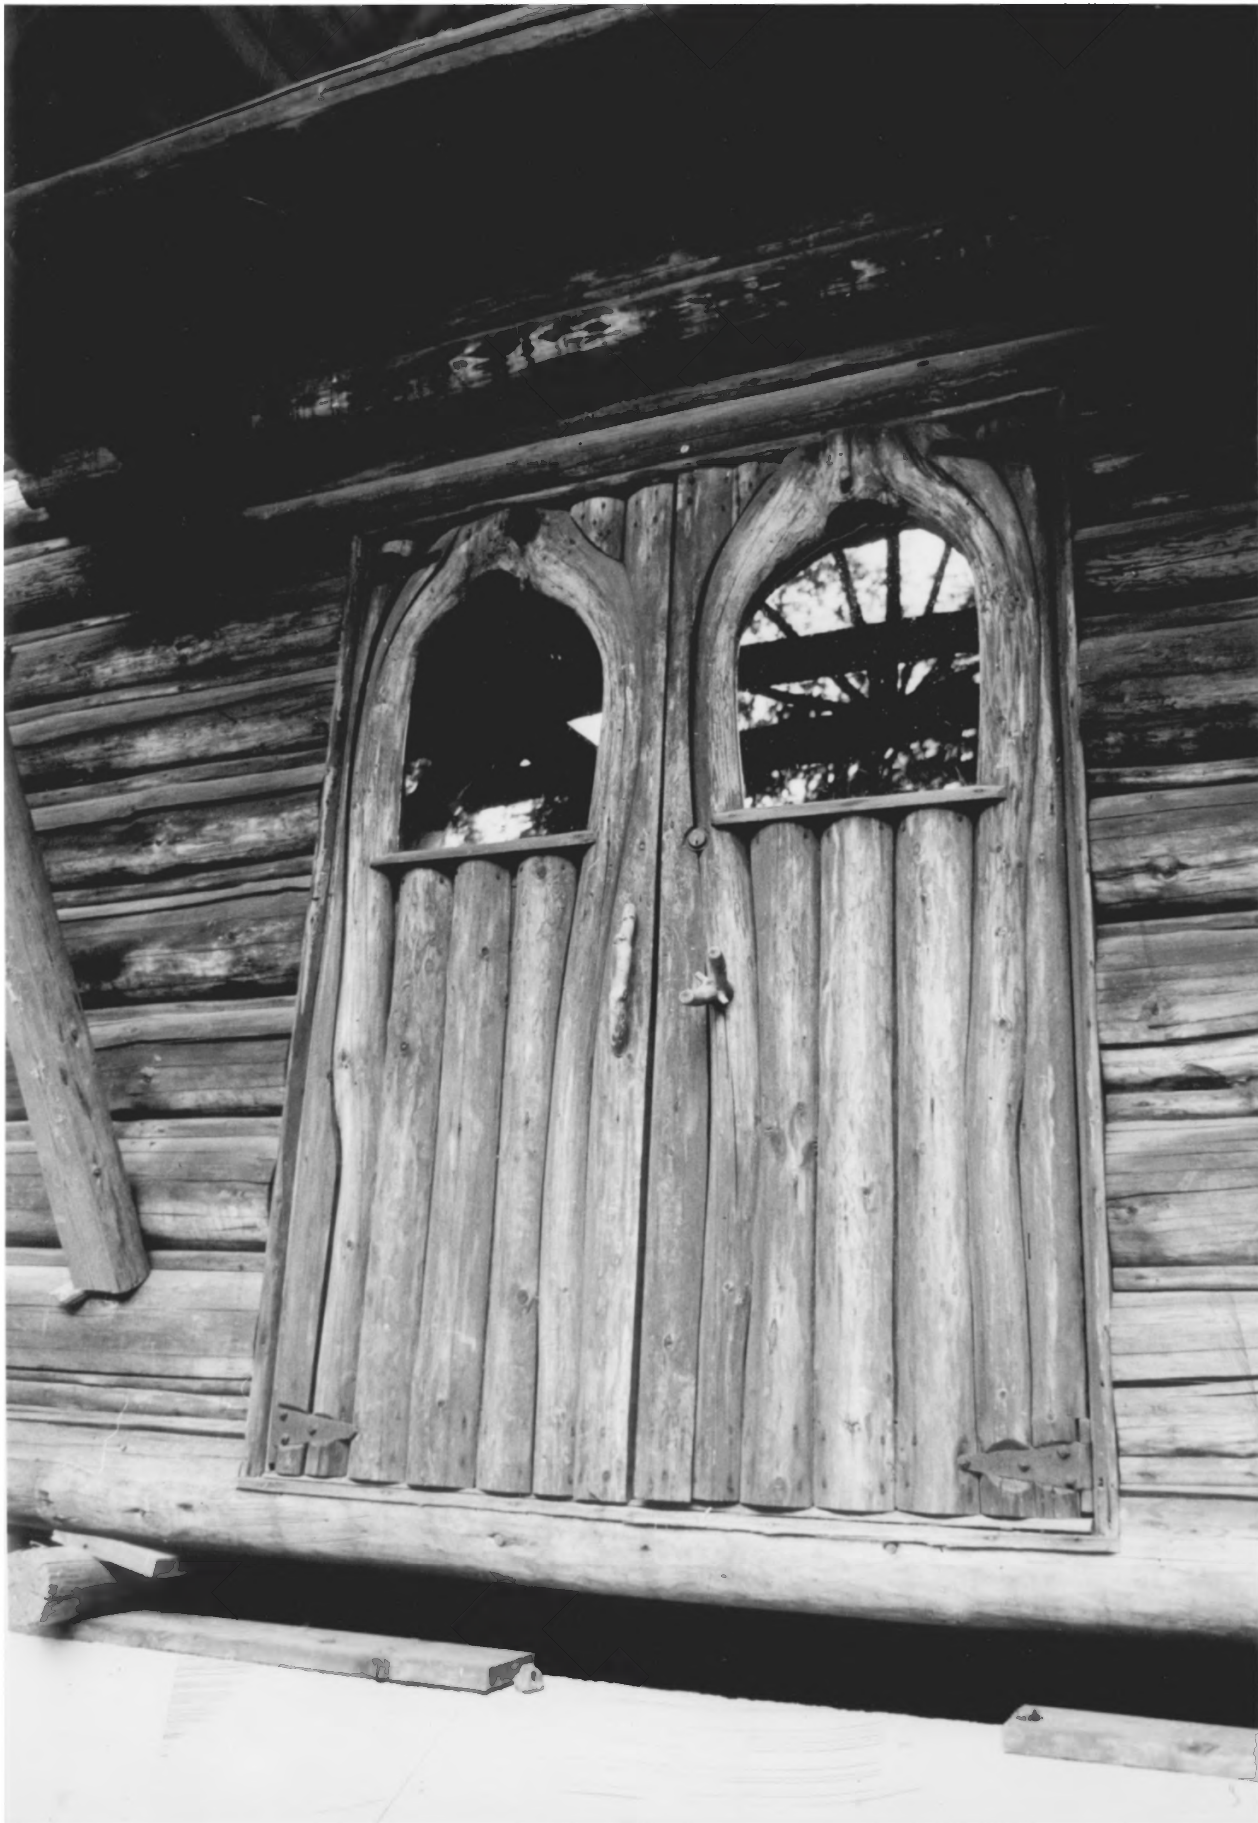
2 of 12 Detail of double-leaf front
door in rustic mode

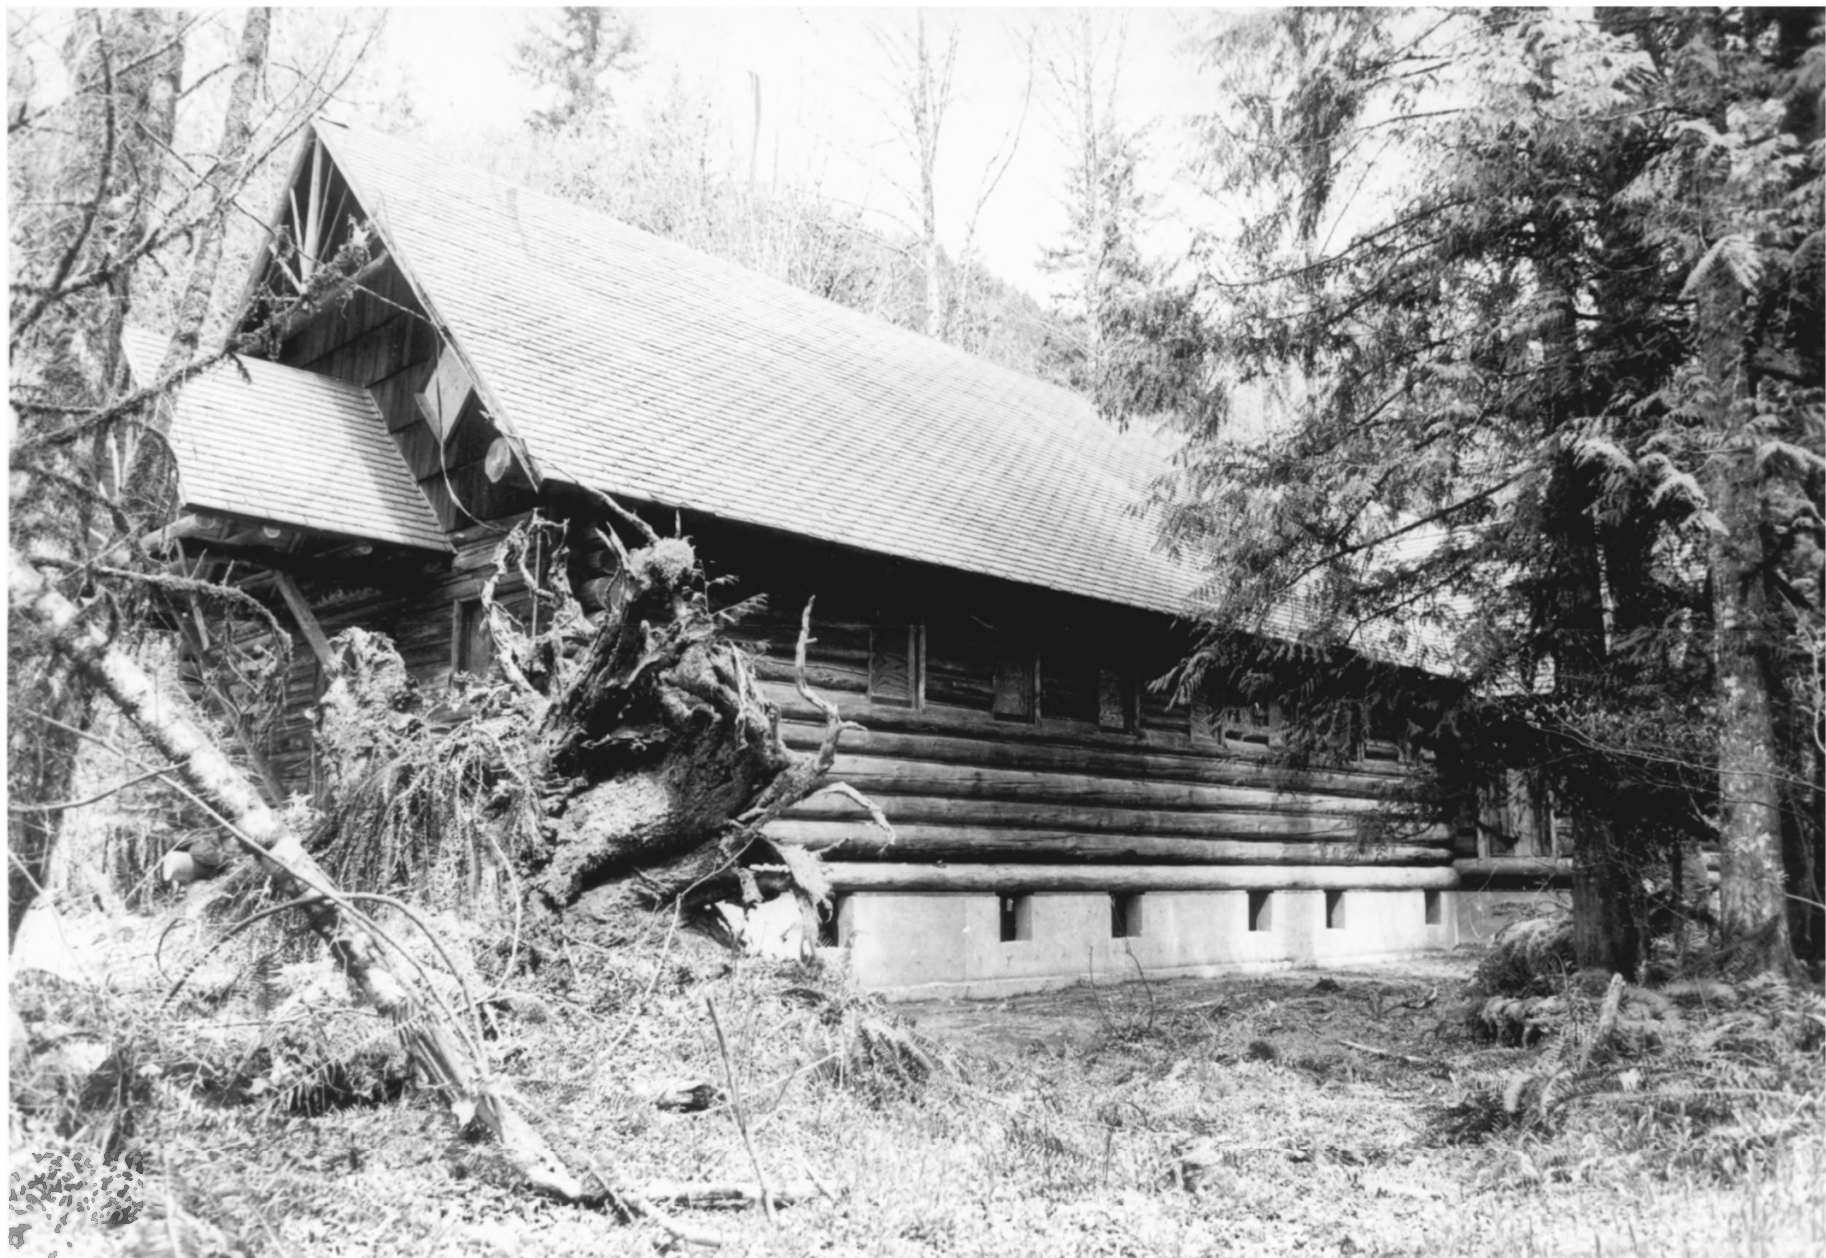
3 of 12 West and south elevations

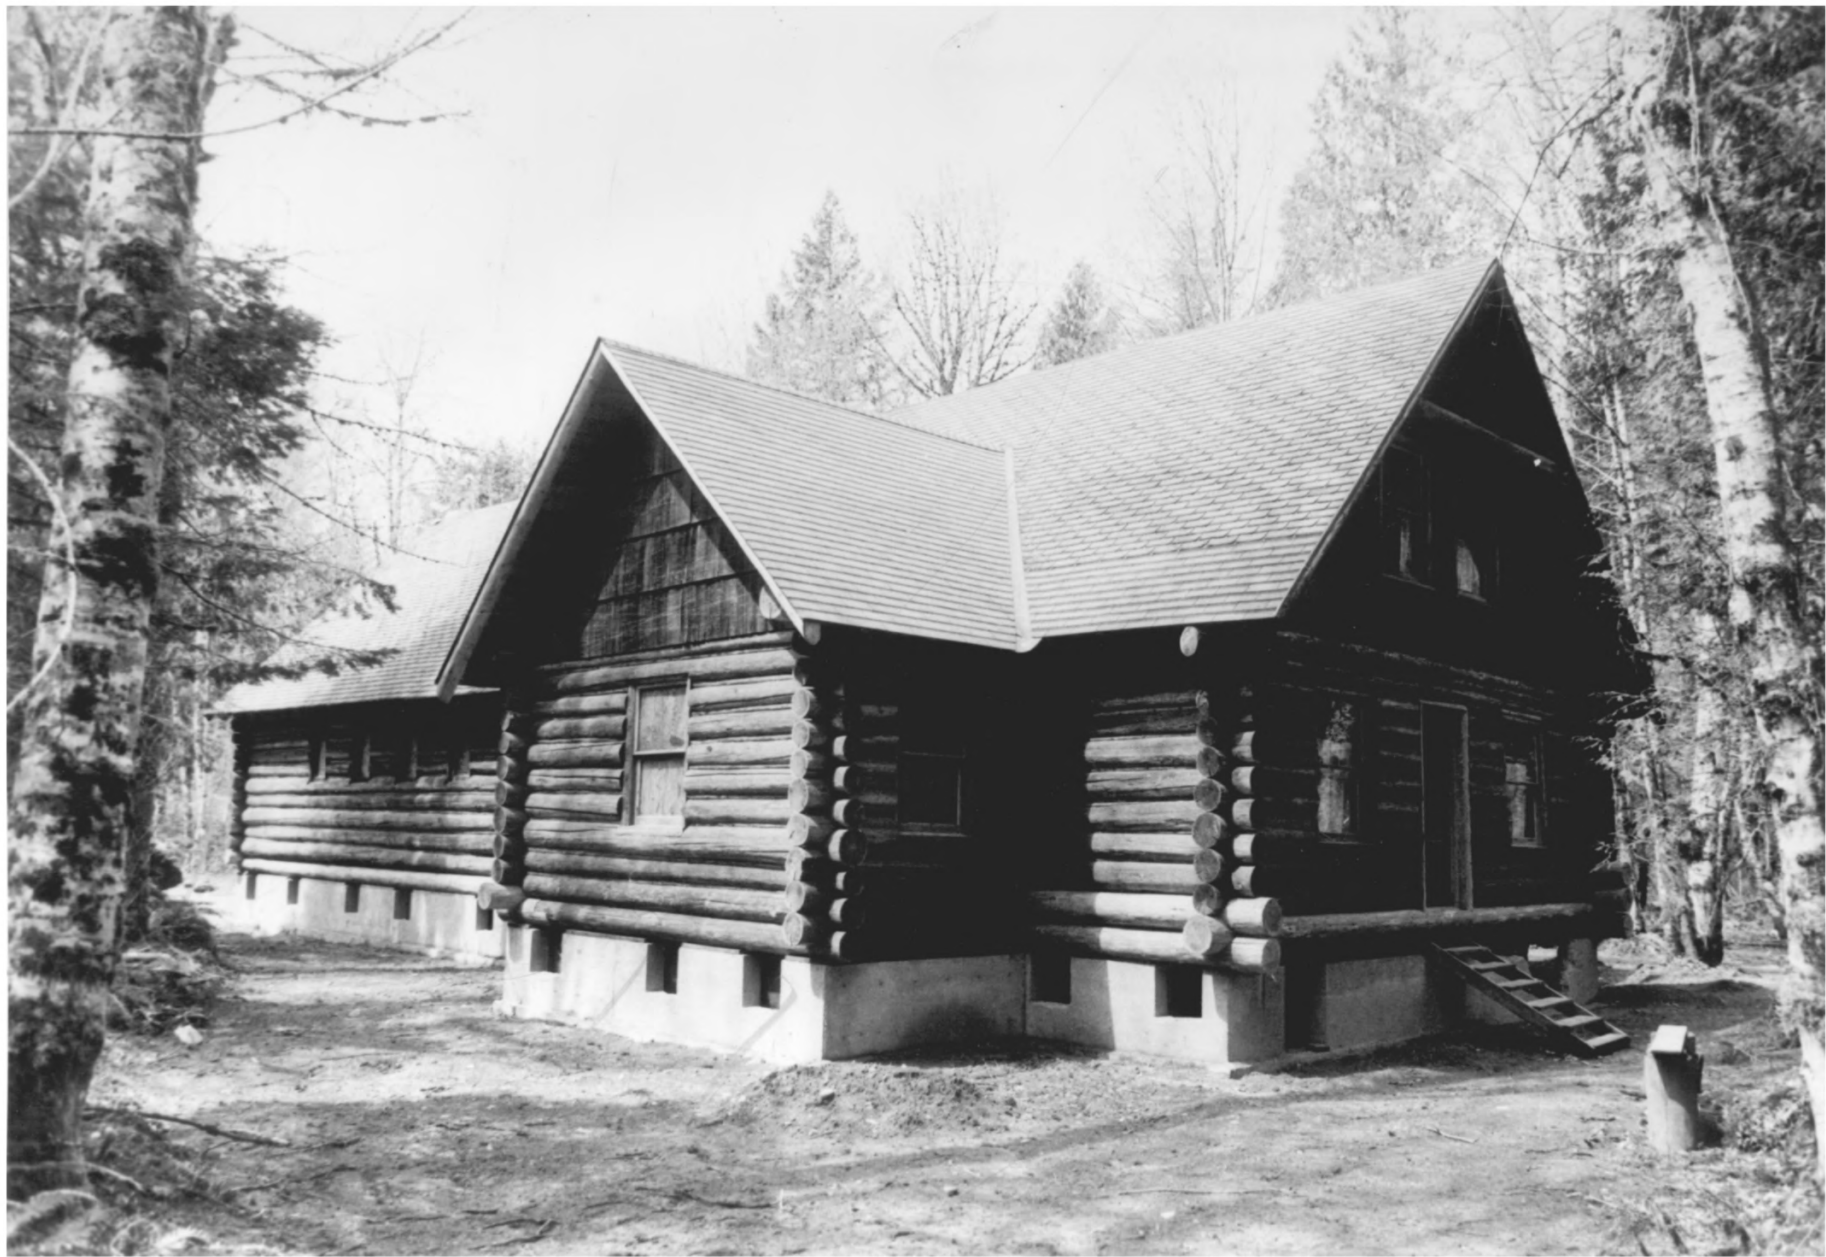
4 of 12 South and east elevations,
showing south transept

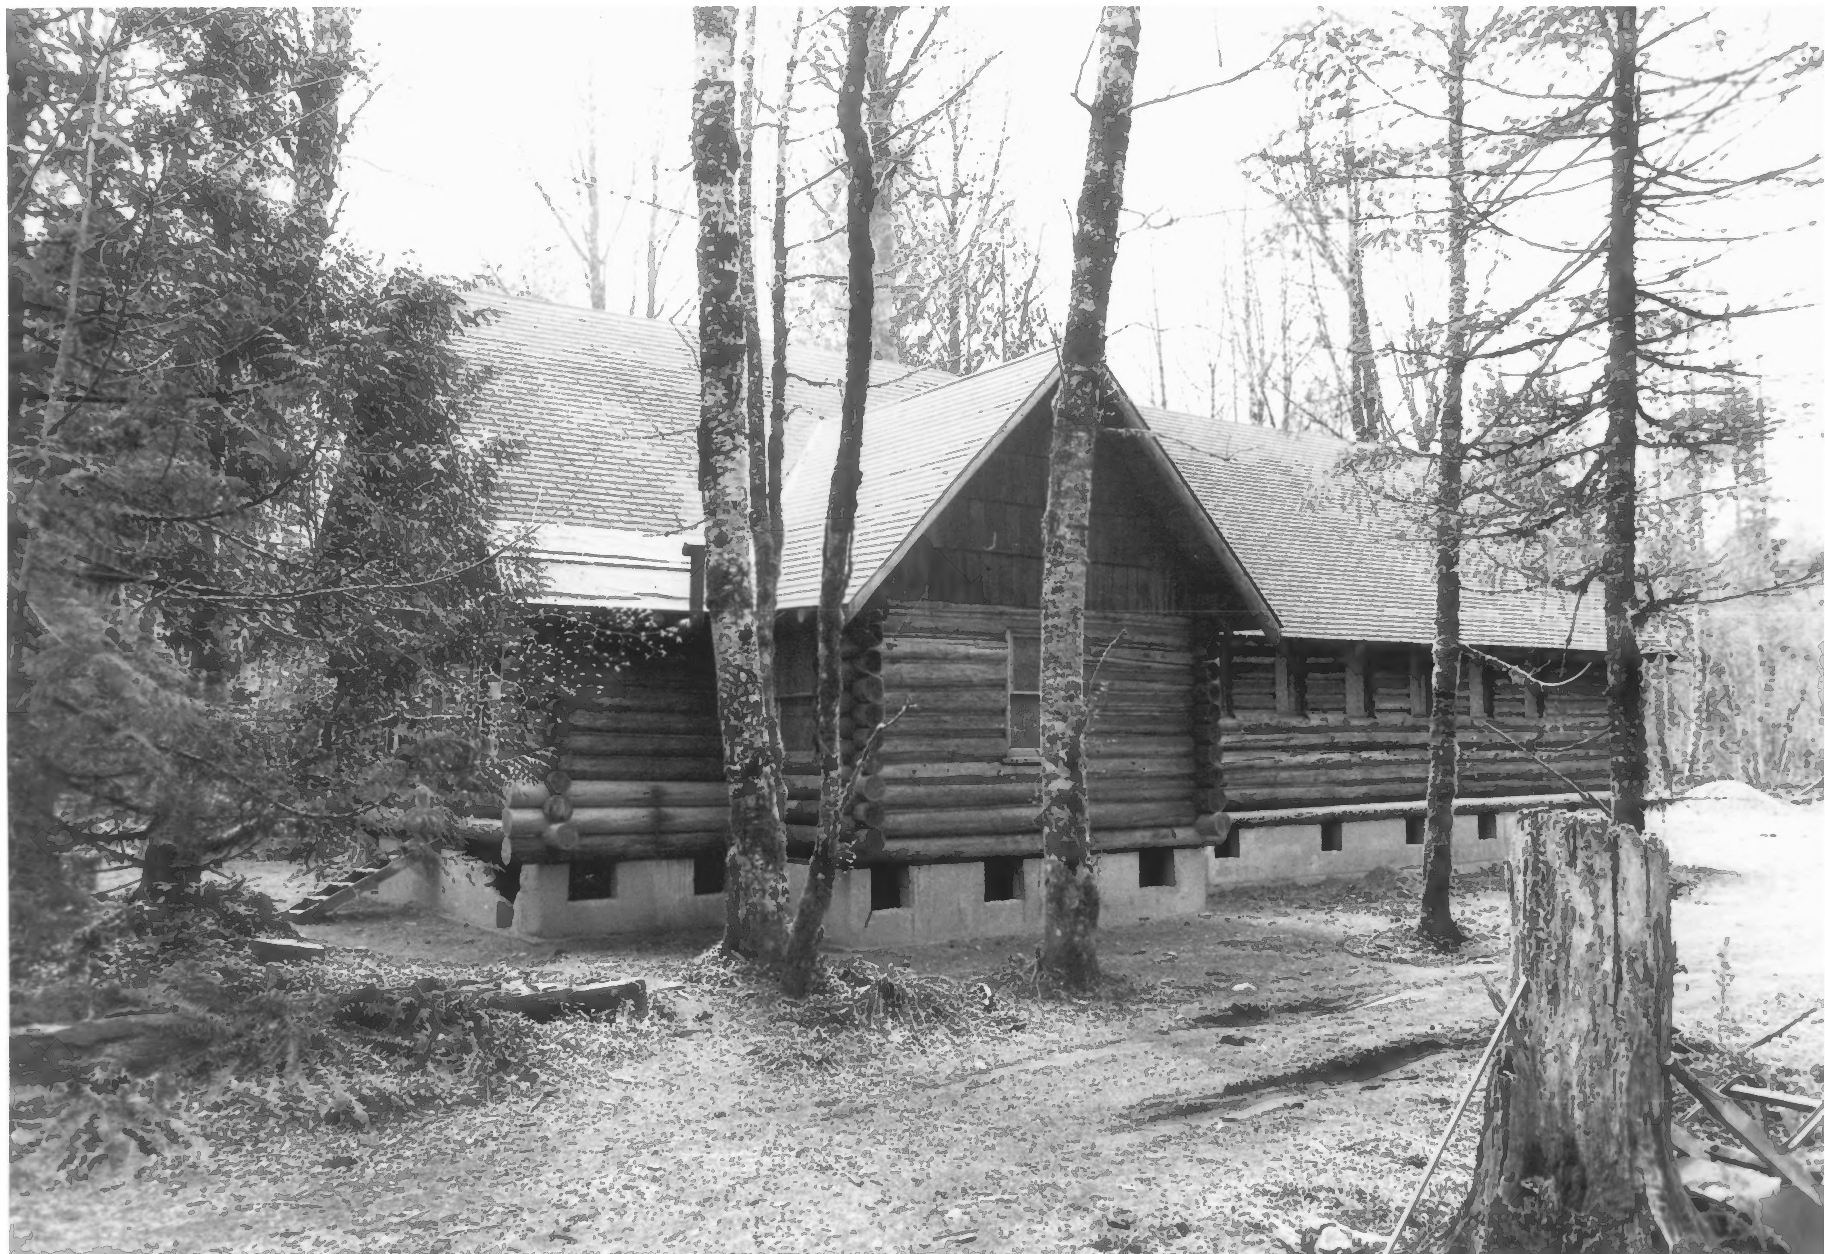
5 of 12 East and north elevations,
showing north transept

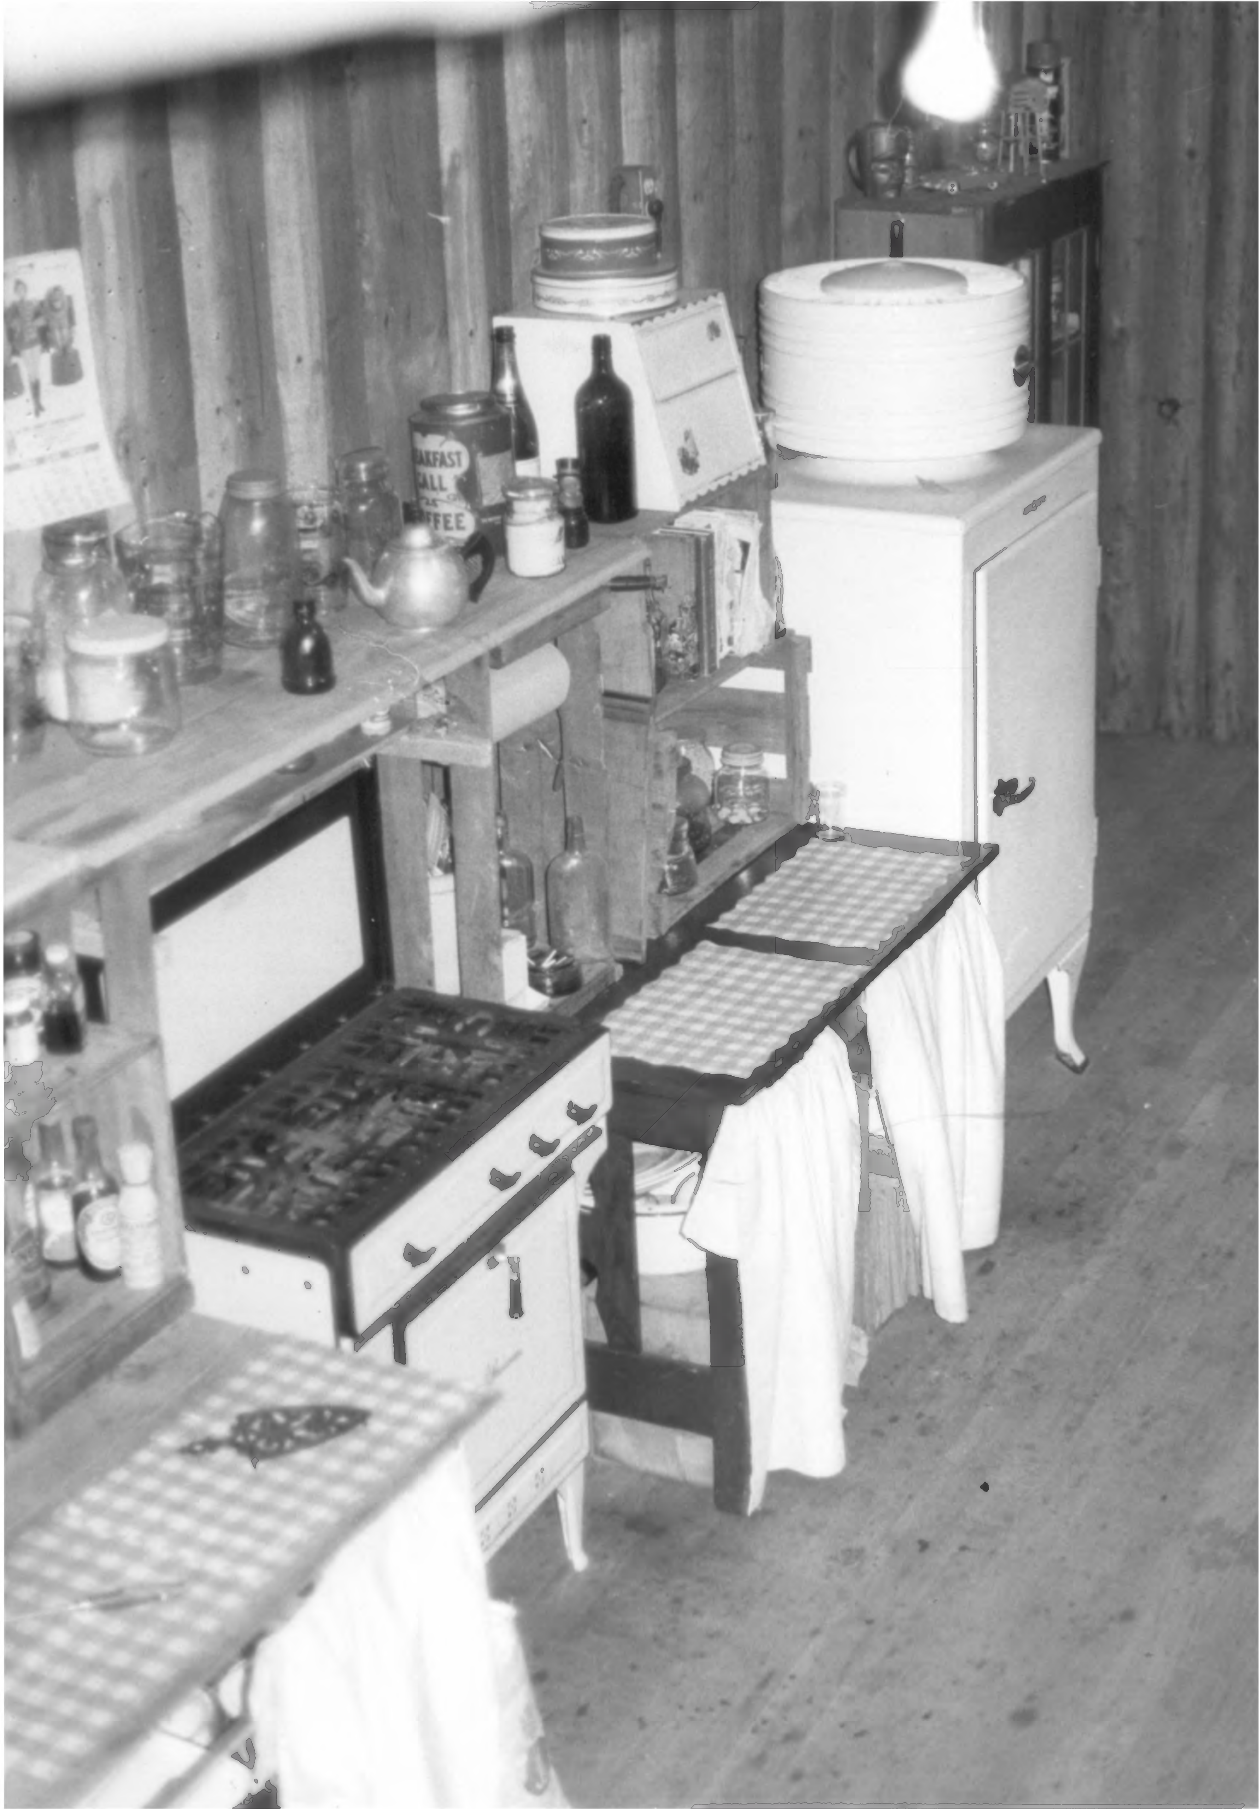
6 of 12 Interior view, showing sacristy
converted to kitchen use

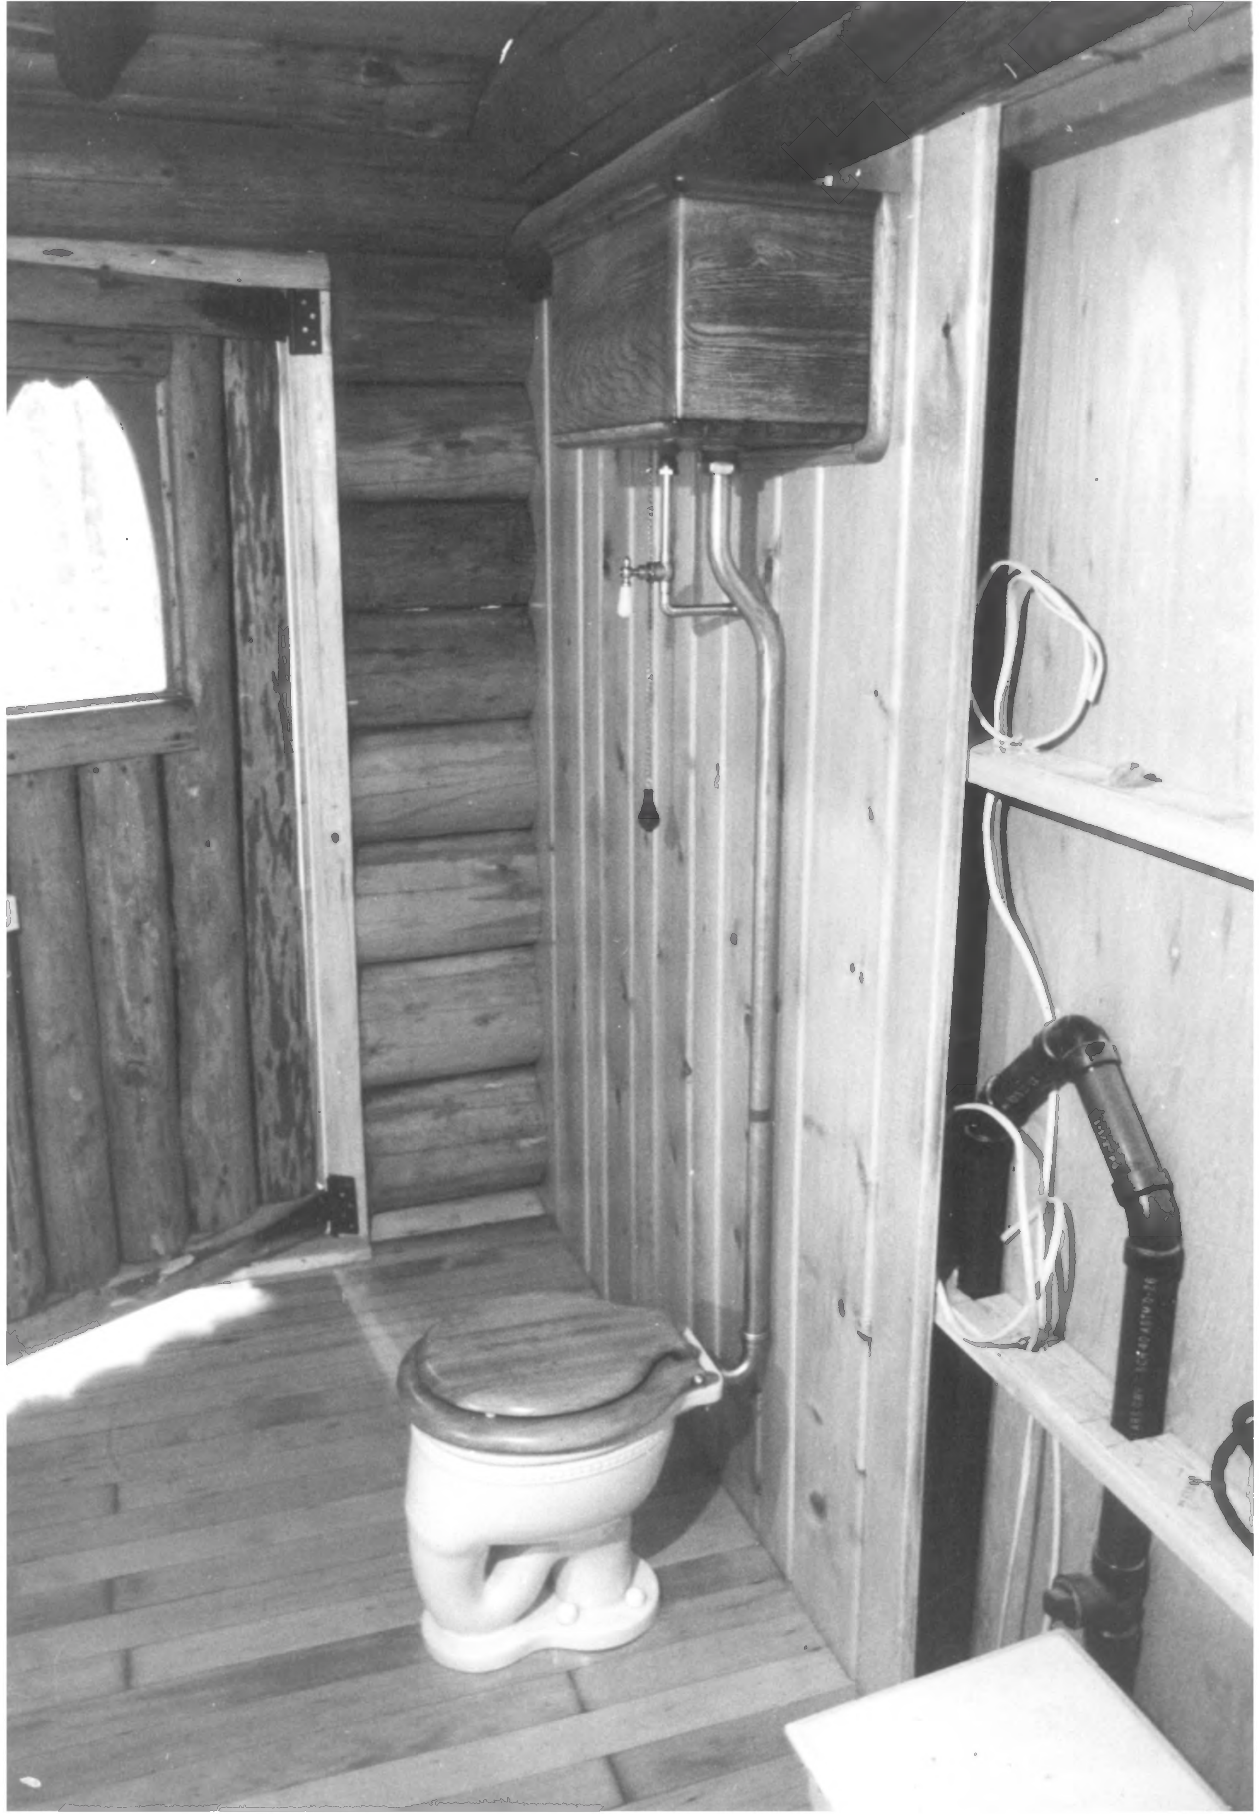
7 of 12 Interior view, showing plumbing
fixture installed in south
transept

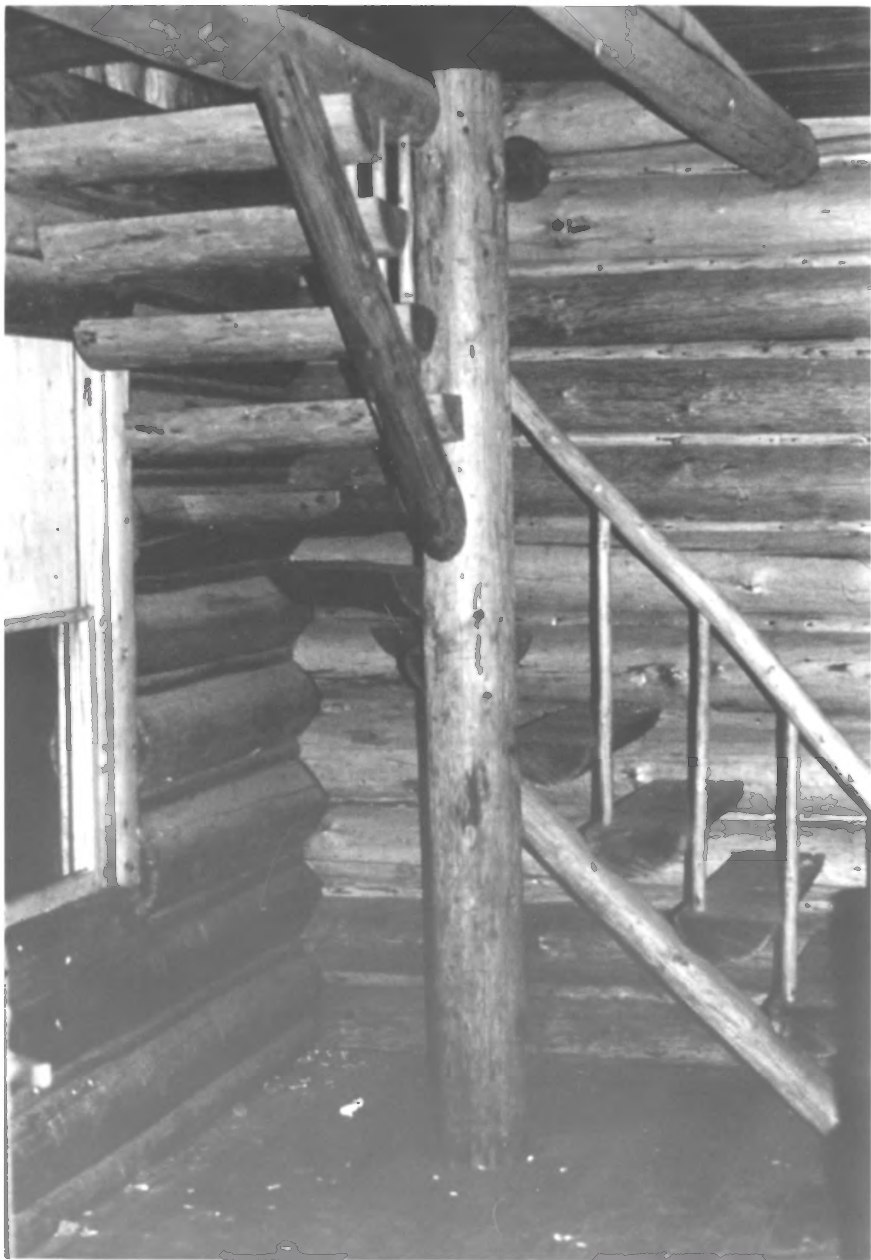
8 of 12 Detail of rustic stairway of
peeled log half-rounds and pole
railing leading from sacristy
to rectory in loft above.

The interior of the church contains confessional stalls and choir loft at the west end of the nave. The altar was situated at the crossing, and the sacristy, behind it, contains a stairway access to the rectory, or priest's quarters in the loft above. With the exception of board flooring, all interior surfaces are of peeled logs or peeled log half-rounds. Beams rafters and braces are exposed. Stairways are formed of log half-rounds--flat side up--as treads notched into the walls and resting on a chord at the string. Handrails are formed of naturalistic curved roots and branches. Balusters are peeled poles. In the choir loft railing, the peeled-pole balustrade is formed of diagonal members under a log top rail.

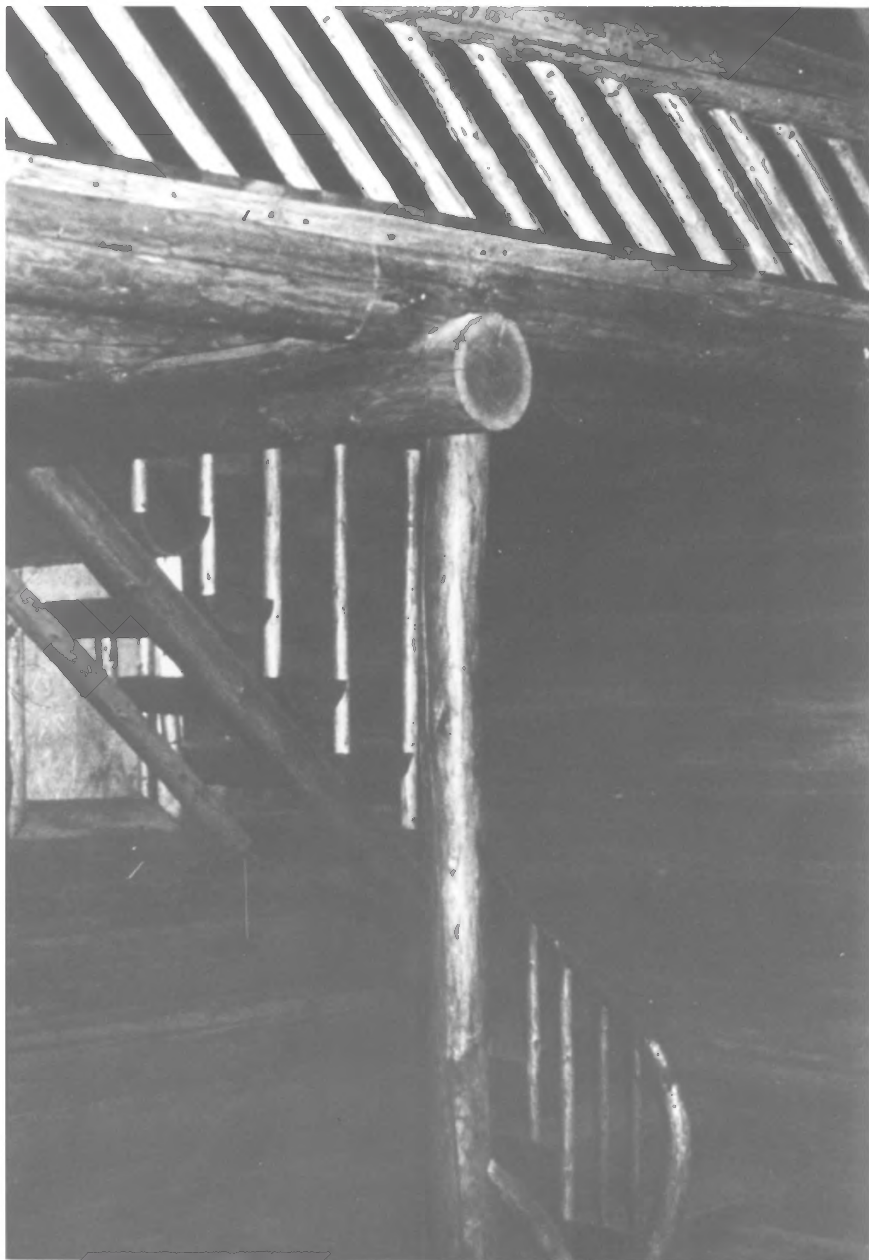
9 of 12 Detail of rustic stairway to
choir loft, west end of nave

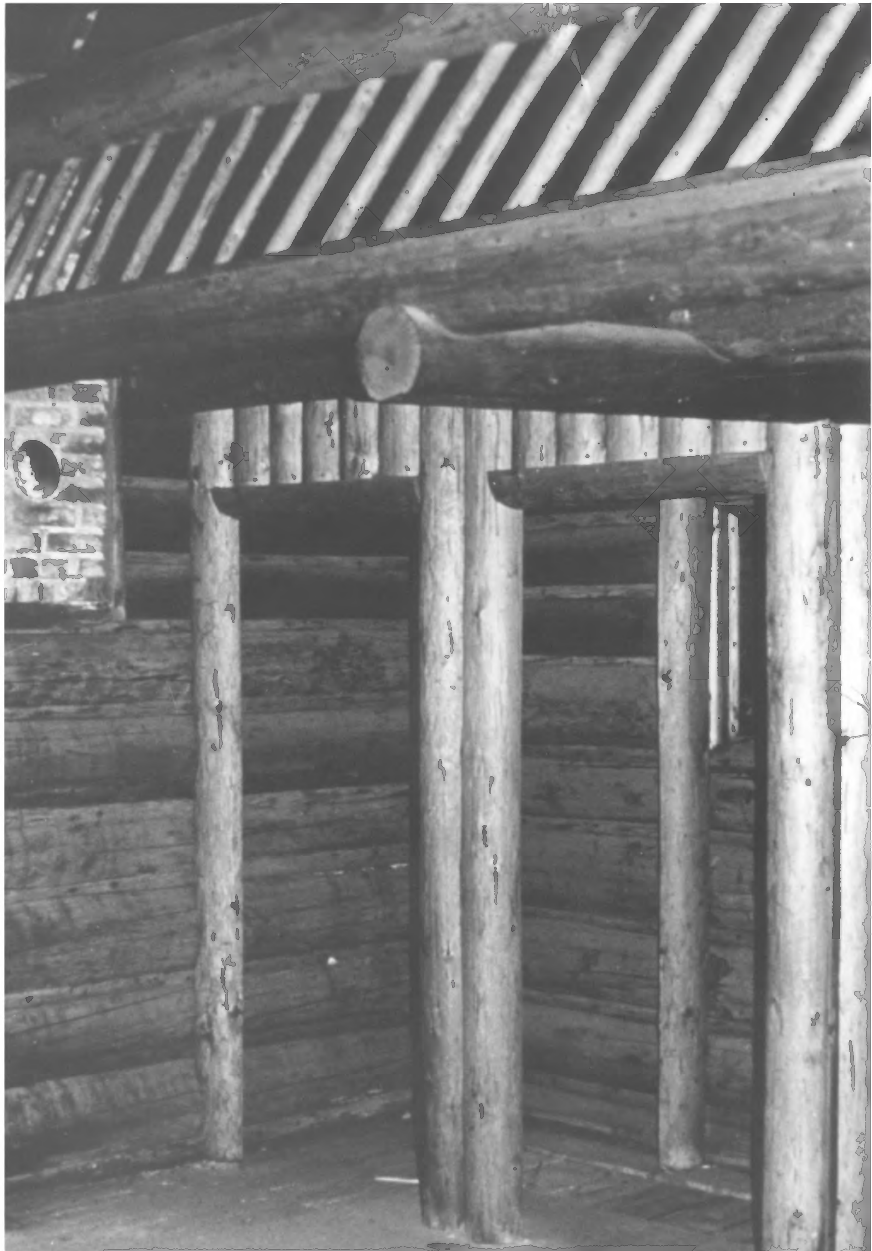
10 of 12 Detail of confessional stalls
with choir loft railing of
peeled pole diagonals above

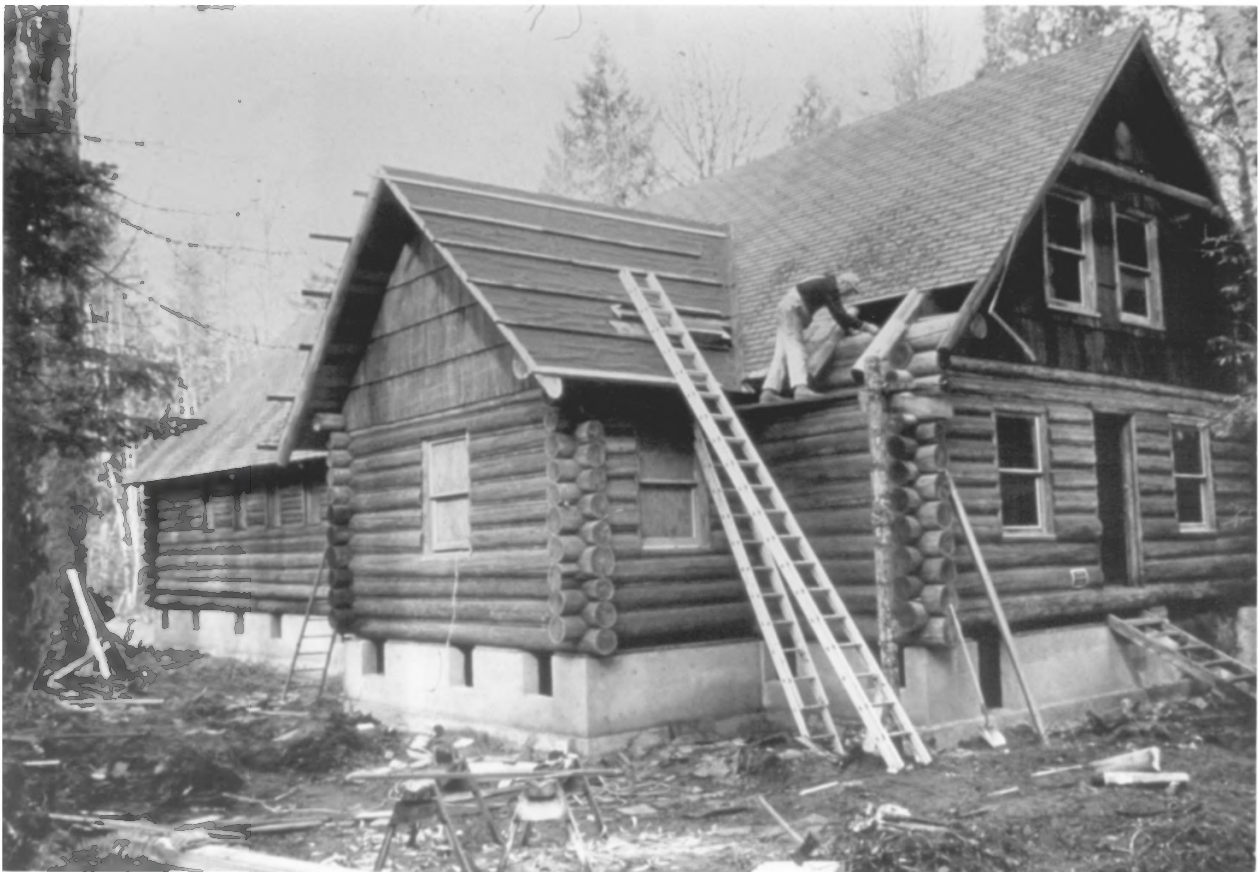
11 of 12 South and east elevations,
showing roof repair in progress

The exterior of the building has remained its original configuration, with no alteration other than the steps to accommodate a new foundation and roof repairs. The stained glass windows were removed to be used in the successor Catholic Church ca. 1972. Interior finish work is essentially intact, although, of course, spatial functions have changed. The south transept is now a bathroom; the sacristy is used as a kitchen, and the rectory in the loft is now a bedroom. While in use as a church, the building was heated with a small wood stove. Under subsequent ownership by the Mt. Hood Players, a furnace was installed, and it was necessary to cut holes in some of the walls for ducting. The ducting has been removed by the current owners, but the wall damage may be difficult to repair. The building is once again heated by a wood stove. The building had never had plumbing installed until the present day. All personal property and sacred objects were removed by the Catholic Archdiocese at the time of the abandonment 1968-1972. This included removal of pews, kneeling benches, communion rails, dias, lighting fixtures and candle holders. All windows had either been removed for reuse by the church or had been broken during the vacant period. All window openings are being reglazed.

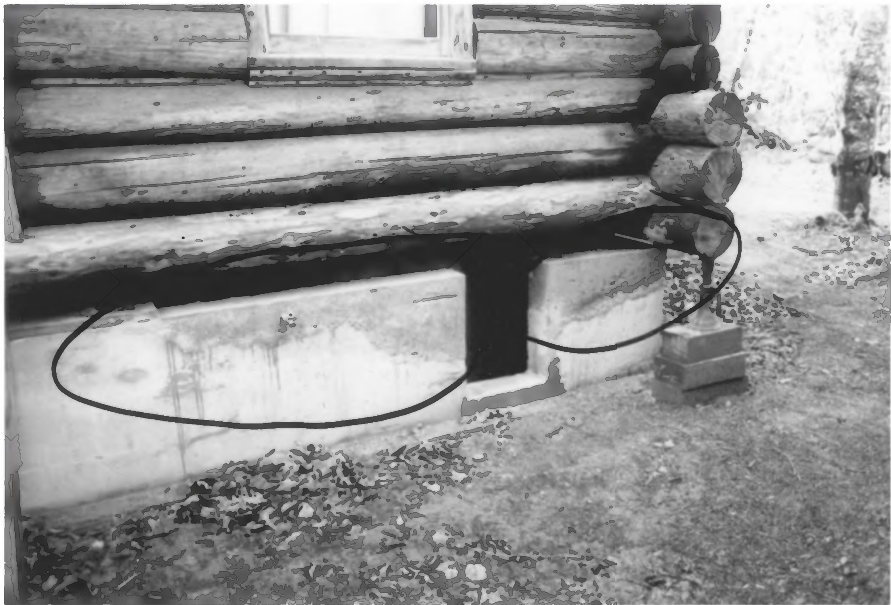
EAST END

REPAIR WORK OF
DAMAGED FOUNDATION
WALL WITH CRAWL
SPACE TEMPORARILY
LEFT OPEN FOR
PLUMBING AND
ELECTRICAL WORK
UNDER BUILDING.

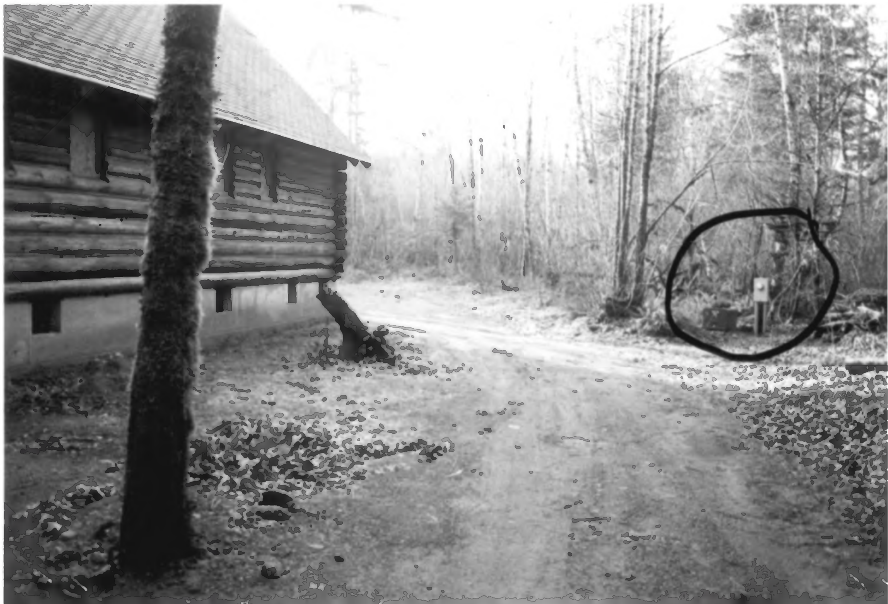
NORTH SIDE

HERE METER BASE
AND ELECTRICAL
TRANSFORMER CAN
BE SEEN SOME
DISTANCE FROM
BUILDING CONCEALED
PARTIALLY IN
BRUSH. THIS IS A
WINTER PICTURE SO
FOUAGE IS SPARSE.

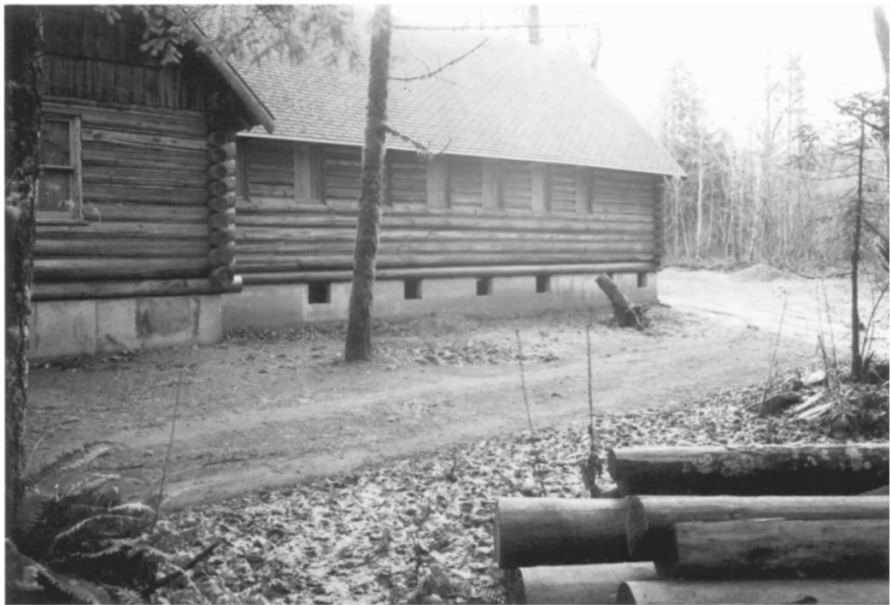
GRADUAL TAPER OF
BACKFILL WILL
EXTEND PAST NORTH
SIDE OF DRIVE TO
AVOID MOUNDED
LOOK AND PROVIDE
BETTER DRAINAGE
FOR BUILDING AND
DRIVE.
