**National Register of Historic Places
Inventory—Nomination Form**

historic ST. JOHN THE EVANGELIST ROMAN CATHOLIC CHURCH

street & number SW of Zigzag on Truman Road not for publication

city, town Zigzag vicinity of congressional district Second

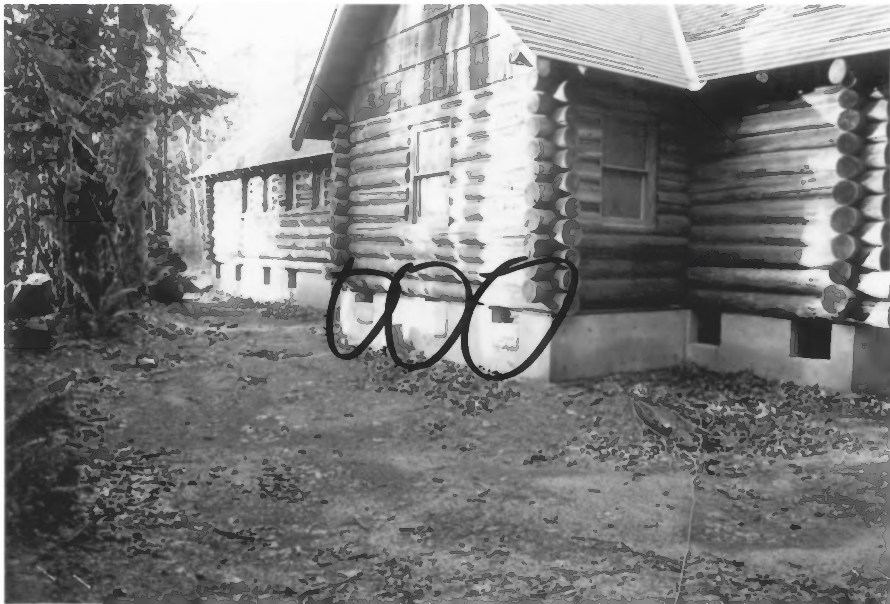
SOUTH SIDE

REPAIR WORK ON
BEAM POCKETS SHOWN
FILLED WITH TWO
VENT HOLES LEFT OPEN.

ALSO THIS SIDE WILL
TAKE BACKFILL NICELY
AS WILL THE SOUTH-
EAST AND EAST
END.

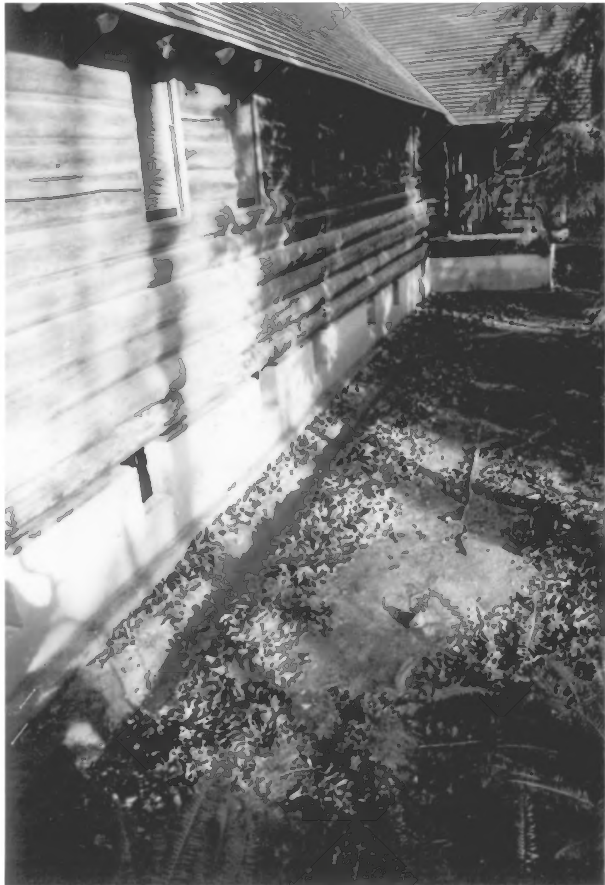
SOUTH SIDE

SHOWS APPROXIMATELY
HOW DRAINAGE TRENCH
WILL RUN. DRAIN
PIPE WILL LAY IN
TRENCH FILLED WITH
DRAIN ROCK AND THEN
APPROX 18" OF FILL
DIRT

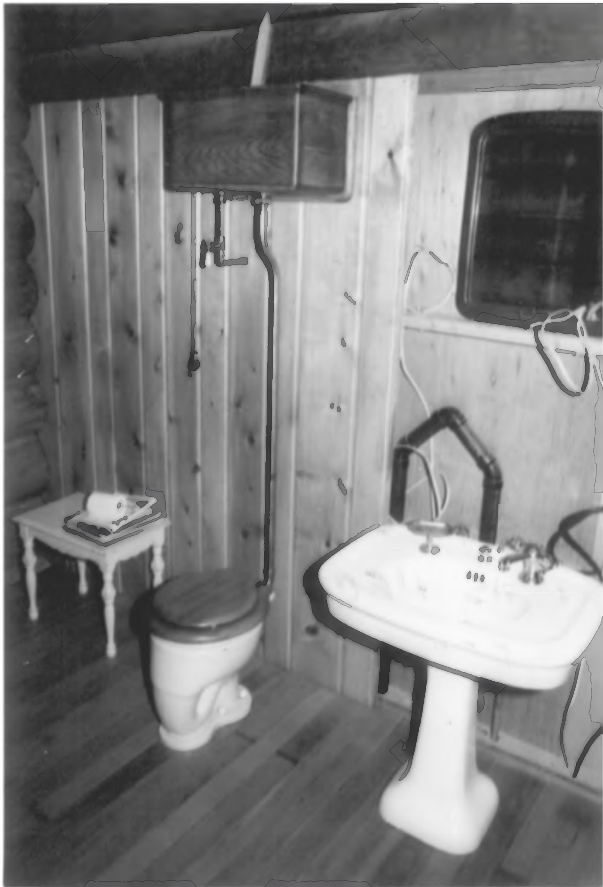
BATH WING.

OLD ORIGINAL
OAK CHAIN PUSH
TOILET (NOT A
REPRODUCTION).

ALSO NOTE KNOTTY
PINE WALL. NO
PLYWOOD IS USED IN
RESTORATION OR
RENOVATION WORK.

ALSO NOTE LOOP
VENT BEHIND LAV.

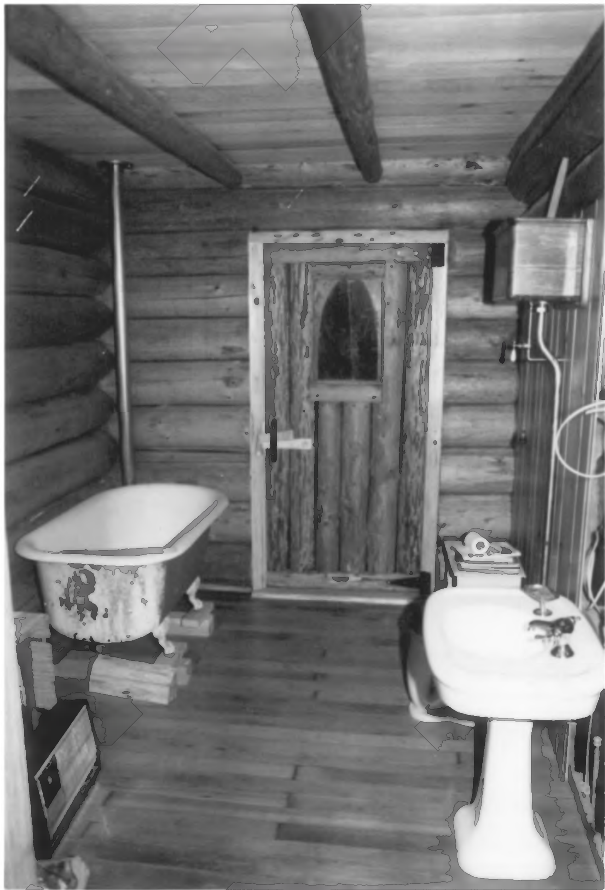
BATH WING

PARTIALLY
COMPLETED BATH
AREA USING OLD
FIXTURES OF CHURCH
ERA. NOTE EXPOSED
COPPER VENT PIPE
BEHIND TUB. IT
WAS NECESSARY TO
MEET CODE BUT
TASTEFULLY DONE.
