NATIONAL REGISTER OF HISTORIC PLACES INVENTORY -- NOMINATION FORM

DEPRESSION-ERA BUILDINGS

NAME: Lake of the Woods Ranger Station (Work Center)

- LOCATION: Winema National Forest, Klamath Ranger Distict; Congressional District 2 Vicinity of Klamath Falls, OR (41); Klamath County (035)
- ADDRESS: USDA Forest Service Winema National Forest 7th and Walnut Street, PO Box 1390 Klamath Falls, OR 97601

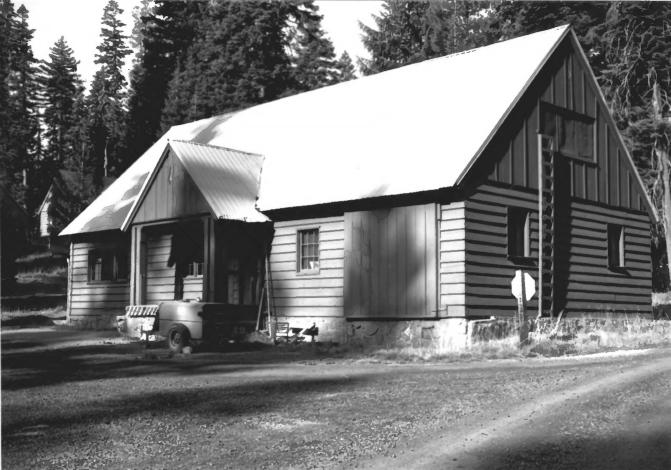
Lake of the Woods Work Center, Crew House #2202: Rectangular, 11/2 story wood frame, poured concrete foundation, coursed rubble stone veneer, high gable roof with center porch gable projecting on east (main) facade, supported by heavy squared timber posts intrinary arrangement having short flush curved brackets, straight side concrete steps access open concrete platform. Rear entry offset on north gable end. Slide-opening vertical board door offset on east facade. Horizontal clapboard (1x12) exterior to eaveline, vertical boards, corner notched, on gable ends and gable porch pediment, battens every other board on north and south gable ends. Six-over-six double-hung sash windows, single and

in combinations with mullions. Single large well-shaped pine tree centered below apex of roof, north and south gable ends, and below apex of porch gable. Textured metal roof material.

1) Name of Property: Lake of the Wood Ranger Station (Work Center) -- Crewhouse/Warehouse #2202 2) City and State: Klamath Falls, Oregon 3) Photographer: Richard Scott 4) Date: 09-22-83 5) Negative Location: USDA Forest Service, Regional Office, Recreation Unit, CRM files. 6) Description: Looking northwest at right front. 7) Photograph Number: 20-03-2202

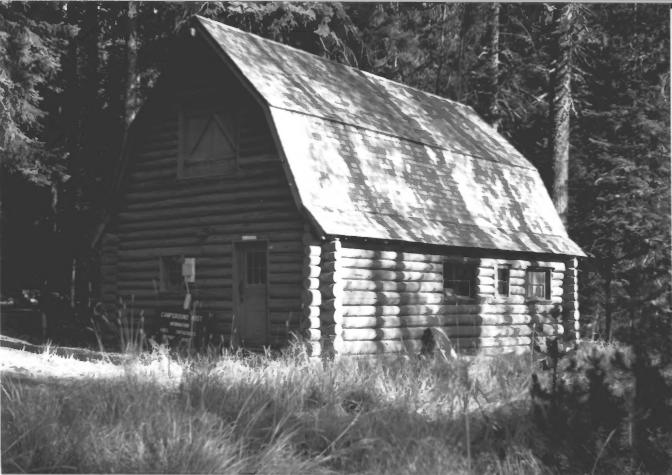
1) Name of Property: Lake of the Wood Ranger Station (Work Center)--Barn #2404

Lake of the Woods Ranger Station, Barn #2404: Rectangular; 1½ story; stone/concrete pier foundation, peeled log construction; corners round-notched, ends straight-sawn; wood-shingled high bell-cast gambrel roof, eaves project, rafters exposed, verges project, fascia alone; fenestration regular, windows on ground floor are single sash of four and six lights; single-leaf four panel door with six-light window panel offset to right on west gable and single leaf vertical board horizontal-slide opening stock door, east gable end, two-leaf vertical board hay door, center, loft level, west gable end. No apparent structural additions or alterations or obvious material changes. No decoration.

- 2) City and State: Klamath Falls, Oregon
- 3) Photographer: Richard Scott
- 4) Date: 09-22-83
- 5) Negative Location: USDA Forest Service, Region-
- al Office, Recreation Unit, CRM files.
- 6) Description: Looking northeast at right facade.7) Photograph Number: 20-03-2404

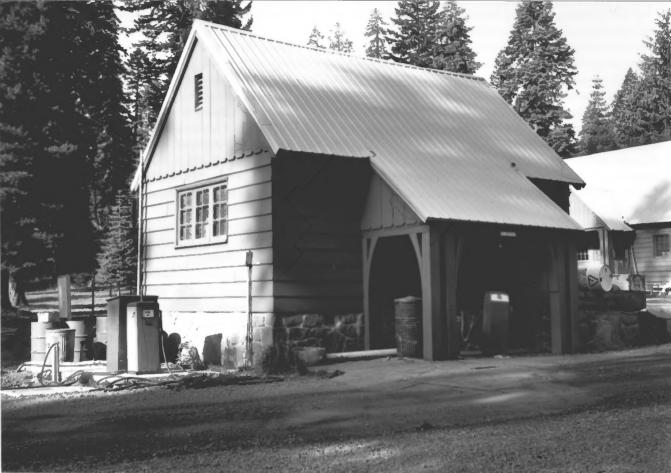
1) Name of Property: Lake of the Wood Ranger Station (Work Center)--Gas House #2502

Lake of the Woods Work Center, Gas and Lube Shed #2502: Rectangular, 1 story wood-frame, poured concrete foundation, coursed rubble-stone veneer, wood shingled high gable roof, center of north slope extends to form shed-roofed porch, supported by two pairs of heavy squared timber posts with short curving brackets, center and side, stone veneered open loading dock extends from west gable end. Main entry recessed, center, under porch roof, slide-opeing door accesses anterior from loading dock. Horizontal clapboard (1x12) exterior to eaveline, vertical boards, corner notched on gable ends with mullions. No decoration. No obvious structural alteration to exterior.

- (WORK Center)--Gas House #2502 2) City and State: Klamath Falle (0
- 2) City and State: Klamath Falls, Oregon
- 3) Photographer: Richard Scott
- 4) Date: 09-22-83
- 5) Negative Location: USDA Forest Service, Region-
- al Office, Recreation Unit, CRM files.
- 6) Description: Looking northwest at main facade.7) Photograph Number: 20-03-2502

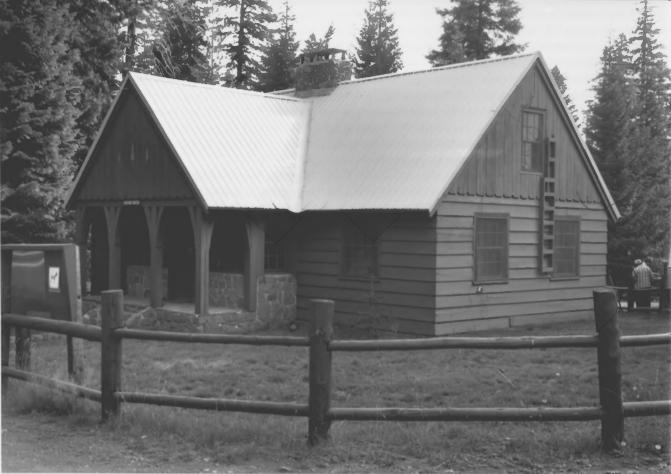
1) Name of Property: Lake of the Wood Ranger Station (Work Center)--Office #2003

Lake of the Woods Work Center, Office #2003: Cruciform, 11/2 story wood-frame, high poured concrete foundation (ea. 30"), coursed fieldstone veneer, high gable roof with center cross gable, main entry recessed under west center gable which forms porch, supported by four large squared timber posts with slender, curving brackets affixed, five straight squared rubble stone steps access open flagged surface platform. Rear entry, recessed, offset on east (rear) center gable, supported by one squared timber post, short curving bracket, accessed by five squared rubble straight steps. Horizontal clapboard (1x12) exterior to eaveline, vertical boards, corner notched, on all gable ends. Eight-over-eight double-hung sash windows. Squared rubble chimney, straddles main ridgeline above juncture of cross gables. Three well-shaped pine trees in rectilinear arrangement, the center tree larger than the flanking trees, centered on east cross-gable pediment. Textured metal roof material. Fluted knotty-pine board paneling with plain pine baseboards interior. Stone fireplace with wood mantel. Ceiling recovered with acoustical tile but boxed beams are still evident. Wood floor.

- 2) City and State: Klamath Falls, Oregon
- 3) Photographer: Richard Scott
- 4) Date: 09-22-83
- 5) Negative Location: USDA Forest Service, Region-
- al Office, Recreation Unit, CRM files.
- 6) Description: Looking southeast at right main facade.
- 7) Photograph Number: 20-03-2003

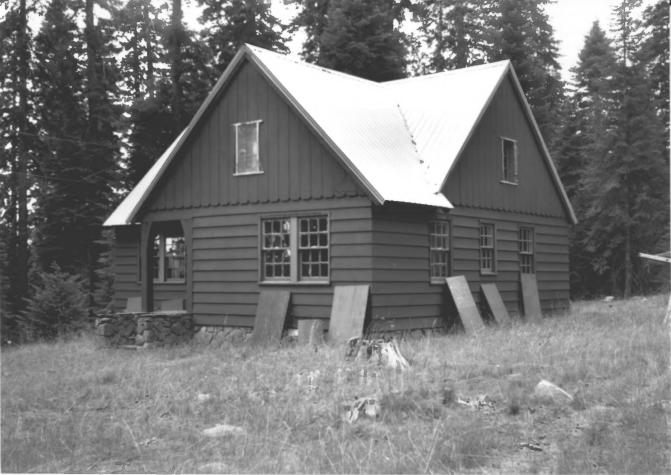
1) Name of Property: Lake of the Wood Ranger Station (Work Center)--Residence #1021

Lake of the Woods Work Center, Administrative Residence #1021: T-shaped, 11/2 story wood-frame, poured concrete foundation, coursed fieldstone veneer, woodshingled high gable roof with cross gable on east end, projecting center porch gable on south (main facade), offset in cross gable end, supported by two heavy

squared timber posts with short, flush curved brackets affixed, two coursed stone steps access open flagged-surface platform, rear entrance recessed, offset in cross-gable end on north facade, porch supported by one heavy squared timber post with short, flush curved bracket, accessed by two straight coursed rubble stone steps. Horizontal clapboard (1x12) exterior to eaveline, vertical boards, corner notched, on all gable ends. Single coursed rubble chimney offset on north slope of main gable. Eight-over-eight double-hung sash windows, boarded. No decoration. No obvious structural or material alterations to exterior. Fluted knotty-pine board paneling with plain pine baseboard, wood floors, interior. Central stone fireplace and chimney. Cellutex ceiling material interspaced by boxed exposed beams.

- 2) City and State: Klamath Falls, Oregon
- 3) Photographer: Richard Scott
- 4) Date: 09-22-83
- 5) Negative Location: USDA Forest Service, Region-
- al Office, Recreation Unit, CRM files.
- 6) Description: Looking southwest at main facade.7) Photograph Number: 20-03-1021

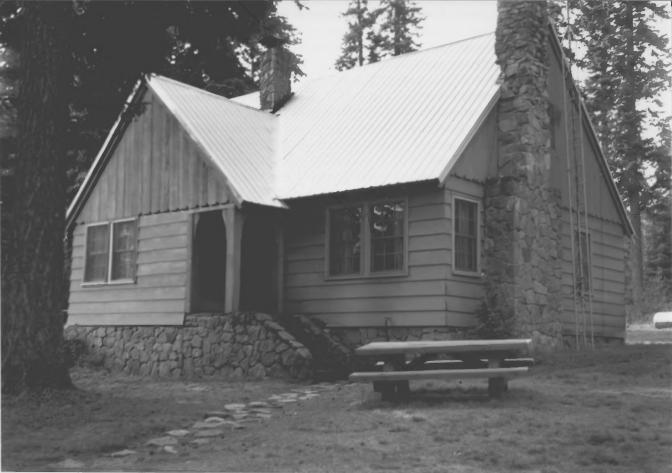
Lake of the Woods Work Center, Residence #1016: L-shaped, 11/2 story wood frame, poured concrete foundation, coursed rubble stone veneer, high gable roof with projecting offset gable on north (main facade), main entry recessed, offset on projecting gable, porch roof supported by two squared timber posts with short flush curved brackets, open flagged-surface platform accessed by five coursedstone straight side steps. Random rubble exterior end chimney offset on west gable end, large squared rubble extending to roof-line, ashlar-like masonry adjoining large squared rubble above roof-line, concrete interior chimney above offset gable on north slope of roof. Horizontal clapboard (1x12) exterior to eaveline, vertical boards, corner notched on all gable ends. Six-over-six double-hung sash windows, singly and in combinations with mullions. No decoration. Textured metal roof material.

- 1) Name of Property: Lake of the Wood Ranger Station (Work Center)--Residence #1018 (#1016 on Site Plan)
- 2) City and State: Klamath Falls, Oregon
- 3) Photographer: Richard Scott
 4) Date: 09-22-83
- 5) Negative Location: USDA Forest Service, Region-
- al Office, Recreation Unit, CRM files.
- 6) Description: Looking southeast at right front of structure
- 7) Photograph Number: 20-03-1018

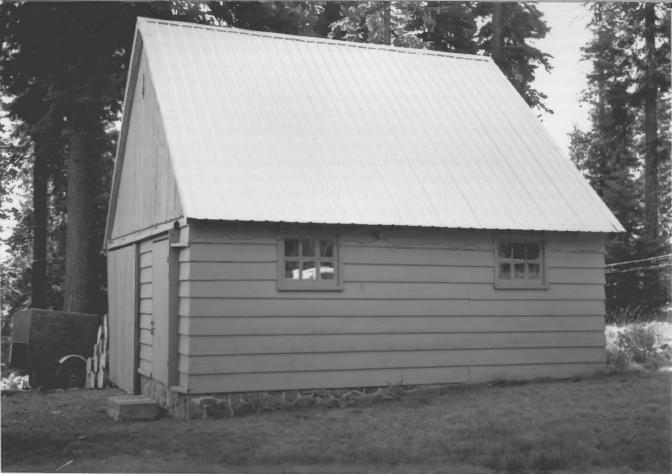
Lake of the Woods Work Center, Residence Garage: Rectangular, wood frame, poured concrete foundation, coursed rubble stone veneer, wood-shingled high gable roof. Horizontal clapboard exterior (1x12) to eaveline, vertical boards, corner notched, on gable ends. Two leaf hinged doors on north gable end. Single large pine tree cutout centered, below apex of roof on north gable end. No obvious exterior alteration.

1) Name of Property: Lake of the Wood Ranger Station (Work Center)--Garage/Building #1508 2) City and State: Klamath Falls, Oregon 3) Photographer: Richard Scott 4) Date: 09-22-83 5) Negative Location: USDA Forest Service, Regional Office, Recreation Unit, CRM files. 6) Description: Looking northwest at main facade.

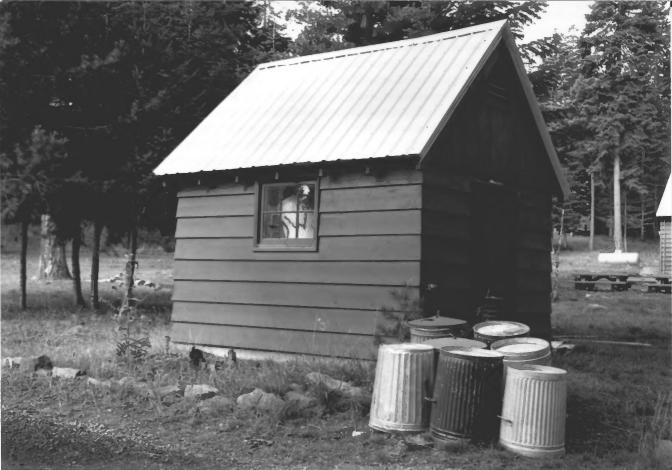
Lake of the Woods Work Center, Storage Shed #1600: Rectangular, poured concrete foundation, wood shingled high gable roof. Horizontal clapboard (1x12) exterior to eaveline, vertical boards, corner notched on gable ends. Single vertical board door, louvered ventilator lower panel, center, north gable end. Six horizontal light siongle-sash windows. No decoration. No obvious alteration.

1) Name of Property: Lake of the Wood Ranger Station (Work Center)--Storage Shed #1600 2) City and State: Klamath Falls, Oregon 3) Photographer: Richard Scott 4) Date: 09-22-83 5) Negative Location: USDA Forest Service, Regional Office, Recreation Unit, CRM files. 6) Description: Looking northwest at right front. 7) Photograph Number: 20-03-1600
