## **National Register of Historic Places Registration Form**

. Name of Property
istoric name Heathman Hotel
ther names/site number Park Haviland Hotel; Park Tower
. Location
treet & number 723 SW Salmon Street not for publication provided not for publication not for publication vicinity
tate Oregon code OR county Multnomah code 051 zip code 97205
State/Federal Agency Certification
As the designated authority under the National Historic Preservation Act, as amended,  I hereby certify that thisX_ nomination request for determination of eligibility meets the documentation standard for registering properties in the National Register of Historic Places and meets the procedural and professional requirements set forth in 36 CFR Part 60.  In my opinion, the propertyX_ meets does not meet the National Register Criteria. I recommend that this property be considered significant at the following level(s) of significance:
nationalstatewideX_local  Signature of certifying official/Title

The 1926 Heathman Hotel is located at 723 SW Salmon Street in downtown, Portland, Oregon. Specifically, it is located on lots 5 and 6 of Block 209 in the City of Portland, Multnomah County, Oregon. The buildin

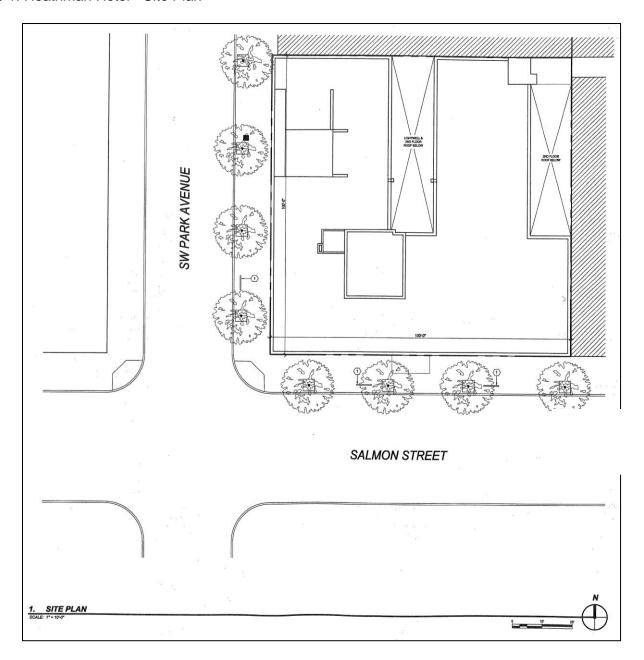
Figure 1: Heathman Hotel - Site Plan

The subject parcel is 10,000 square-feet. The building is constructed to the lot lines. The site is fully developed, and slopes slightly down from west to east and from south to north. There are no character-defining landscape features. Framing the building on the south and west sides are sidewalks with street trees.

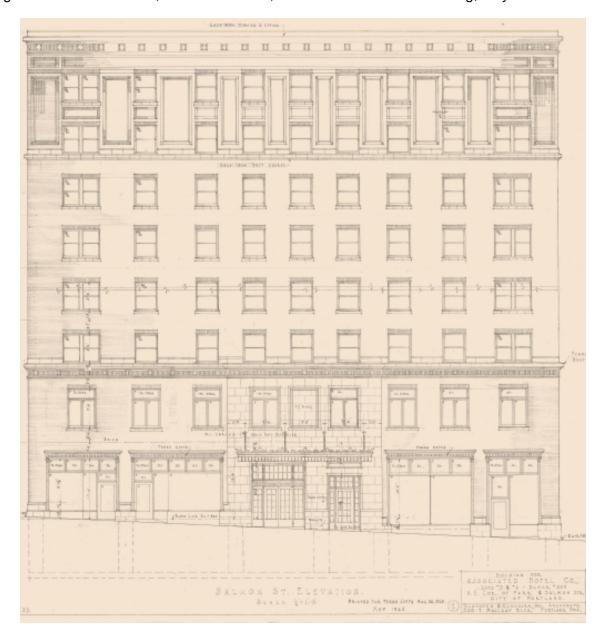
Figure 4: South Elevation, Heathman Hotel, Clausen and Clausen drawing, May 1925

The building's primary façade faces south onto Salmon Street with a second primary façade facing west onto Park Avenue. Both façades are similar in design and materials. Both are clad in tapestry brick that vary in shading from deep red to black. Brick is laid in a stretcher bond with gray mortar. Upper floor windows are double-hung, one-over-one lights with original wood frames and white terra cotta sills; within the frames, the sashes have been replaced with modern sashes.

Vertically, fenestration divides the 100-foot wide south façade into nine vertical bays. The outside bays are slightly wider with windows divided by a wood mullion. The seven interior bays each have a single window in the center; west bays are slightly narrower than the outer bays.

Horizontally, a classically detailed terra-cotta belt course above the third-floor and a painted sheet-metal belt course above the ninth floor divide the façade into a traditional tripartite configuration with a two-story base, seven-story shaft, and two story capital. The base is defined by terra-cotta and glass-fiber reinforced-concrete (GFRC) skin. At the first floor is a central entry flanked by two storefronts on each side, with the outside storefront narrower than the inside. Storefronts are modern aluminum frame with plate glass surmounted by a multi-light transom. At the second-floor are casement windows surmounted by a transom; the easternmost second-floor window is substantially larger as it fills the opening of a one-time pedestrian bridge installed in the 1960s and then removed in the 1980s. The seven-story shaft above is consistent from floors three to nine with tapestry brick and one-over-one-light windows. The two-story capital is distinguished by distinctive decorative brickwork. This brickwork includes rectangular brick panels in header bond between each window that runs the height of the capital. These panels are similar but the three central west windows are narrower than the remaining windows. Complementing this ornamentation are spandrels of similar rectangular brick panels in header bond. The brick just below the cornice features a horizontal band displaying a similar design. The cornice is classically detailed, painted sheet-metal.

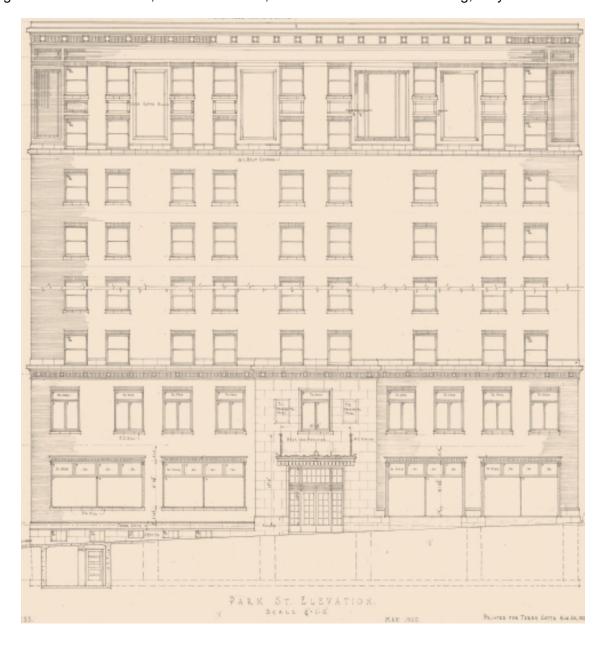
Figure 5: West Elevation, Heathman Hotel, Clausen and Clausen drawing, May 1925

The west façade is very similar to the south in materials and general organization. At the ground-floor, the central entry is narrower than its counterpart on the south elevation. Also, on the west, upper floor windows are paired in four of five bays; the second bay from the south being different with only a single window. This contrasts with the south façade, where fenestration is consistent. Similar to the south elevation, the windows at the eleventh floor were again widened.

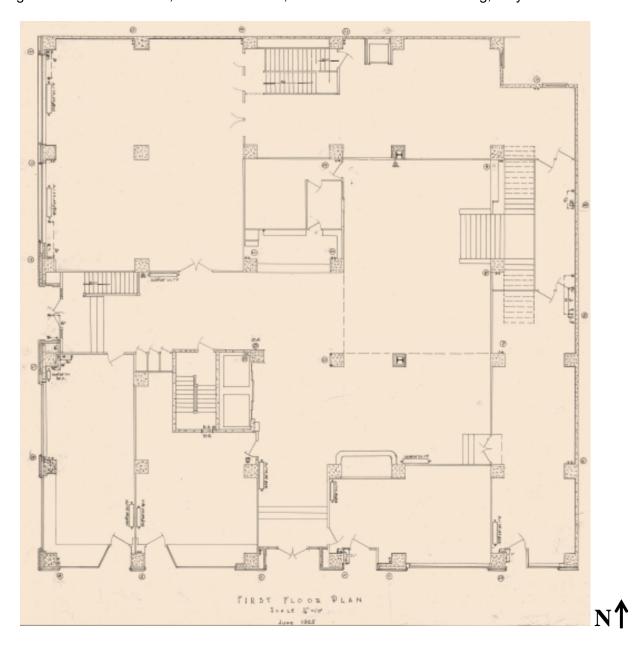
Figure 6: First Floor Plan, Heathman Hotel, Clausen and Clausen drawing, May 1925

The hotel was entered primarily from a doorway at the center of the south façade, supplemented by a second entry at the center of the west façade. These two entry corridors led to the hotel lobby, a two-story space at the northeast with an open stair along the east wall. To the northwest was a formal dining room. Along Salmon Street at the south were retail storefronts. Finishes then included travertine marble at the entries, stained wood paneling in the lobby and a wood-beamed ceiling. In the 1984 rehabilitation, when the building was adapted for affordable housing, the first floor was modified. The south entry became the sole entry to the building; the west entry was incorporated into an expanded leased commercial space at the west. The dining room at the northwest corner also became part of that retail space, though none of the original finishes remained. The building lobby was the width of the south entry with building offices north just beyond the elevators. The remaining portion of the lobby, including the two-story space, was walled off and incorporated into an expanded commercial space to the east. This space retained the wall panels and beamed ceiling.

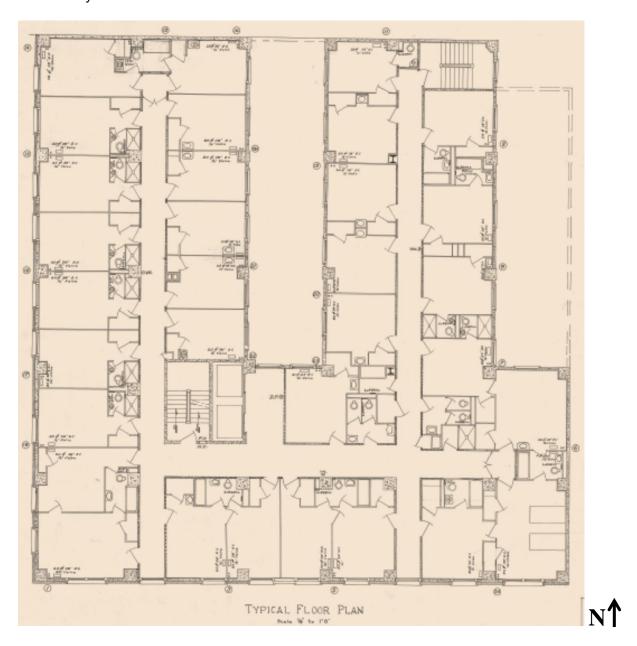
Figure 7: Typical Floor Plan (Floors 3-11), Heathman Hotel, Claussen and Claussen drawing, May 1925

Floors three through ten were built as guest rooms, organized around a double-loaded "U"-shaped corridor with the hotel lobby located at the center rear. Today, these floors retain their original form but the hotel rooms

have been adapted into single-room occupancy accommodation. As built, each floor had 29 rooms. Some included only a sink/toilet; others shared a bath, while others had a full private bath. In the renovation, a bathroom and kitchenette was installed in each room. As built, the eleventh floor was similar to the lower guest room floors.

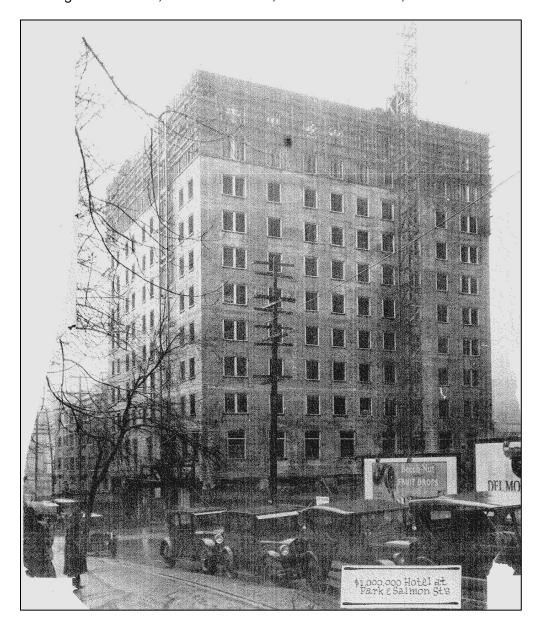
Figure 8: Looking NE from SW, Heathman Hotel, under construction, circa 1925

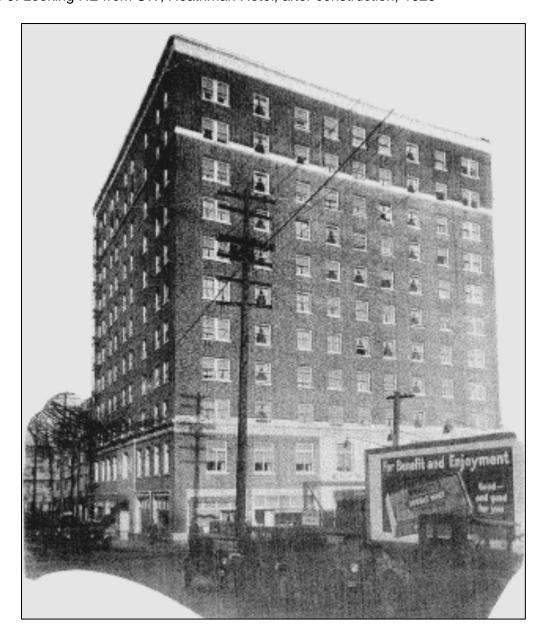
Figure 9: Looking NE from SW, Heathman Hotel, after construction, 1926

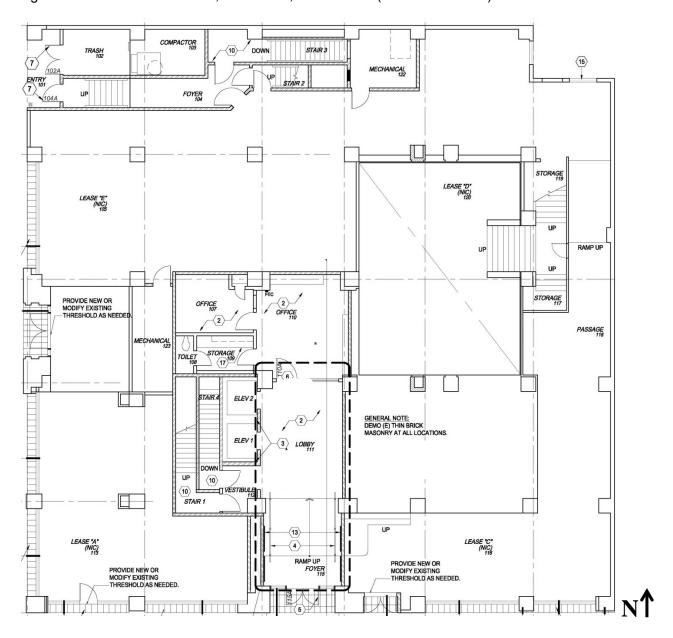
Figure 12: Current Floor Plans, First Floor, Park Tower (Heathman Hotel)

The interior has been modified twice. In the 1960s, the eleventh floor was adapted from guest rooms to a swimming pool and "sky lounge" in an attempt to meet market demands. In the 1980s, the building, which by this time had become private senior housing, was first closed for fire, building and other code violations, and then modernized for government-sponsored senior housing. This 1980s renovation modified the ground floor by expanding the commercial lease spaces, adapted the second floor for guest units, returned the eleventh floor to guest units, and modernized units on floors three through ten. The modernization included installing individual bathrooms and kitchenettes into each unit, as well as air conditioning the entire building. Just recently, the interior was again modernized using federal historic tax credits with updated systems and finishes but without any reconfiguration.

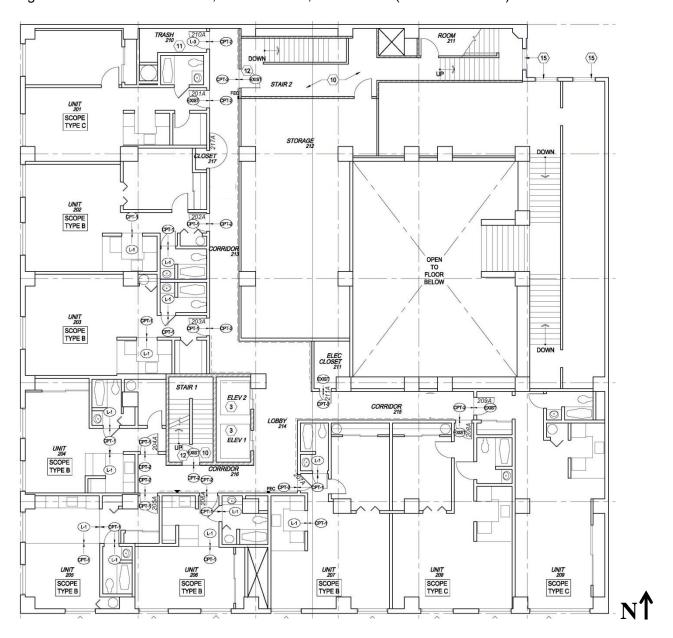
Figure 13: Current Floor Plans, Second Floor, Park Tower (Heathman Hotel)

As built, the second floor housed dining spaces at the west and south, along with a beauty parlor at the southeast corner. It also included a mezzanine overlooking the lobby with the lounge. Following the 1984 renovation, the mezzanine was retained but the remainder of the floor adapted to nine rental units.

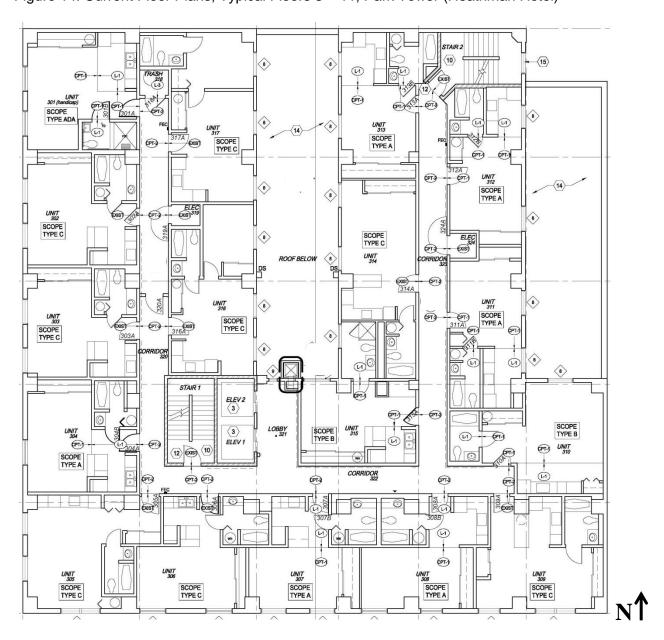
Figure 14: Current Floor Plans, Typical Floors 3 – 11, Park Tower (Heathman Hotel)
