NATIONAL REGISTER OF HISTORIC PLACES
INVENTORY -- NOMINATION FORM

HISTORIC
Dunn (Patrick) Ranch
AND/OR COMMON

STREET & NUMBER: 4224 Highway 66
CITY, TOWN: Ashland
STATE: Oregon
VICINITY OF: 4th
COUNTY: Jackson
CONGRESSIONAL DISTRICT: 4th
CODE: 029

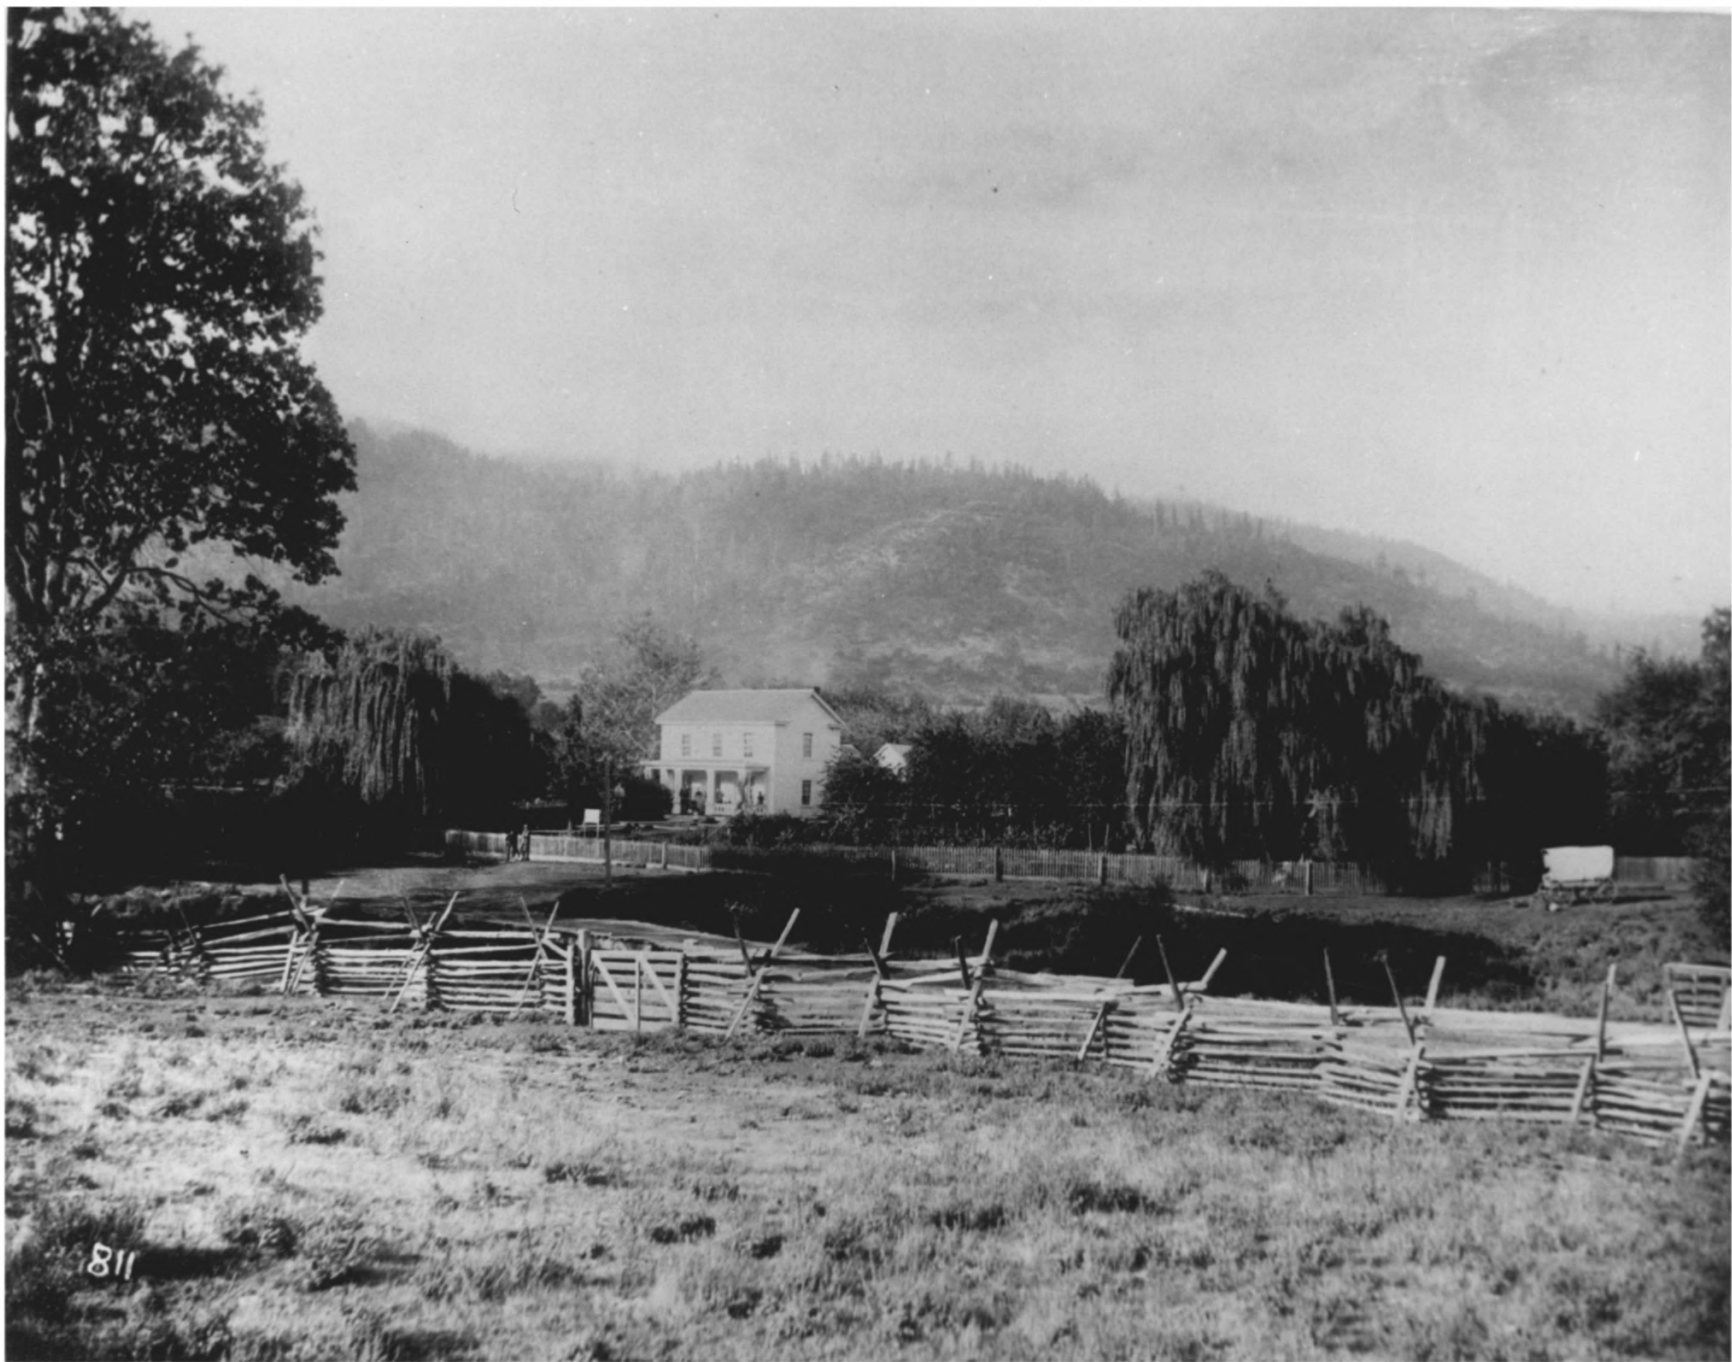
Dunn (Patrick) Ranch **JAN 31 1978** of 4
Ashland, Jackson County, Oregon
Undated historic view by Peter Britt
(estimated date: 1880s)

shows front (east and north elevations)
of house from Territorial Road

Front (east) Porch -- access to the porch is via four risers (wood). The porch is covered by a low hipped roof supported by four turned wood columns. Two additional posts are engaged with the east wall. A simple railing of square members engages the columns and defines the porch. An historic view of the house taken sometime prior to the turn of the century shows that the porch posts at one time were decorated clustered columns, typically paired, and they had a more substantial--perhaps pierced--railing in between them.

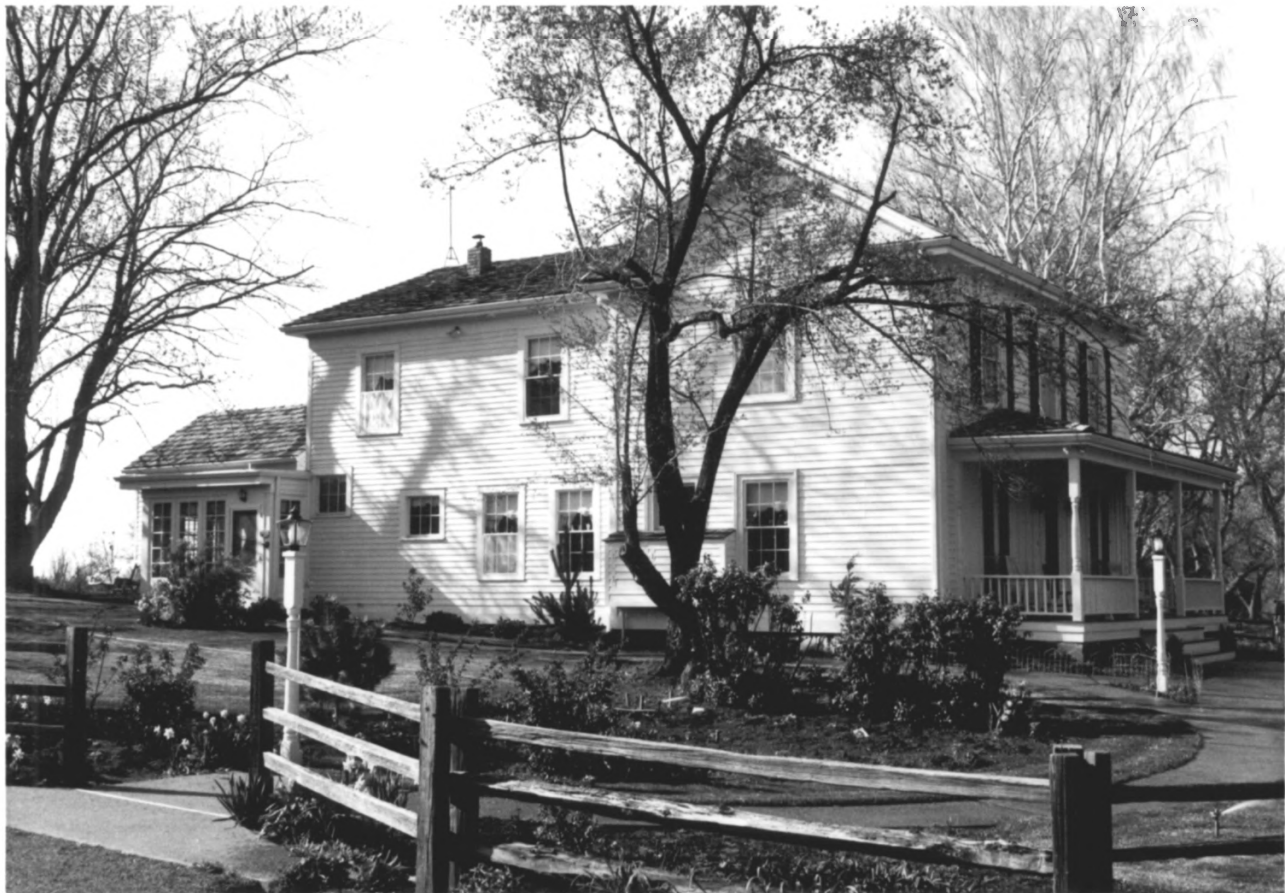
Dunn (Patrick) Ranch 2 of 4
Ashland, Jackson County, Oregon

South and east elevations
Robert Fink photo, 1977 MAR 8 1978

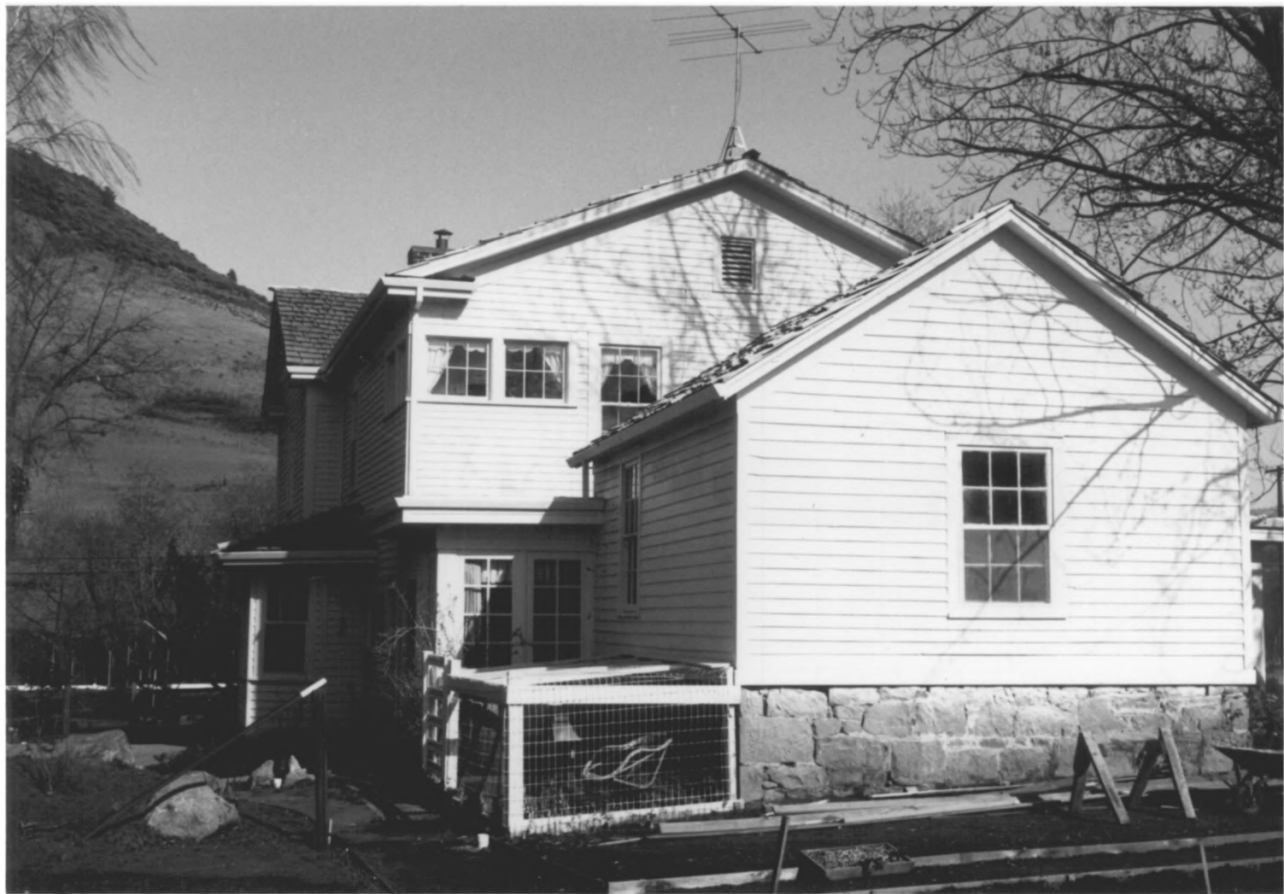
Dunn (Patrick) Ranch 3 of 4
Ashland, Jackson County, Oregon

West and north elevations, showing root
cellar and recently enclosed porch above,
polygonal bay projecting from kitchen
wall. Robert Fink photo, 1977.

Based on recollections of members of the Dunn family, the house is understood to have been remodeled somewhat and enlarged around 1910. The rear portion of the house was raised to two stories, and a rear porch was added. A polygonal bay window in the north wall of the kitchen is believed to date from this time. The back porch was enclosed by the present owners in 1970, and structural tie-beams were also added by the new owners to downstairs rooms as a stabilization measure.

Roof -- the house and attached root cellar are covered by gabled roofs. Although the house is generally rectangular in plan due to similar widths of the two sections, the east portion has an axis which aligns north-south; therefore, the roofs of each section intersect with each other. On the ends, gable verges project. Eaves feature a boxed cornice above a wide frieze. Two brick chimneys project through the roof; one from each of the two sections. The roofs are presently sheathed with wood shakes.

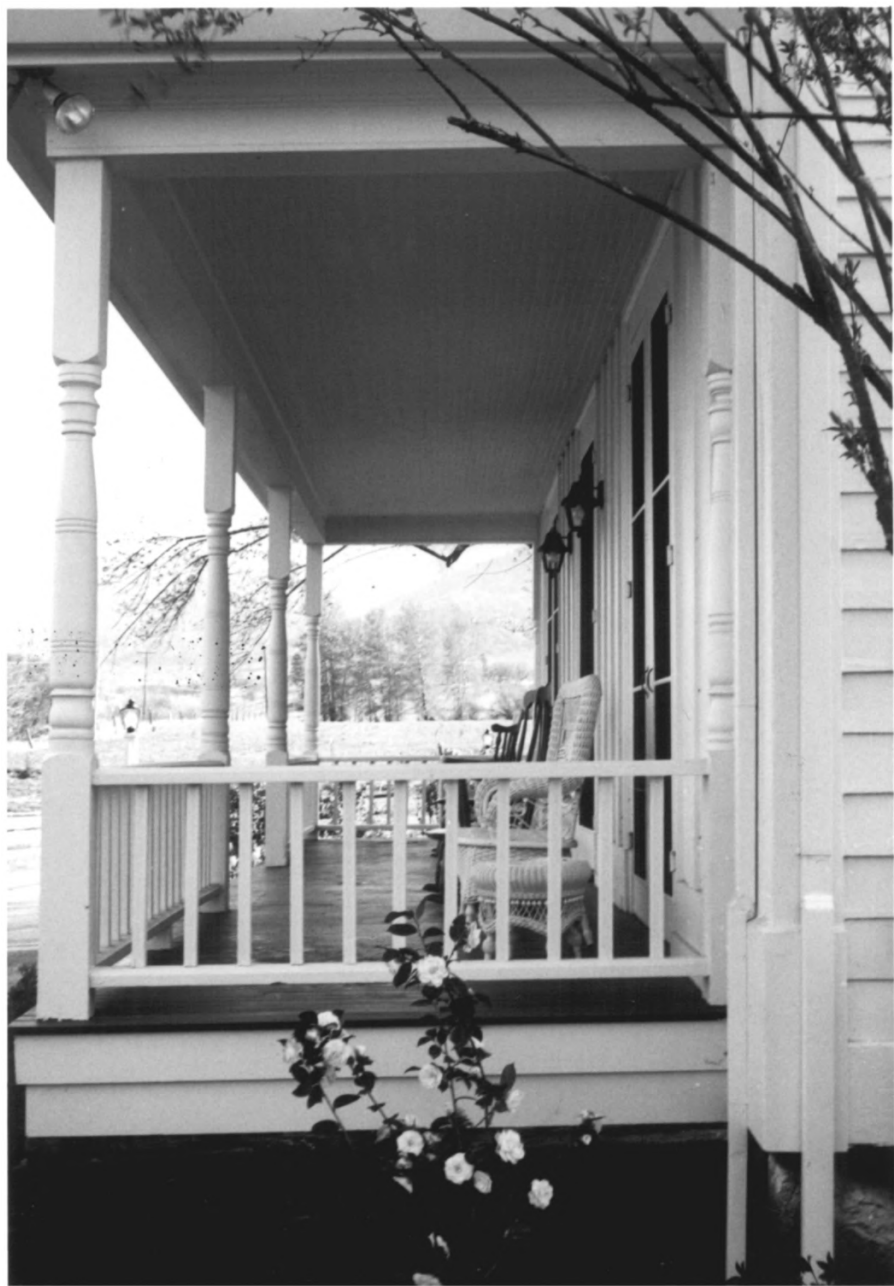
Dunn (Patrick) Ranch 4 of 4
Ashland, Jackson County, Oregon

Front porch with current post and railing treatment believed to date from 1910 remodeling. Looking south.
