**National Register of Historic Places
Inventory—Nomination Form**

historic Markle-Pittock House

street & number 1816 SW Hawthorne Terrace ~~N/A~~ not for publication

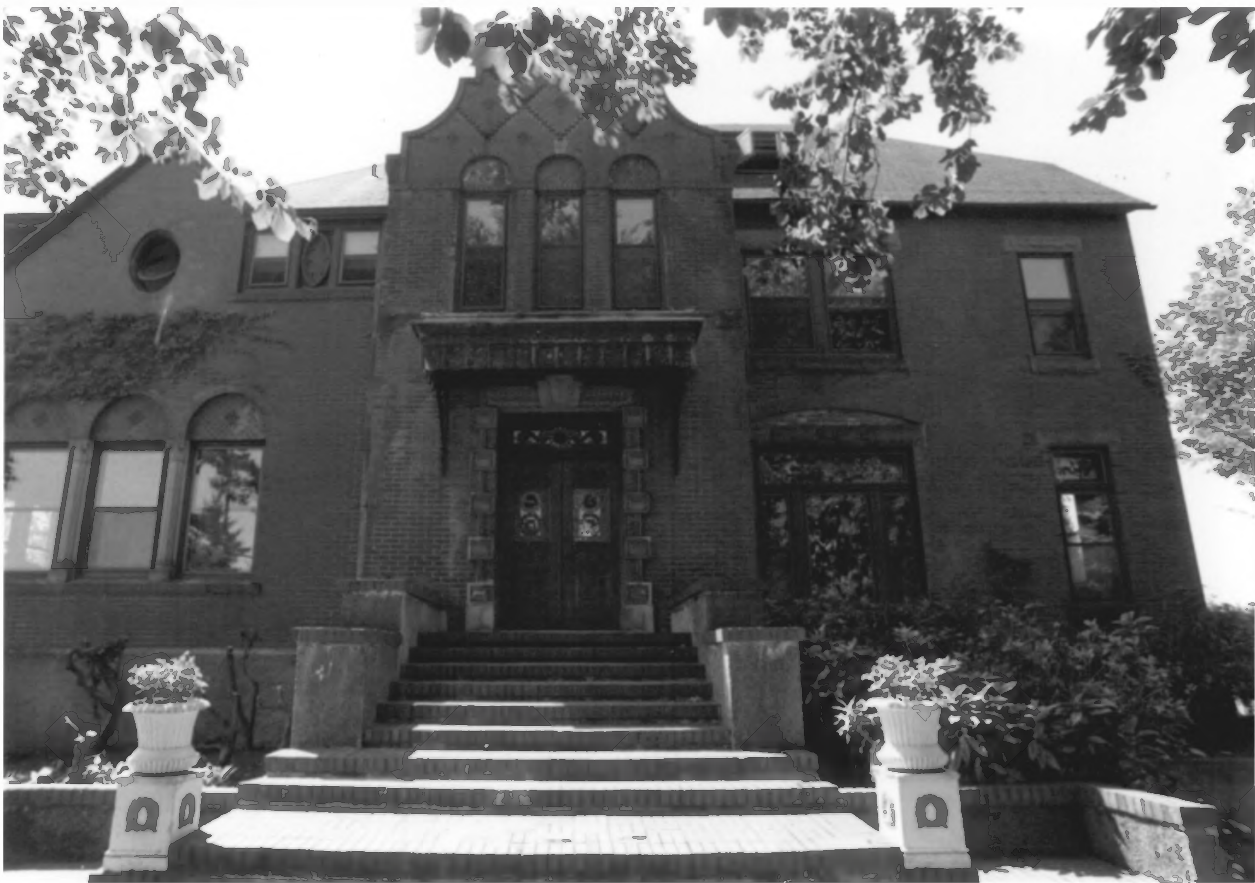
4 of 29

DESCRIPTION: Main entrance north elevation

gable ends were either bricked (east), covered with slate (west), or given a new meandering Jacobethan style parapet (north). The northeast corner, once the location of the two-story veranda, was eliminated. Using essentially the same ground floor area, a new living room-master bedroom wing was added. On the north elevation of the main floor, the three windows are joined by keystoned arches with decorative brickwork in the tympanum, which complements the altered upper window treatment in the entrance bay.

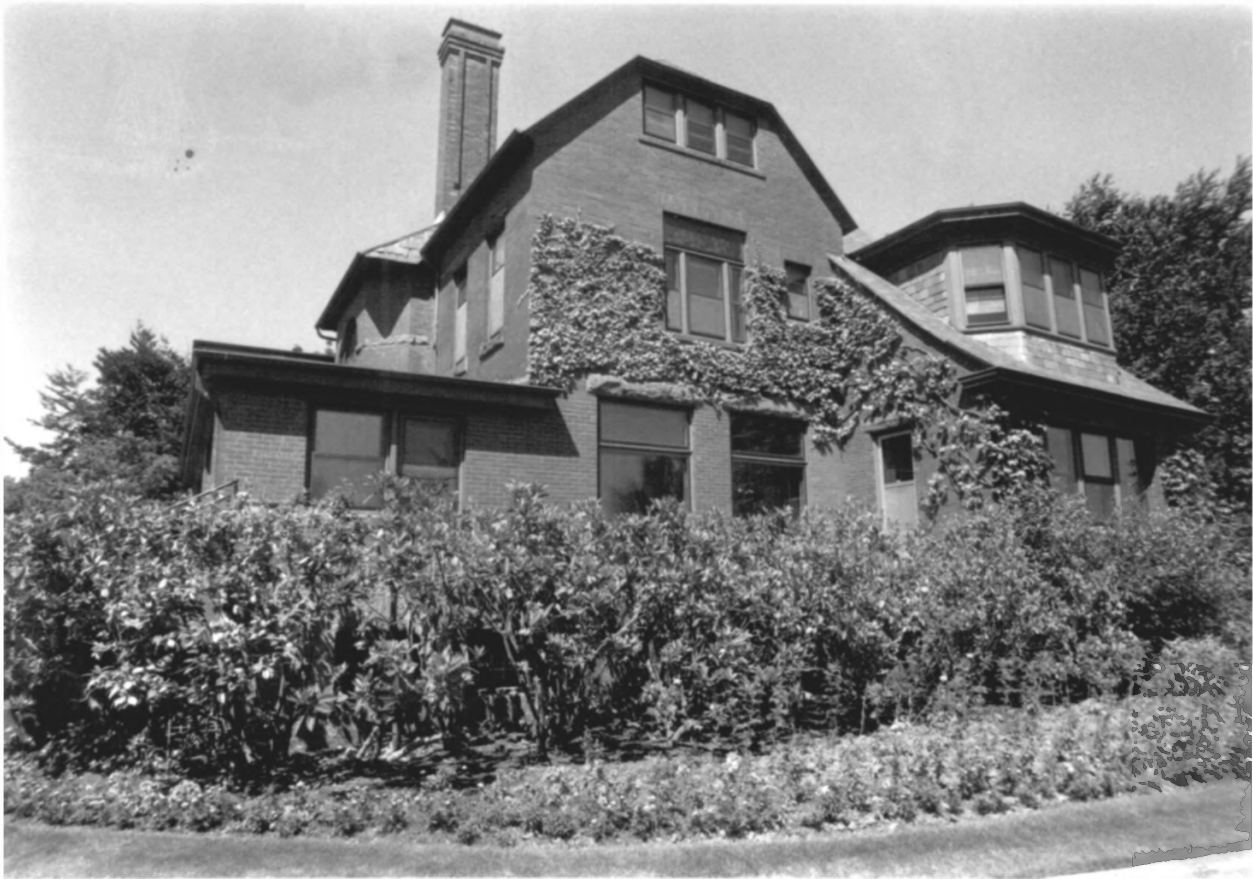
5 of 29

DESCRIPTION: East elevation

A large, slant-bay dormer is located above the living room on the eastern downslope of the new wing and corresponds to the master bedroom space upstairs. Other alterations to the exterior include a new metal and glass marquee, a terrace on the eastern elevation which links the living room and the one-story sun room and open porch, also an addition located on the southern elevation. Also constructed at the same time was a two-story addition to the southwest corner which serves the kitchen facilities on the lower floor and as a conservatory or sun room on the upper floor.

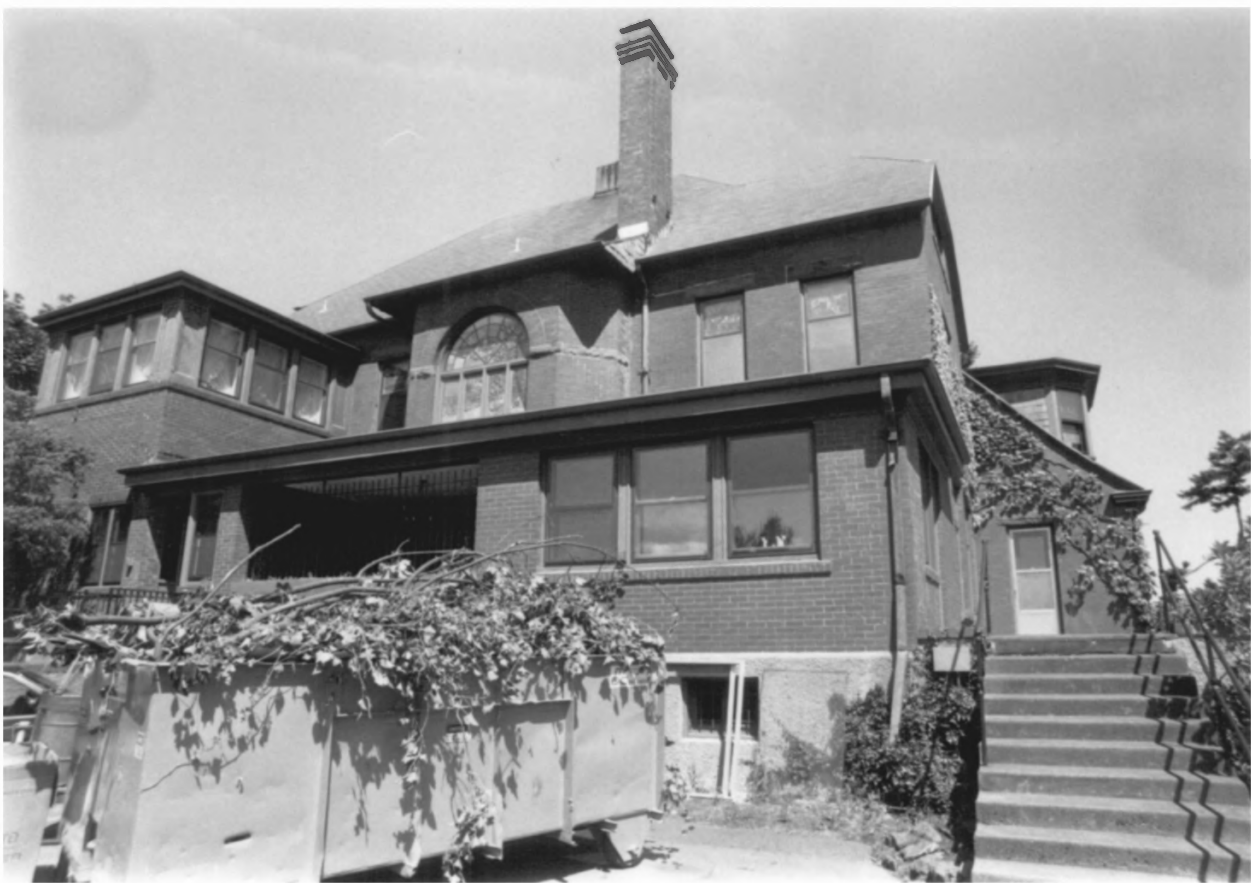
6 of 29

DESCRIPTION: Rear of house south elevation

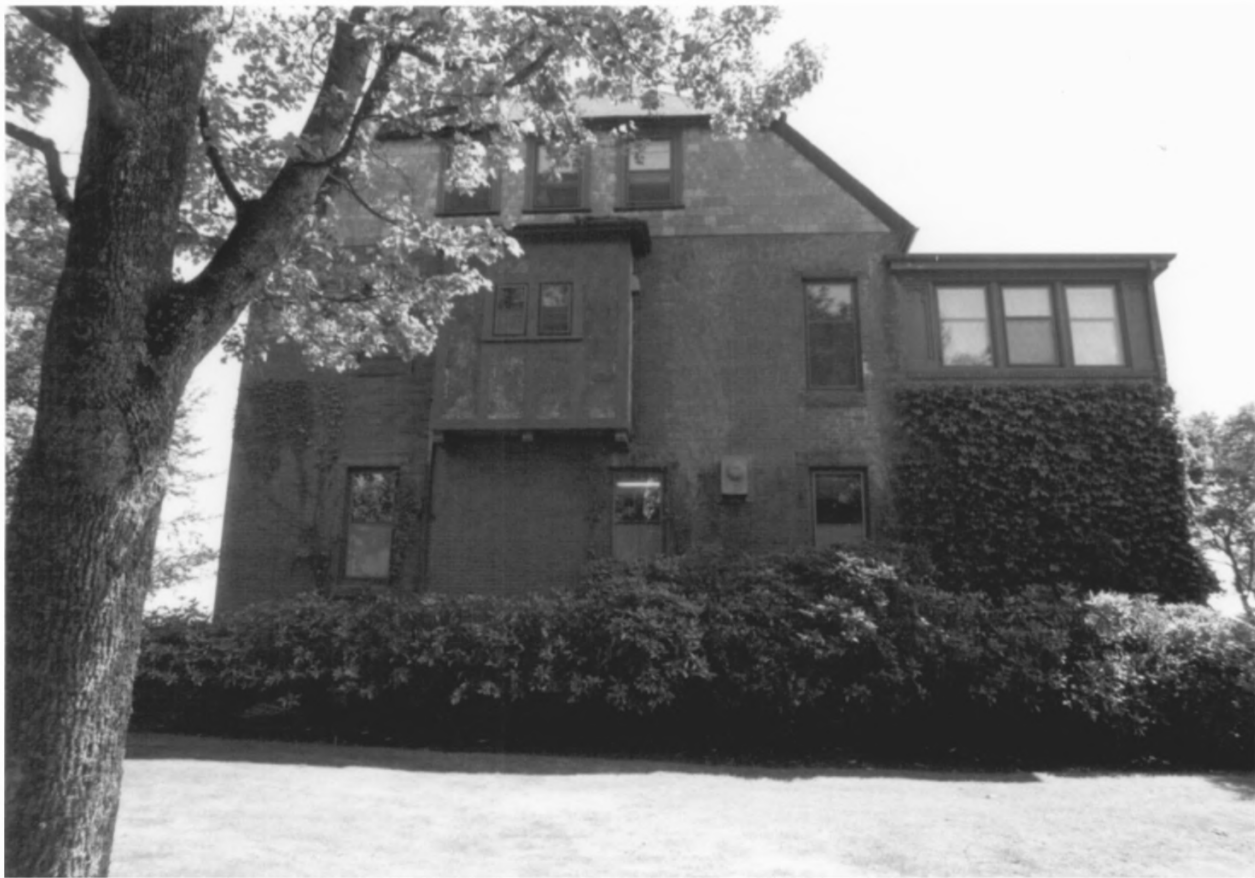
7 of 29

DESCRIPTION: West elevation

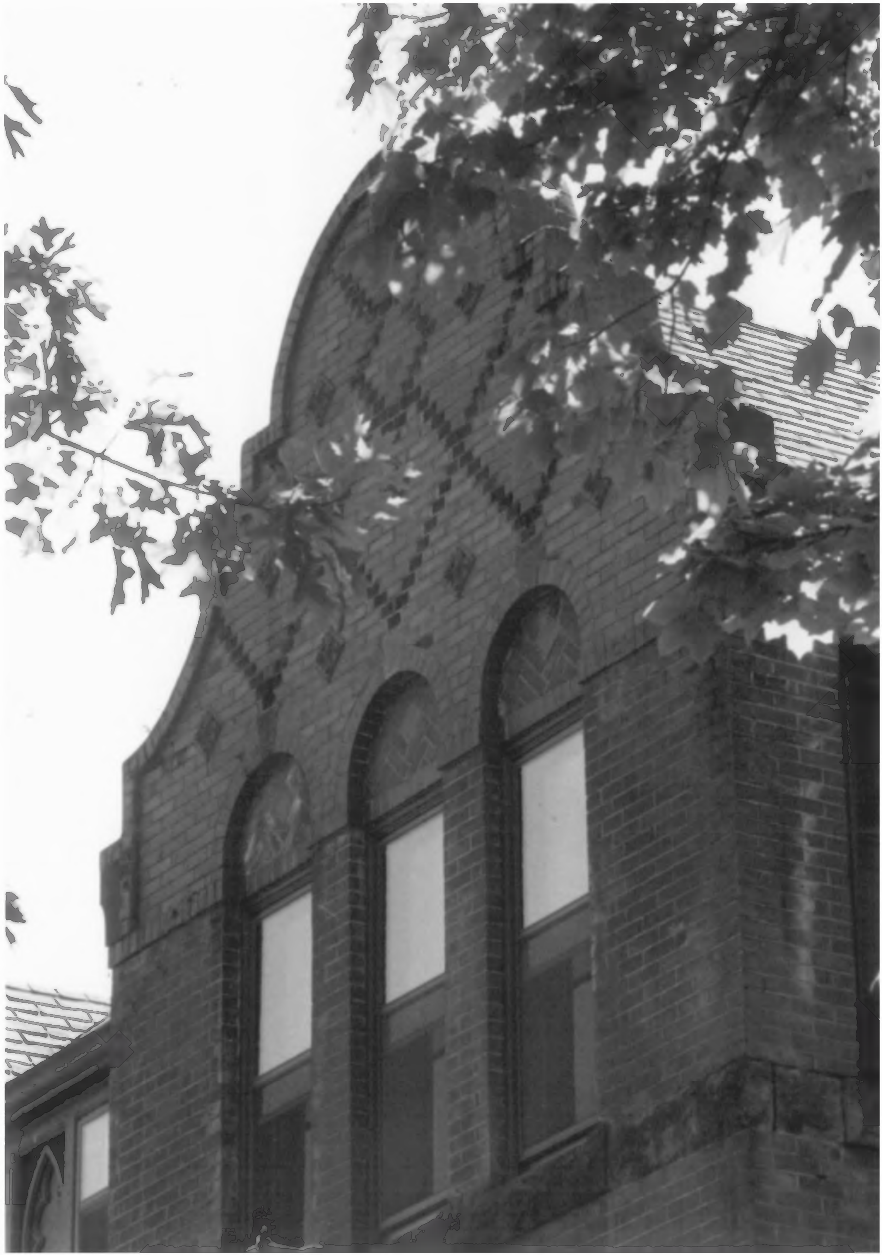
8 of 29

DESCRIPTION: Detail north elevation

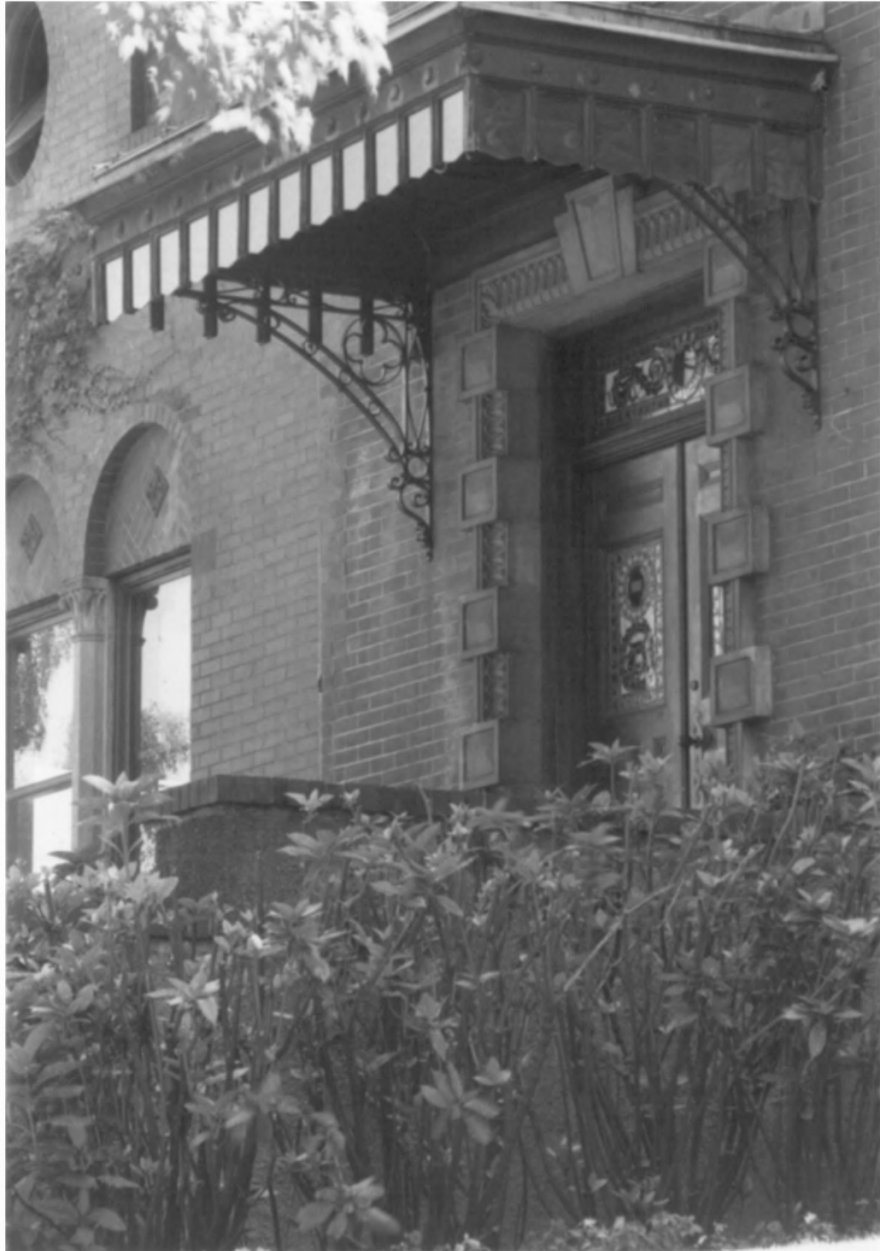
9 of 29

DESCRIPTION: Main entrance north elevation

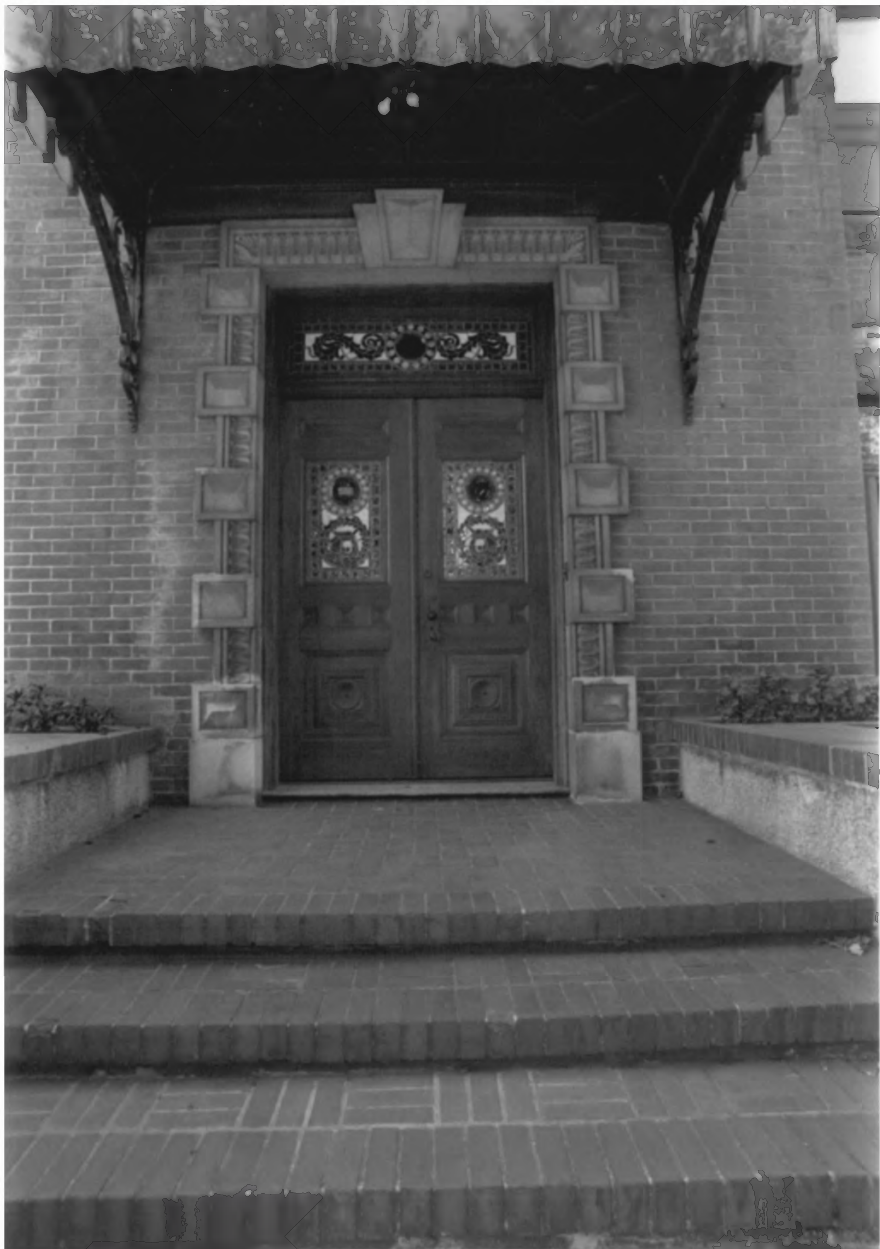
10 of 29

DESCRIPTION: Main entrance north elevation

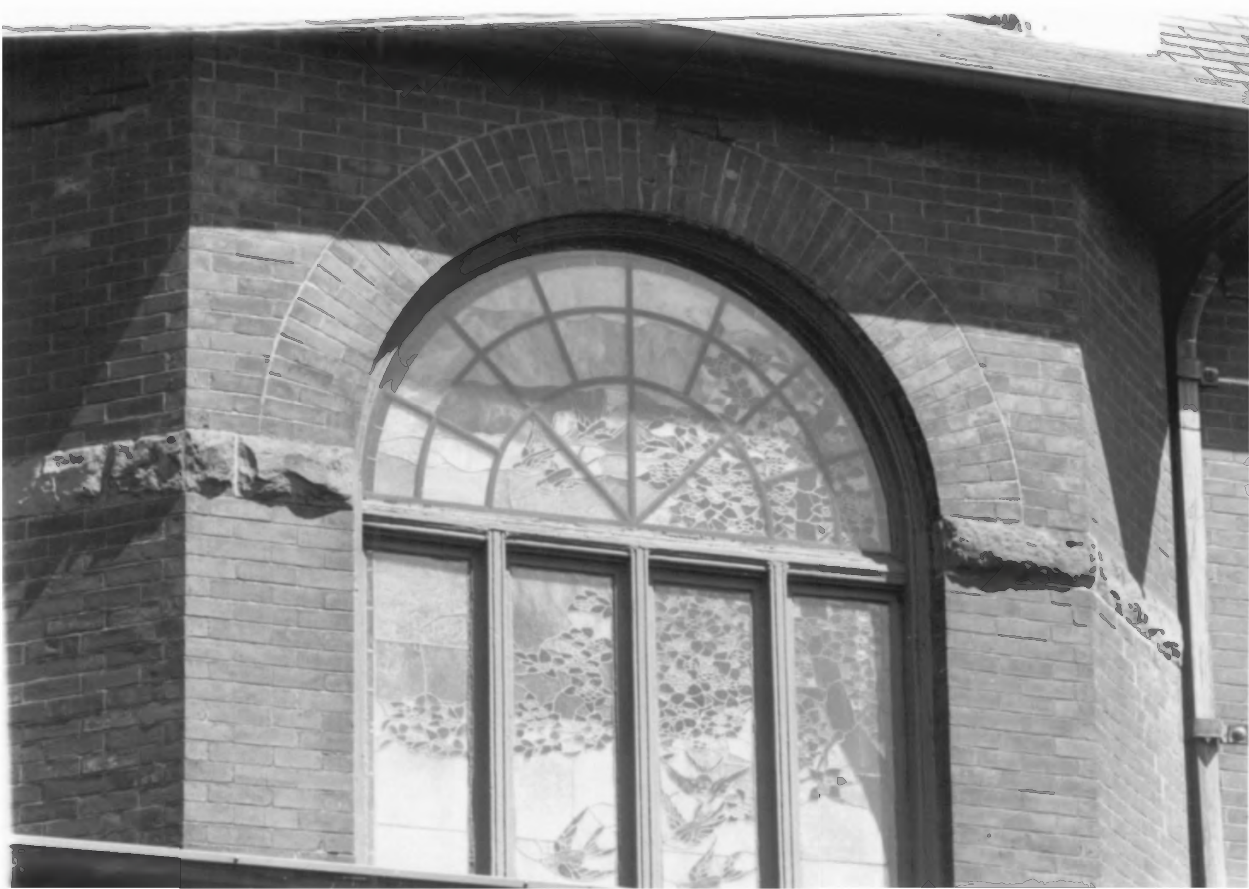
11 of 29

DESCRIPTION: Window detail

Building materials for the main mass are bearing wall brick with rough cut stone being used for sills, lintels and belt courses. Windows are varying sizes, generally one-over-one sliding sash. Many are embellished with exquisite transoms or upper panes in Povey Brothers stained glass, most of which are in excellent condition.

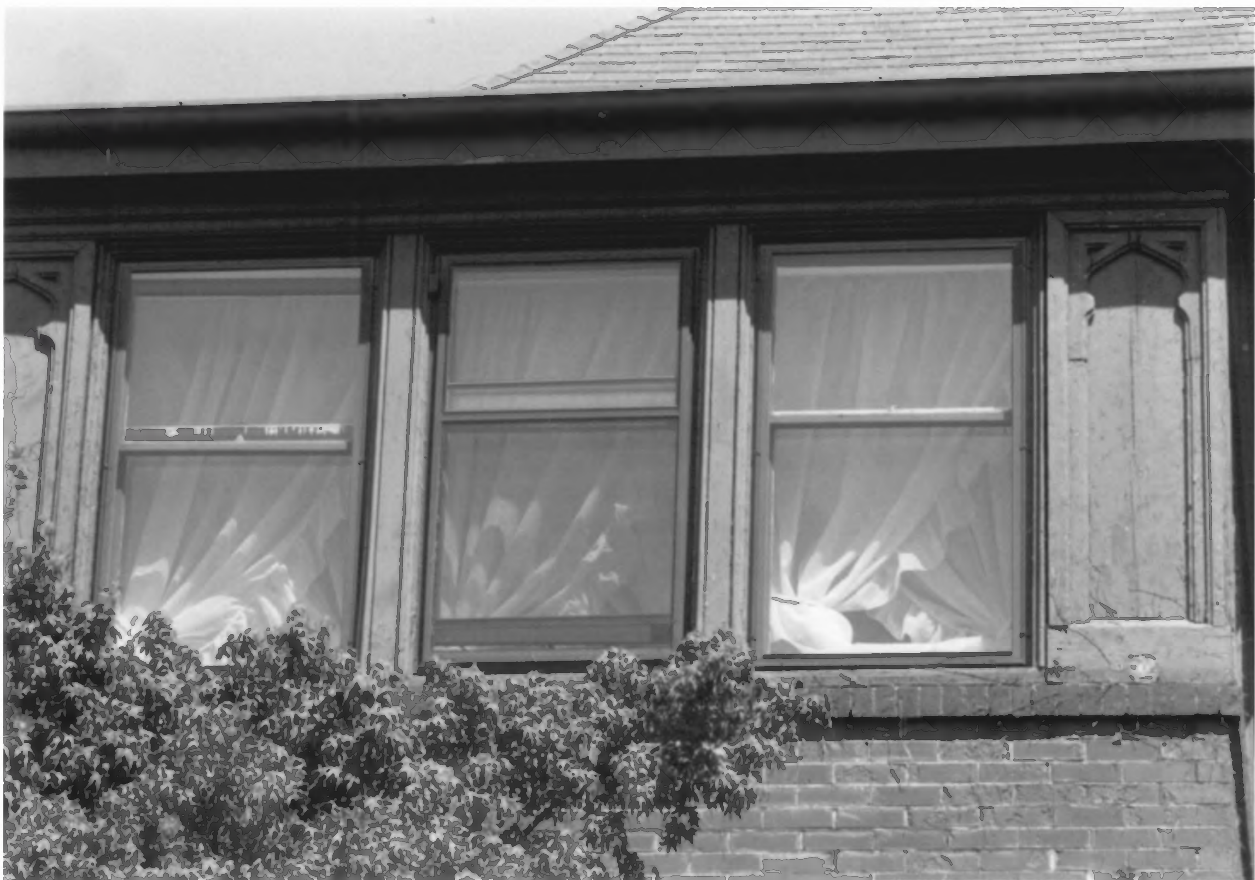
12 of 29

DESCRIPTION: Window detail

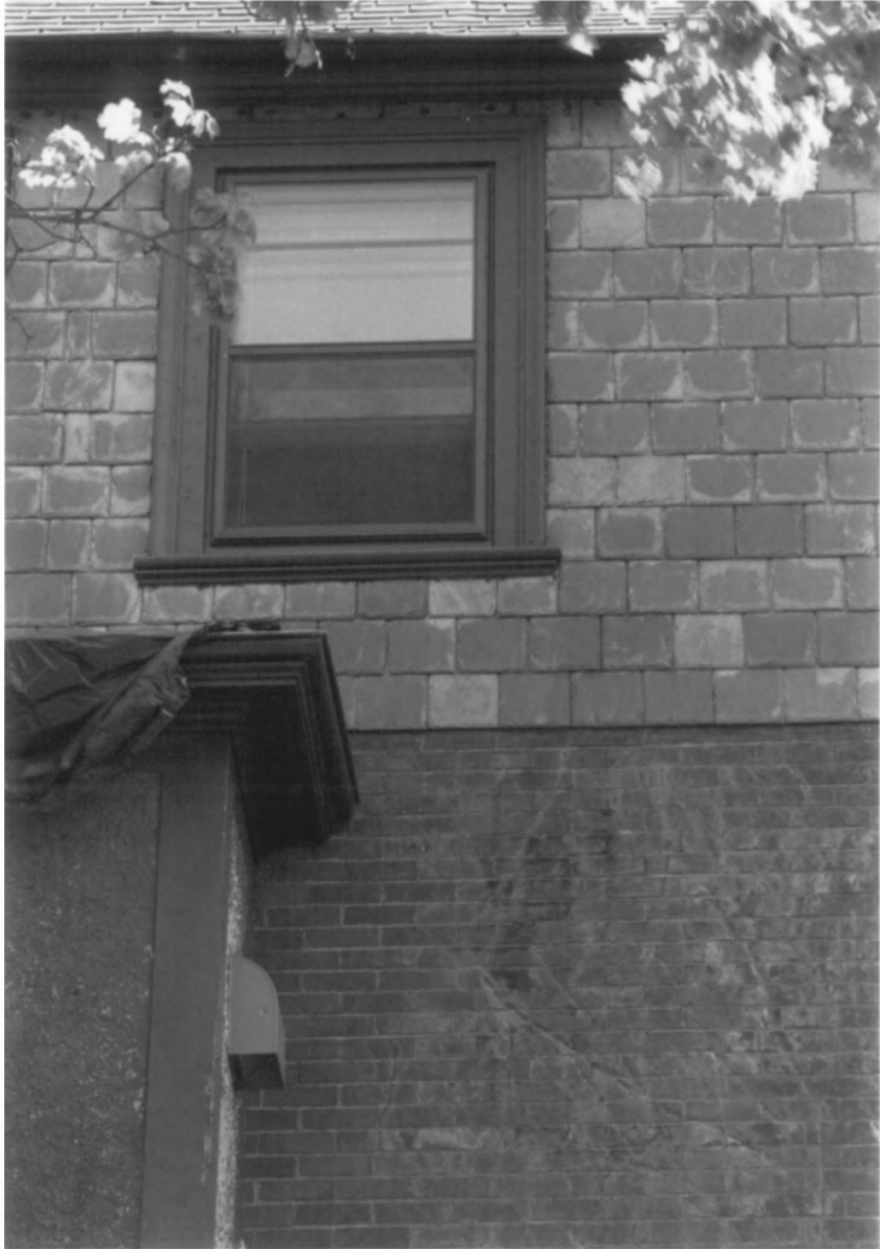
13 of 29

DESCRIPTION: Window detail

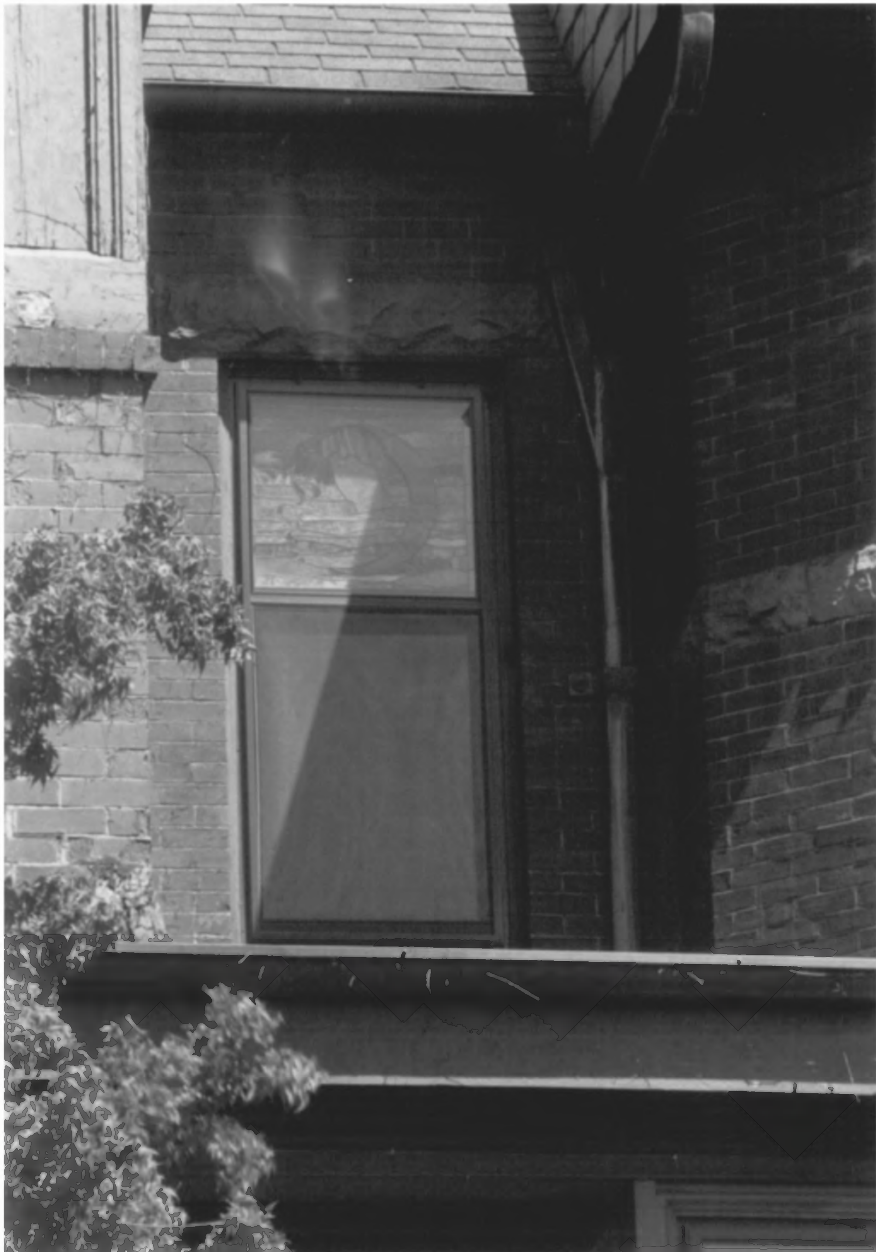
DESCRIPTION: Window detail
