National Register of Historic Places
Registration Form

historic name United States Naval Air Station Dirigible Hangars A and B
other names/site number Tillamook Naval Air Station Dirigible Hangars
U. S. Naval Air Station, Tillamook, Dirigible Hangars

street & number Port of Tillamook Bay Industrial Park N/A not for publication
city, town Tillamook vicinity
state Oregon code OR county Tillamook code 057 zip code 97141

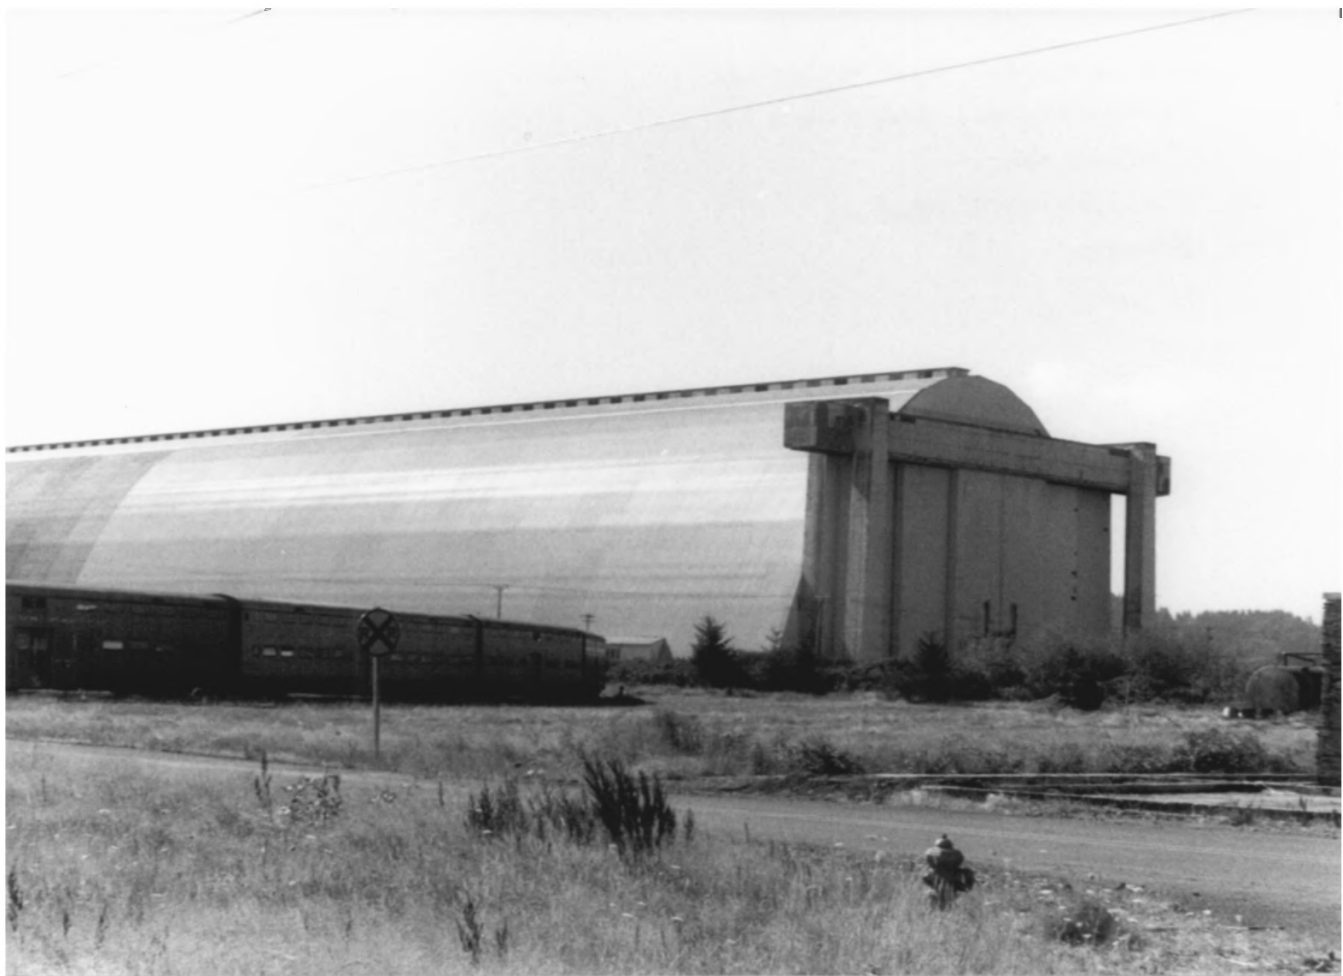
U.S. NAVAL AIR STATION
DIRIGIBLE HANGARS A AND B
TILLAMOOK
TILLAMOOK COUNTY
OREGON
11 OF 20

August 1988
Hanger "A"
T.N.A.S.

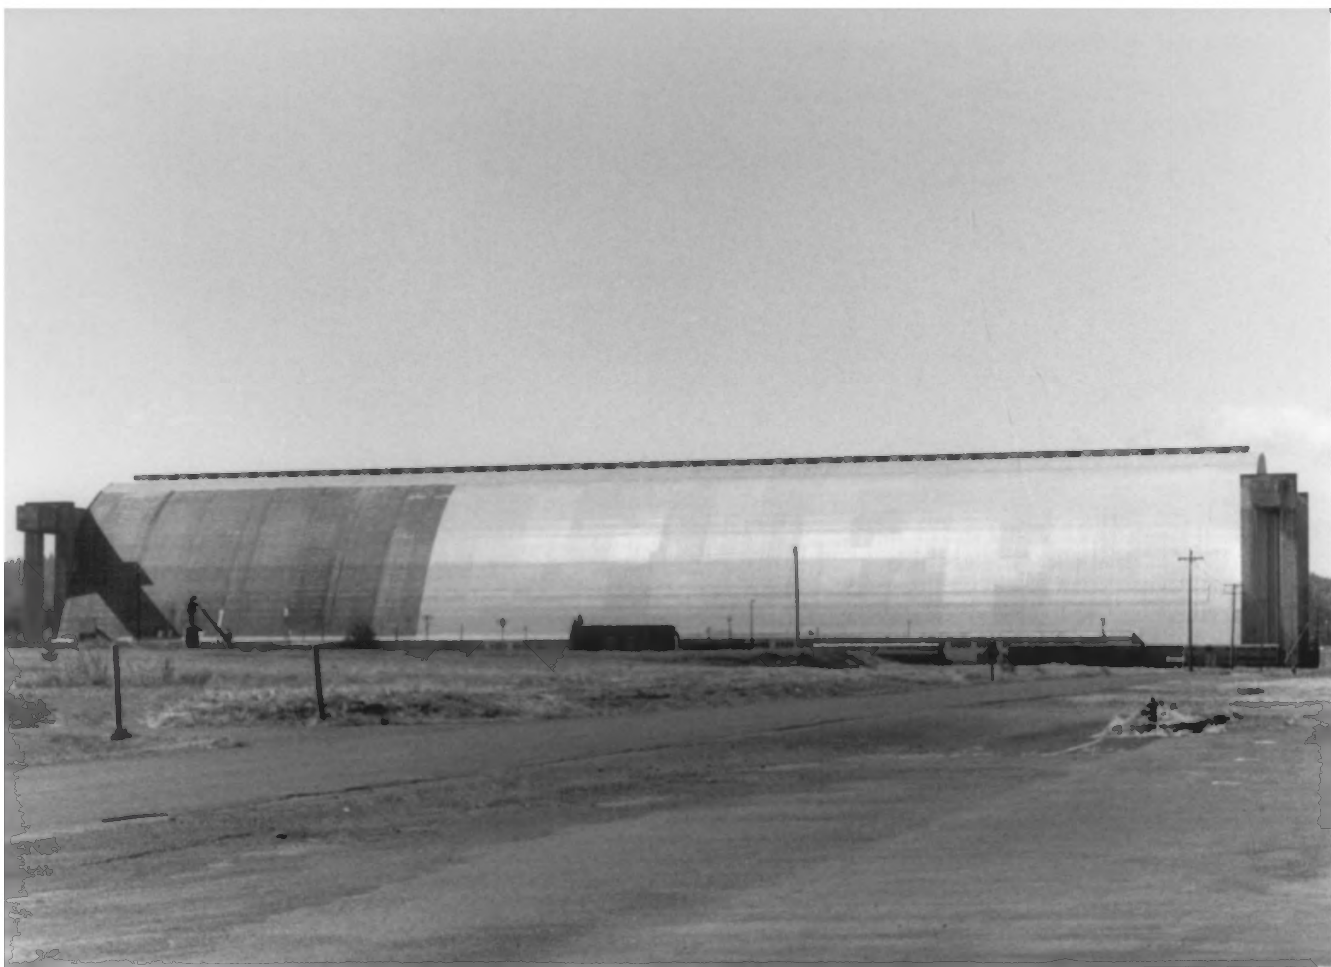
U.S. NAVAL AIR STATION
DIRIGIBLE HANGARS A AND B
TILLAMOOK
TILLAMOOK COUNTY
OREGON
12 OF 20

August. 1988
Hanger "A"
T.N.A.S.

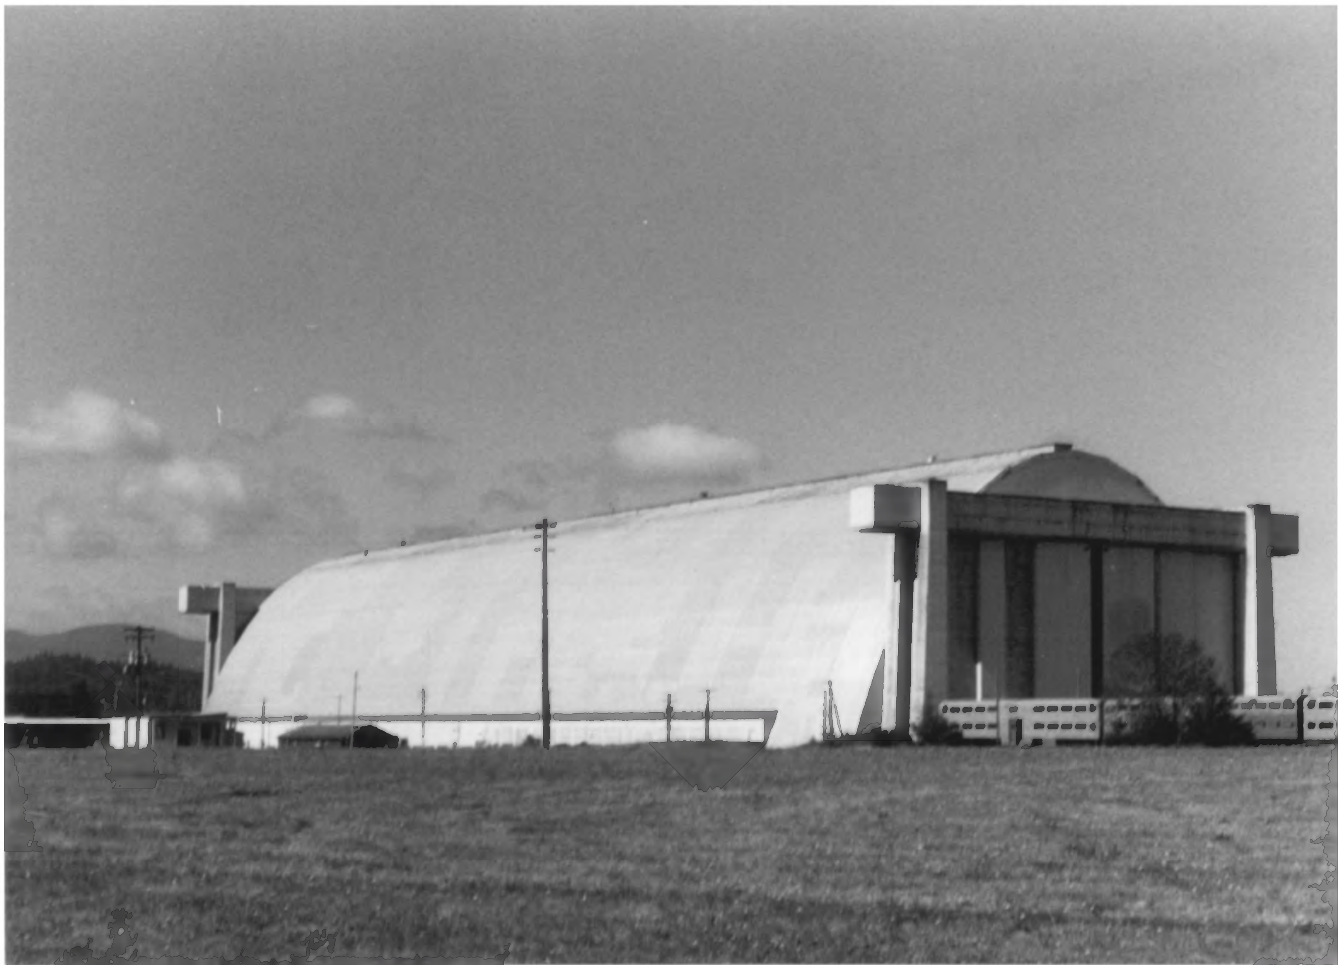
U.S. NAVAL AIR STATION
DIRIGIBLE HANGARS A AND B
TILLAMOOK
TILLAMOOK COUNTY
OREGON
13 OF 20

August 1988
Hanger "B"
T.N.A.S.

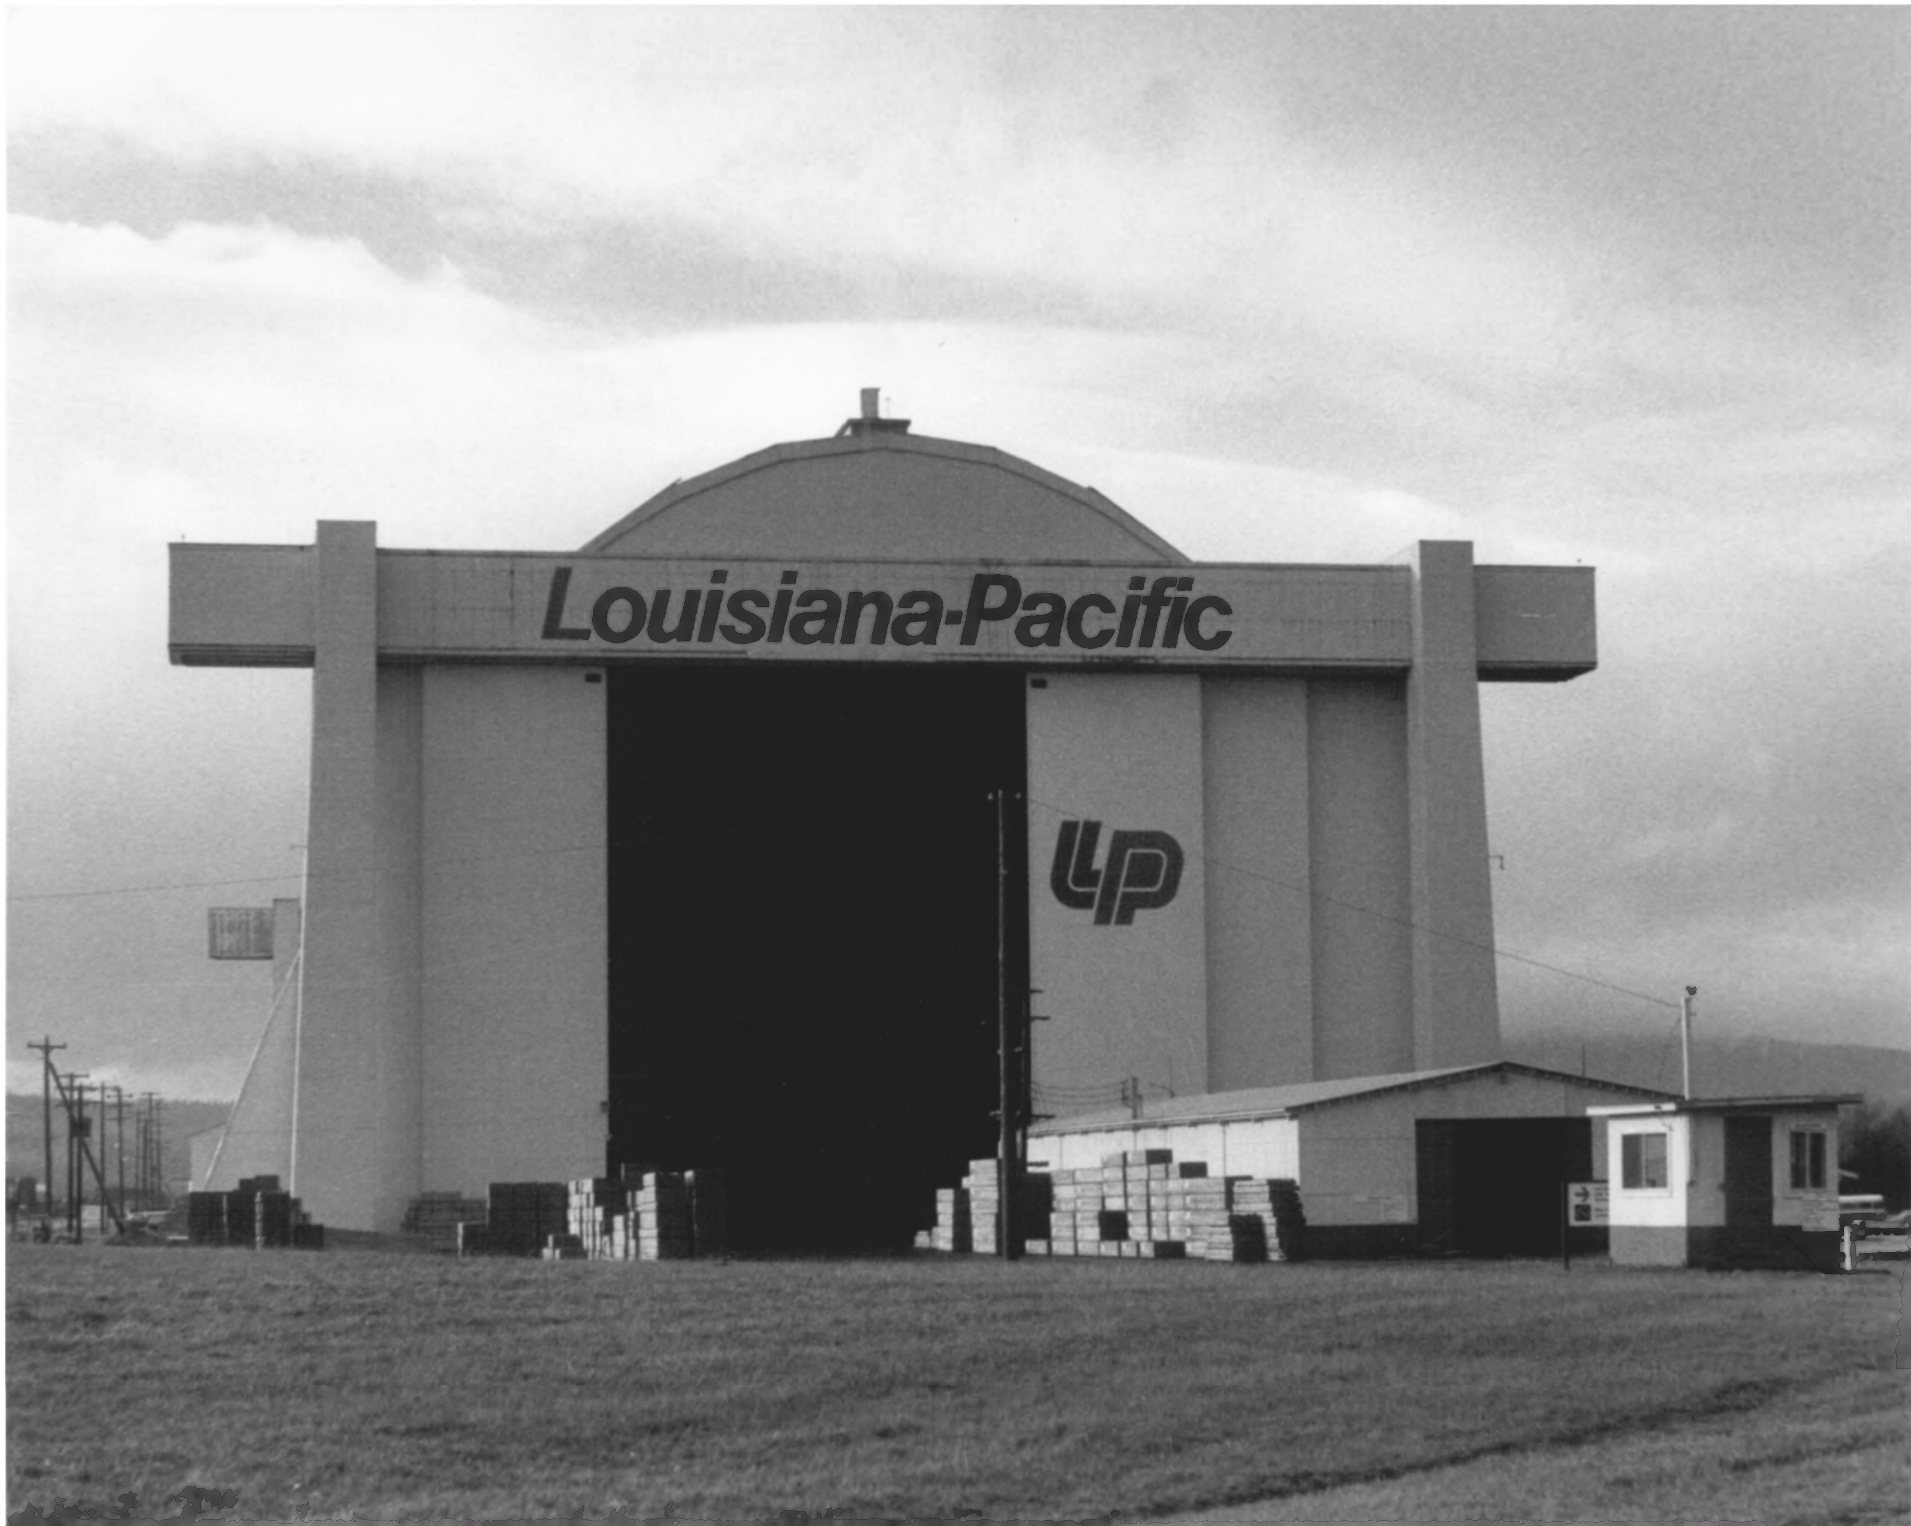
14 OF 20

North End Hangar B

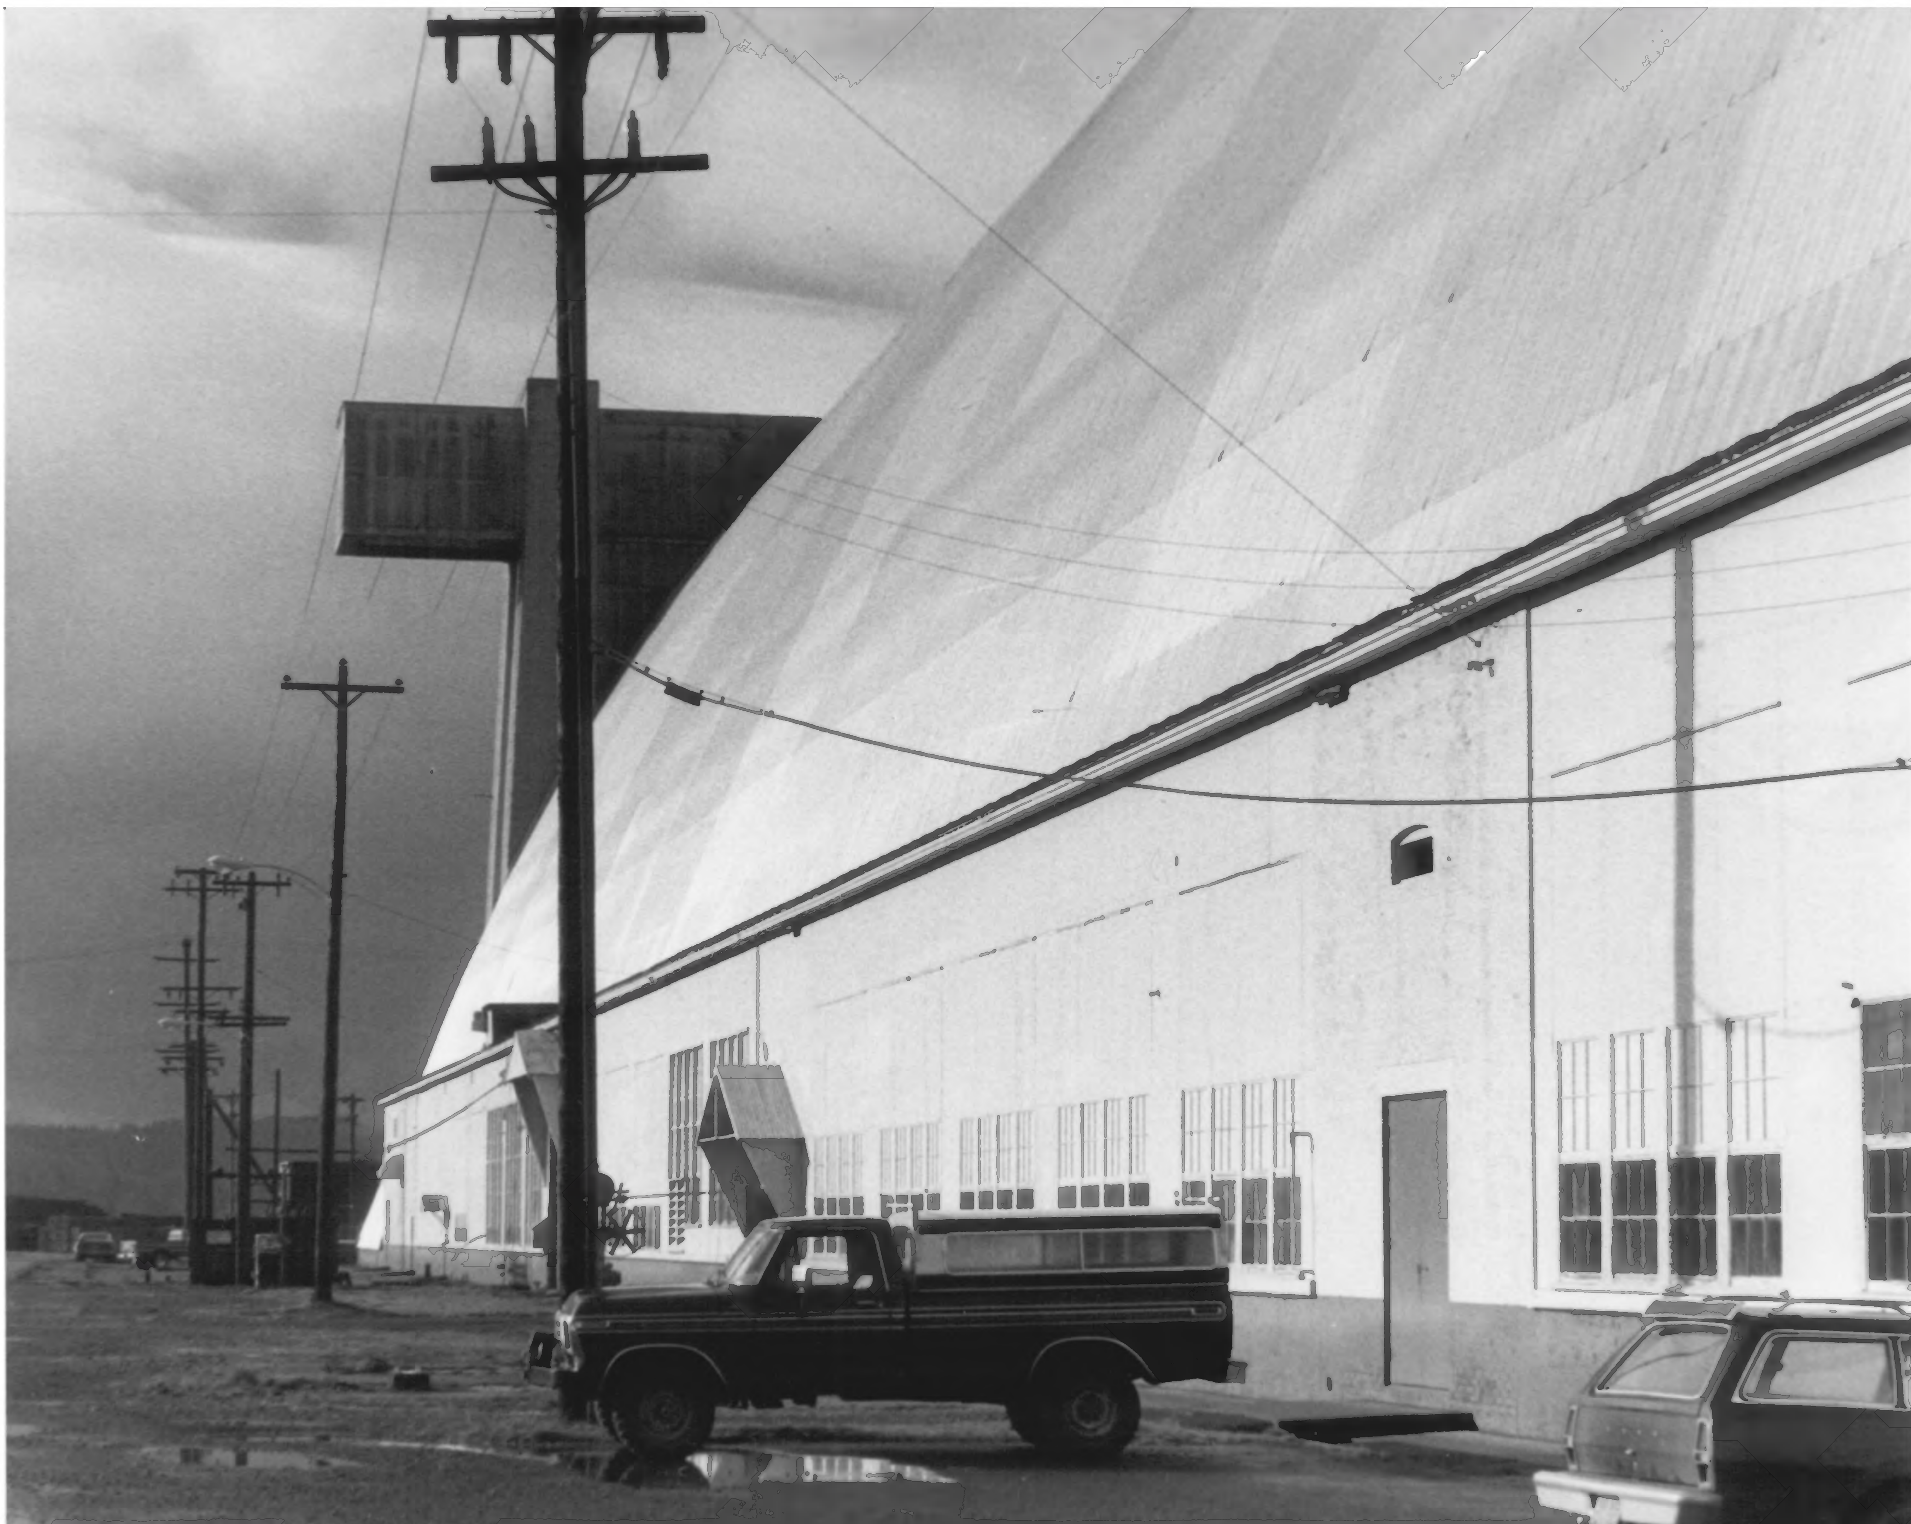
17 OF 20

Outside Hangar B

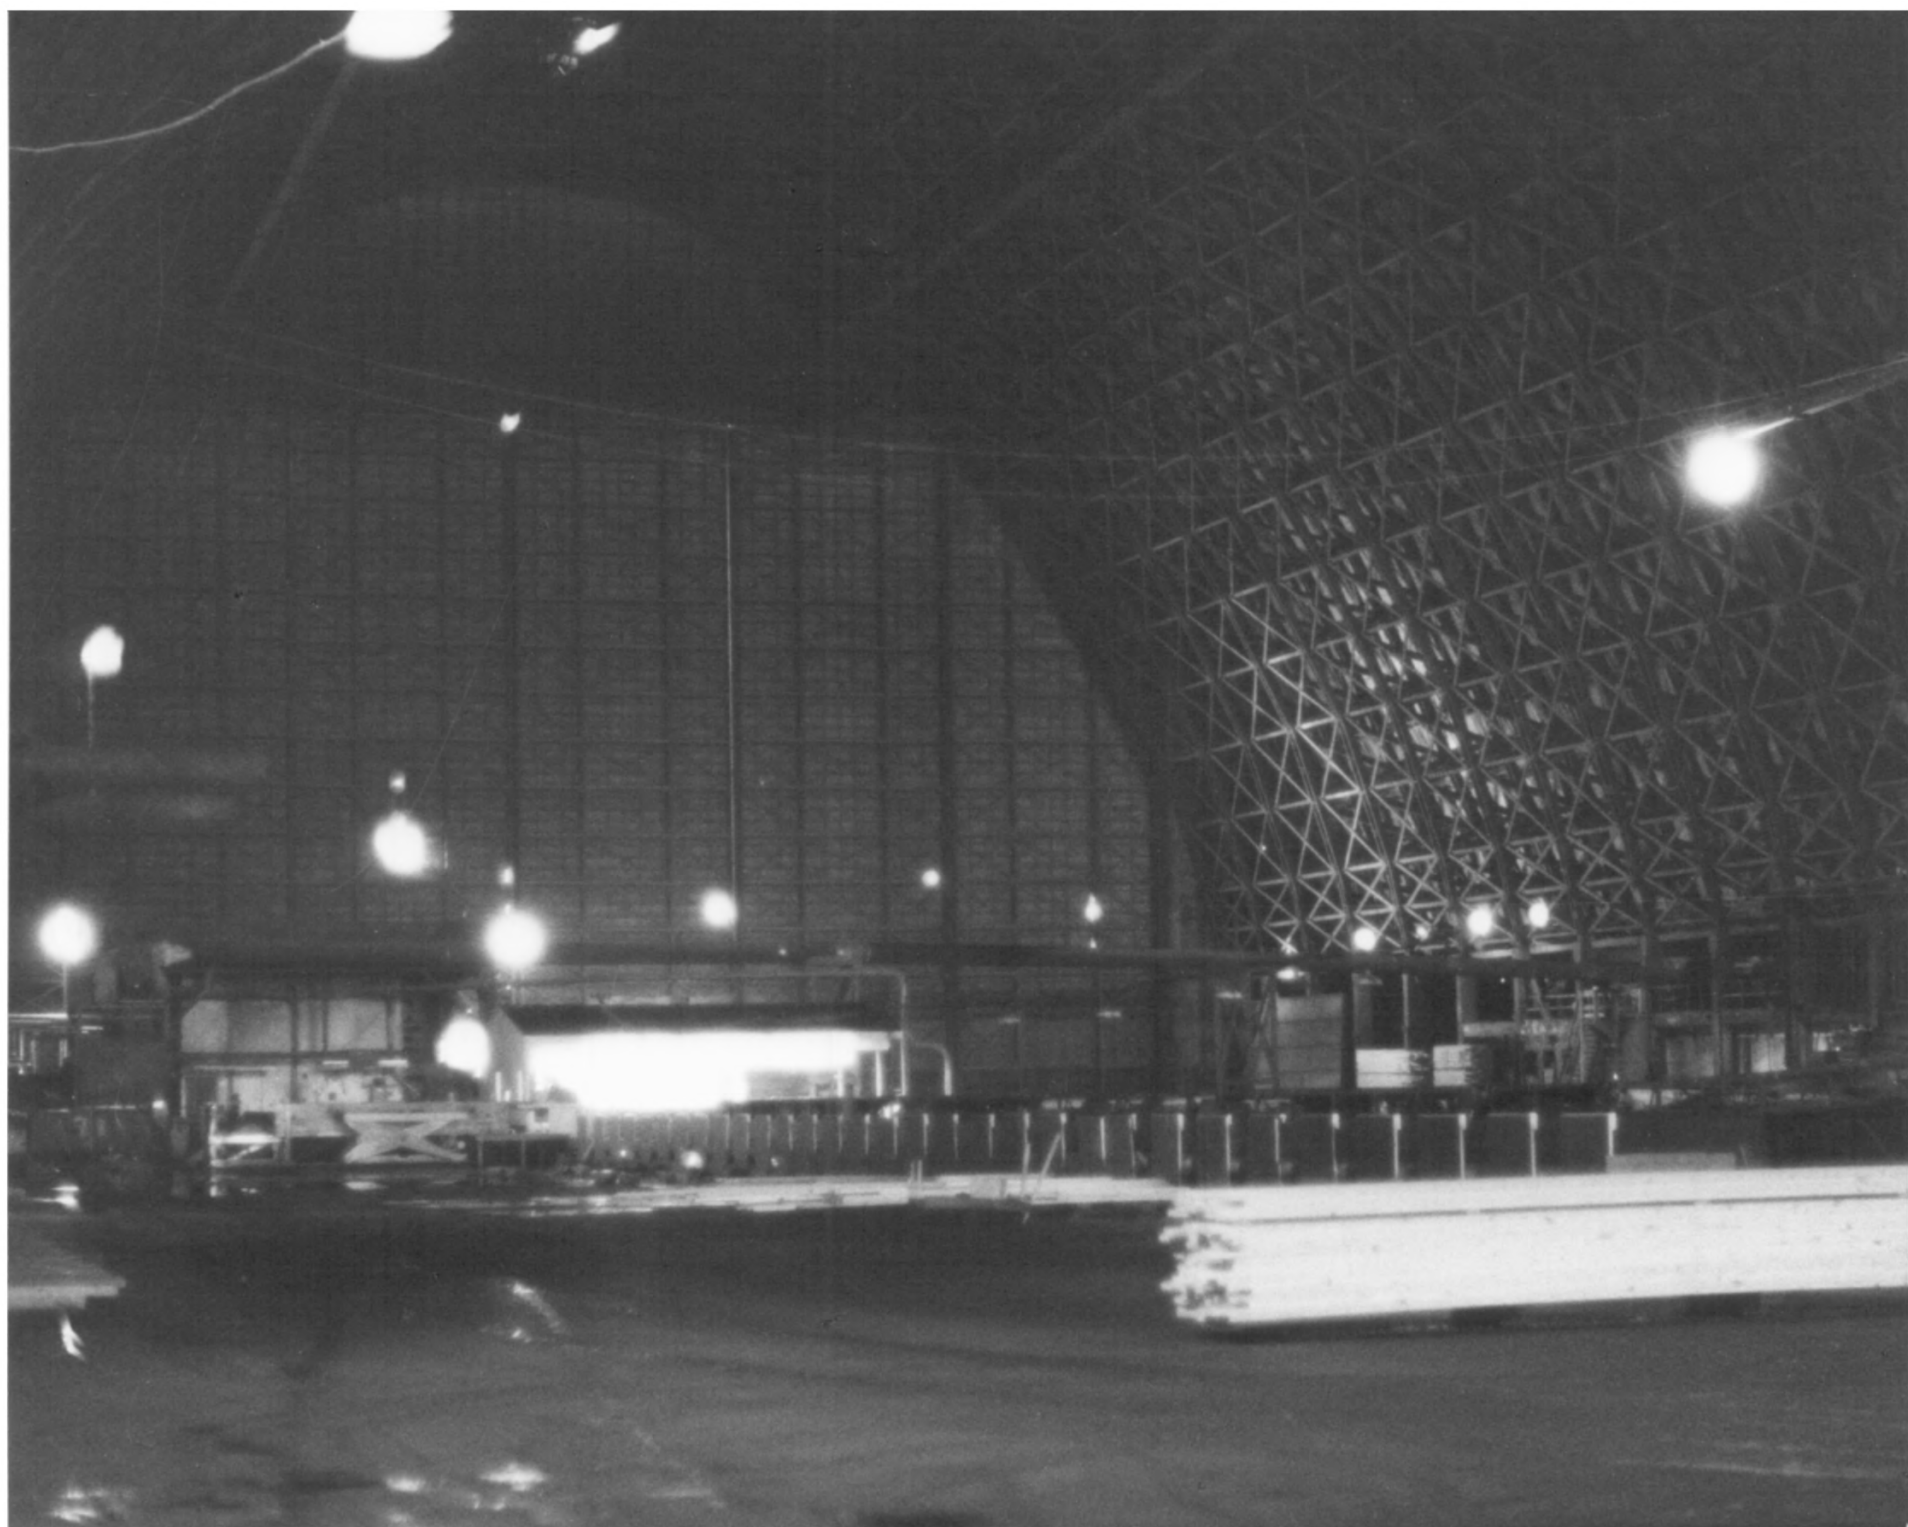
Looking South West Hangar B

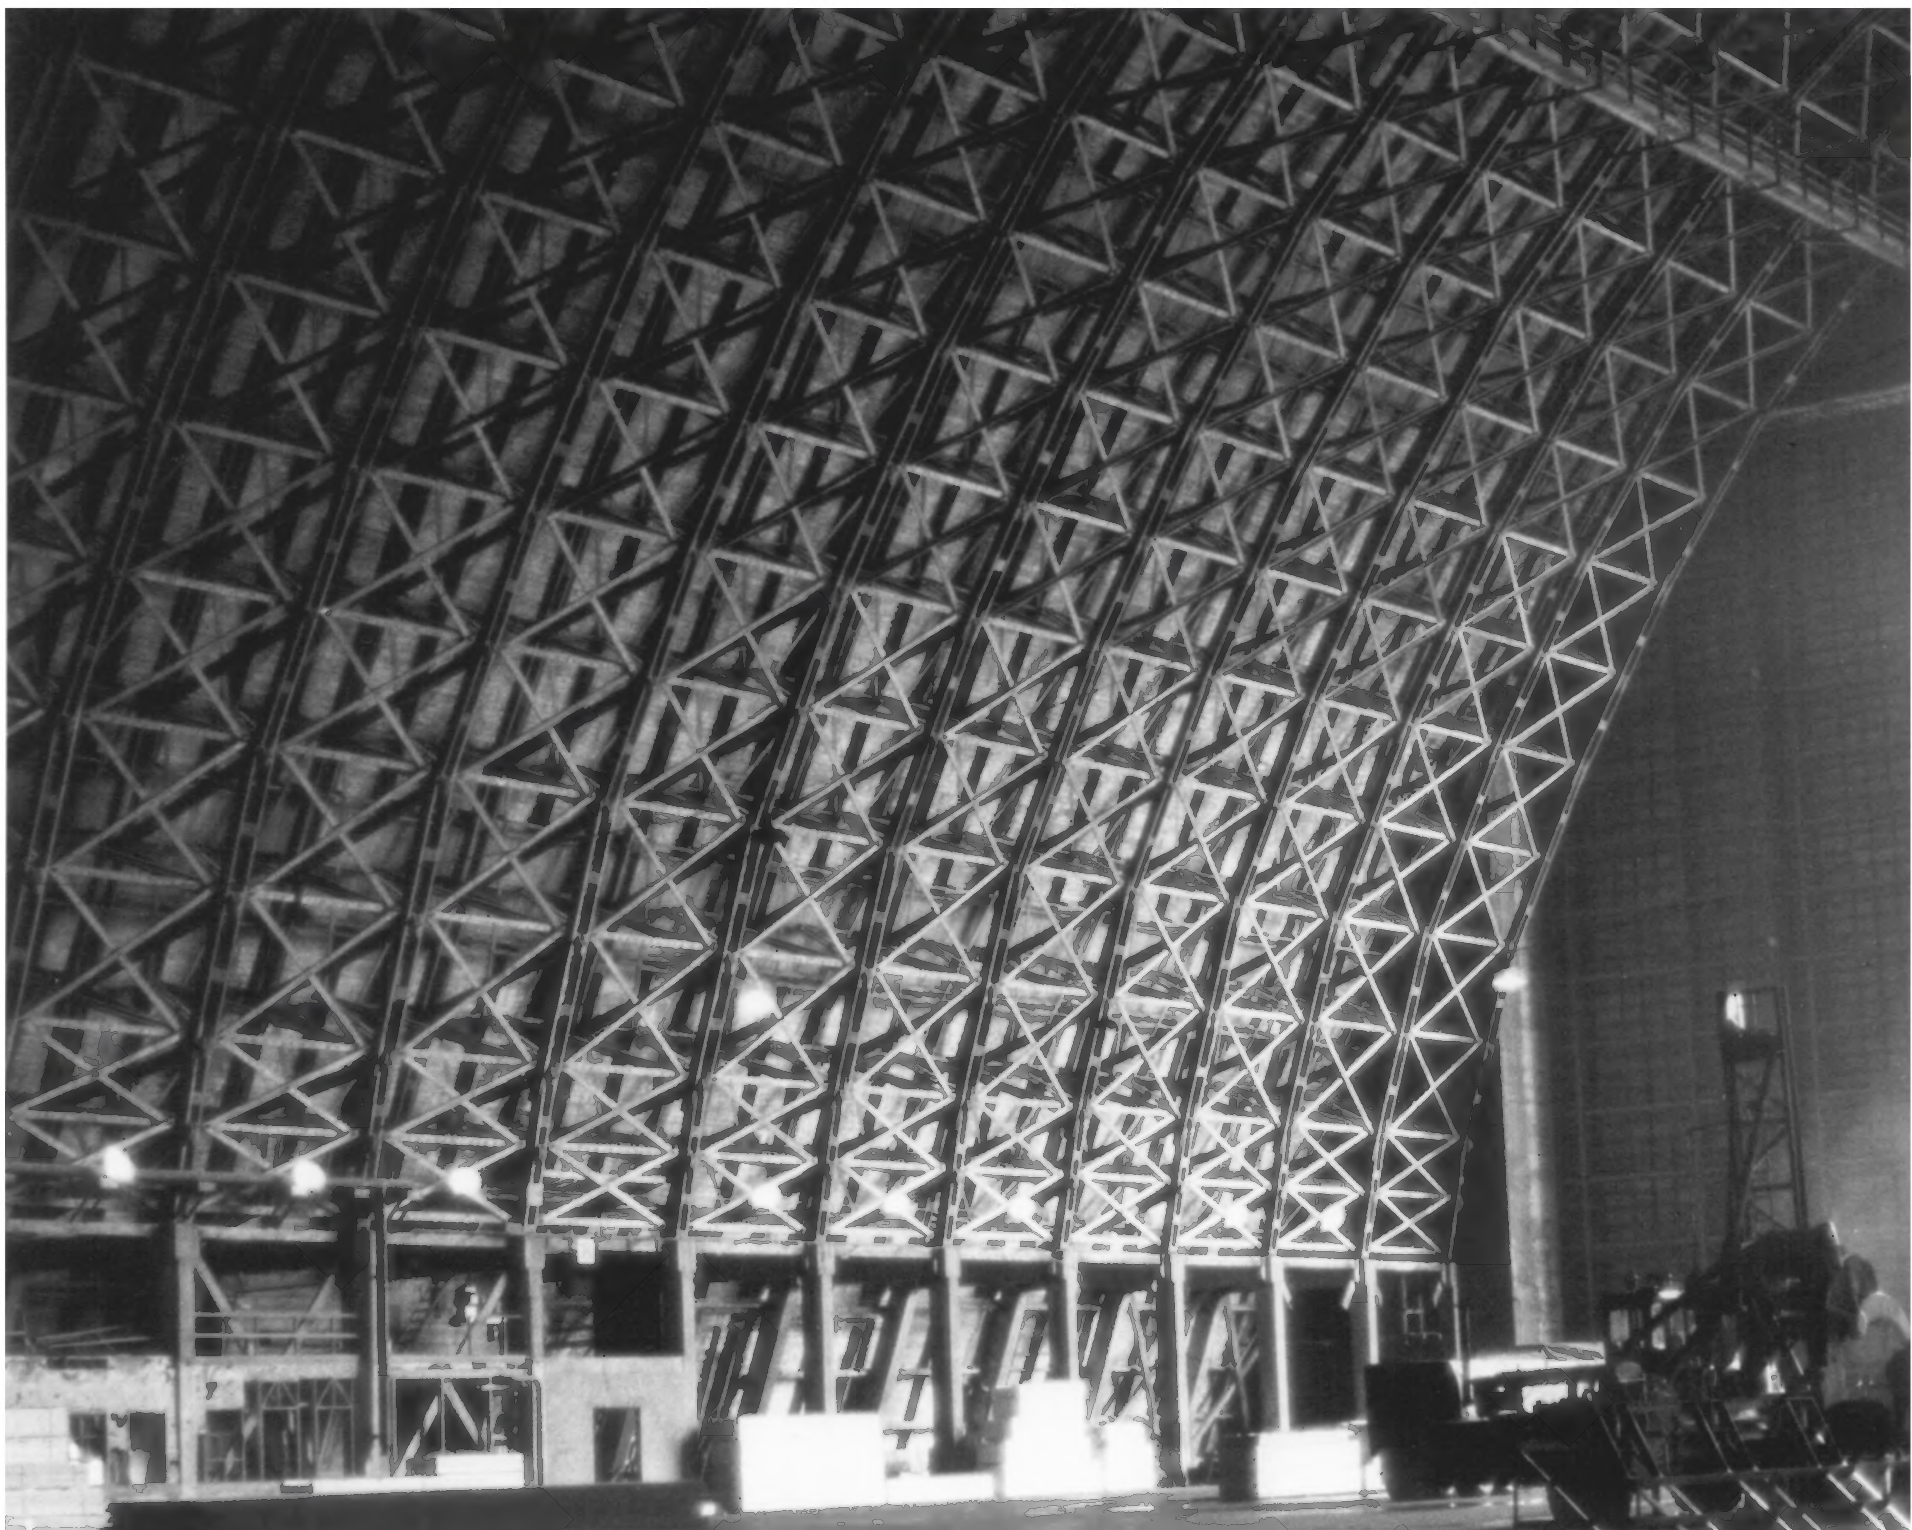
UNITED STATES NAVAL AIR STATION DIRIGIBLE HANGARS A AND B
TILLAMOOK
TILLAMOOK COUNTY
OREGON
17 OF 20

Looking North inside Hangar B
