National Register of Historic Places Multiple Property Documentation Form

U.S. Post Office Department Facilities in Oregon, 1940 to 1971

Section E. STATEMENT OF HISTORIC CONTEXT

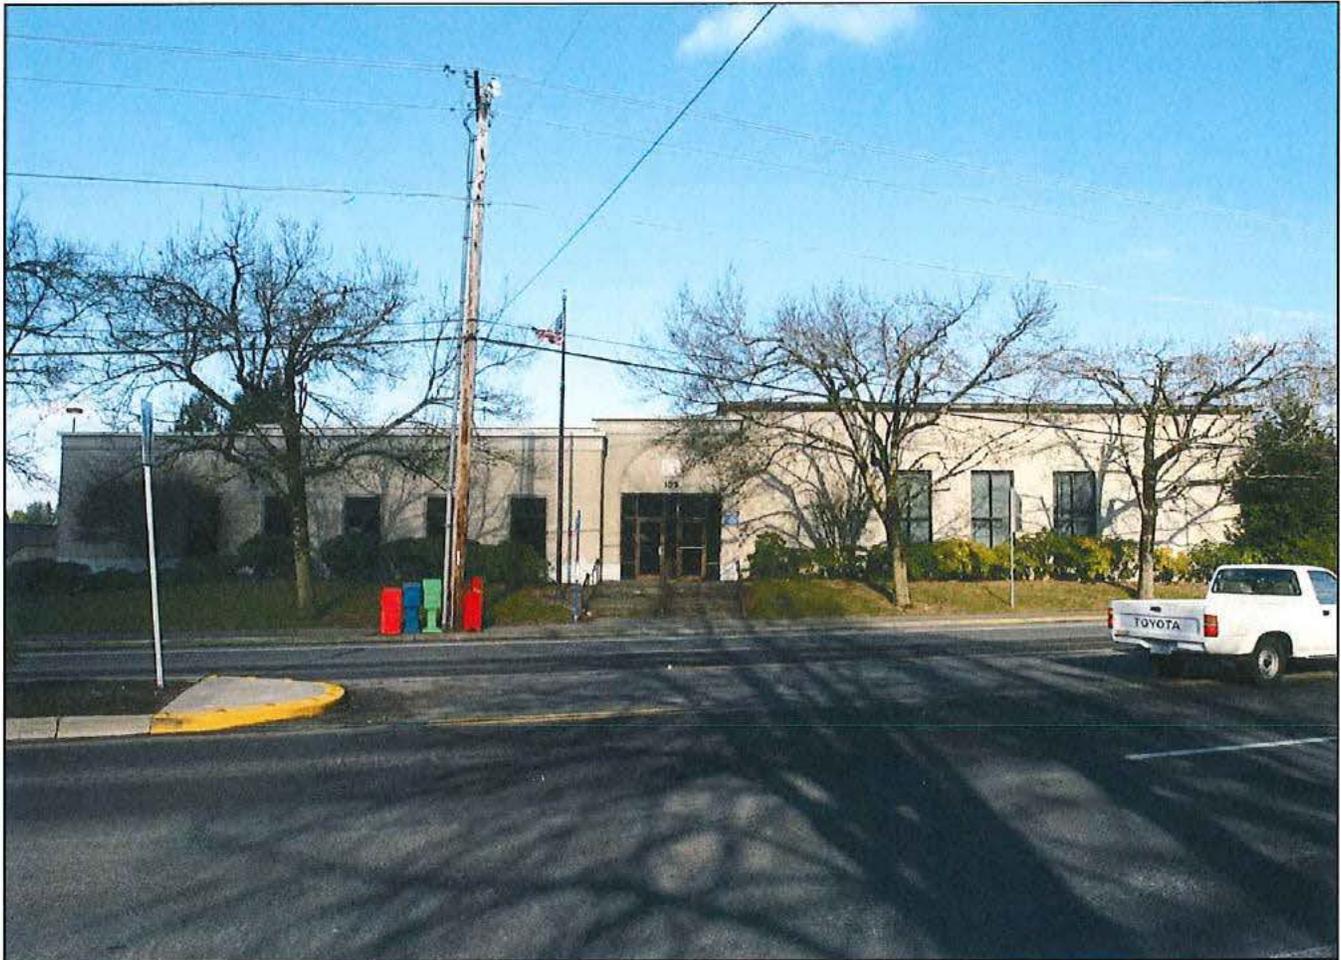
Figure 1: Main Post Office (103 W. Powell Boulevard, Gresham, Multnomah County)

Exterior: First completed in 1941 as a 5,200 square-foot facility, the building was expanded in 1990 to its current size of 23,243 square-feet. The building is one-story in height with a rectilinear shape. Architecturally, the structure today is of nominal design but may be considered an example of the Neo-Renaissance Revival style. The original post office was designed by architect Theodore Ballew; the addition was designed by Mackenzie/Saito & Associates. The building has a flat roof with parapet, poured concrete slab--on-grade foundation, and is unreinforced masonry block. Facade materials are consistent and include tan brick stretcher-bond veneer with matching mortar, cast stone, metal coping, dark brown aluminum-framed glass-panel windows and entryways.

The post office fronts to the south on Powell Boulevard. The south facade is asymmetrical and divided into two main sections; the original building and the new addition. The original building is located in the southeast corner, clad in stretcher bond veneer with three bays of fixed windows. The windows have been replaced with aluminum frames and a 2/2 fixed configuration from their original double-hung style. Two, decorative arched cast-stone elements have been recessed into the south facade, each flanking a side of the three bays.

Integrity: The integrity of the building is absent. The building is in its original location and the setting is generally similar to when it was built. However, there have been substantial design and material changes to both the exterior and interior. In massing, the 17,000 square-foot addition dwarfs the original 5,200 square-foot building. The main entry was moved from the east to the south. The facades of the historic portion were integrated into the addition, such that the building is more 1990 than 1941. All windows in the original building have either been replaced with modern aluminum-framed fixed-glass panels, with 2/2 configurations, or have been bricked in. On the interior, the spaces have been entirely reconfigured. The building is unrecognizable compared to its 1941 appearance.

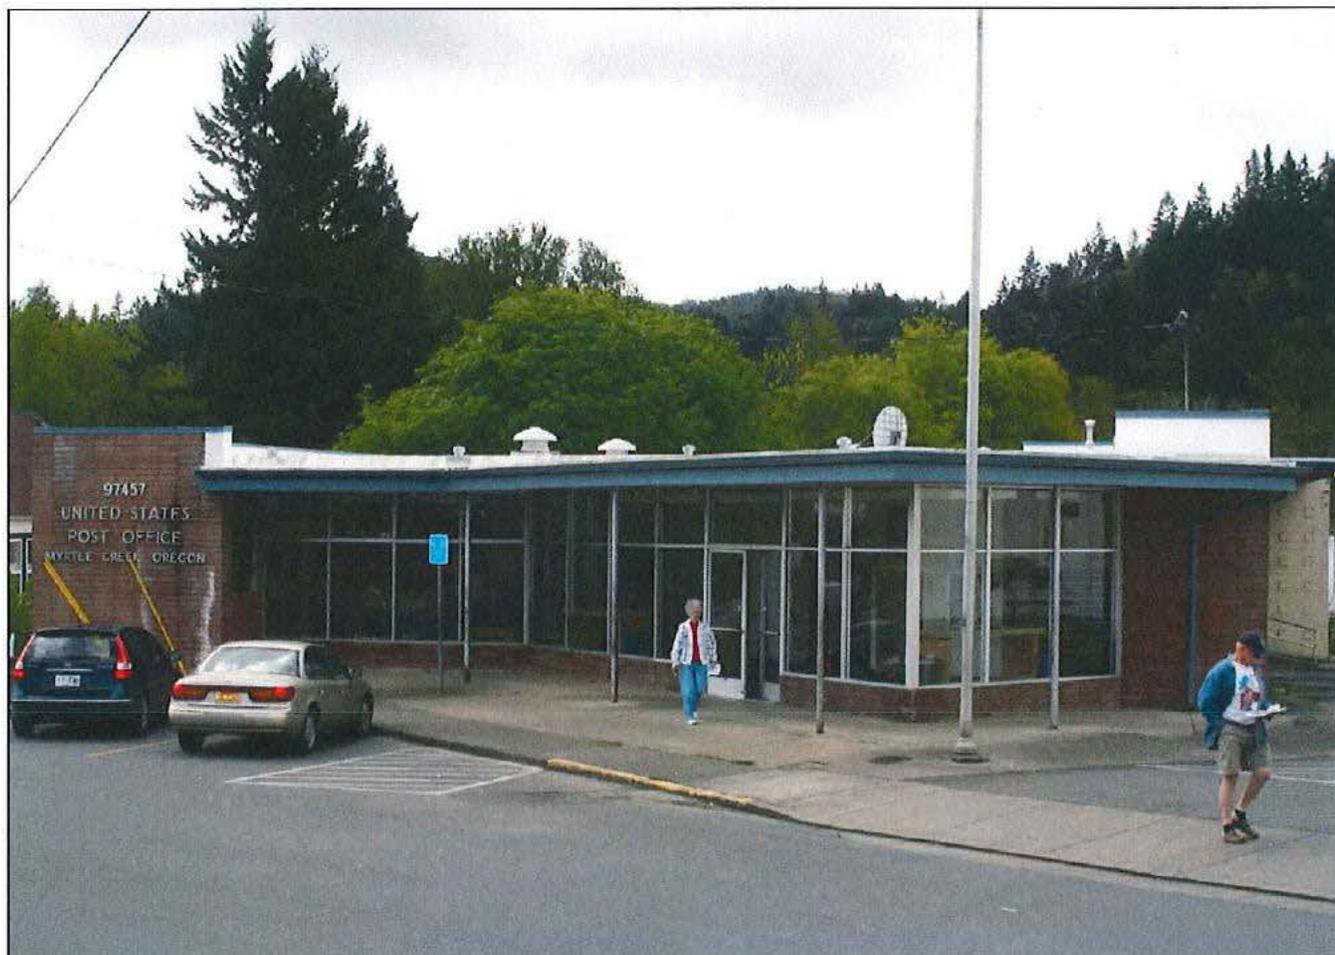
Figure 2: Myrtle Creek Main Post Office (124 Broadway Street, Myrtle Creek, Douglas County)

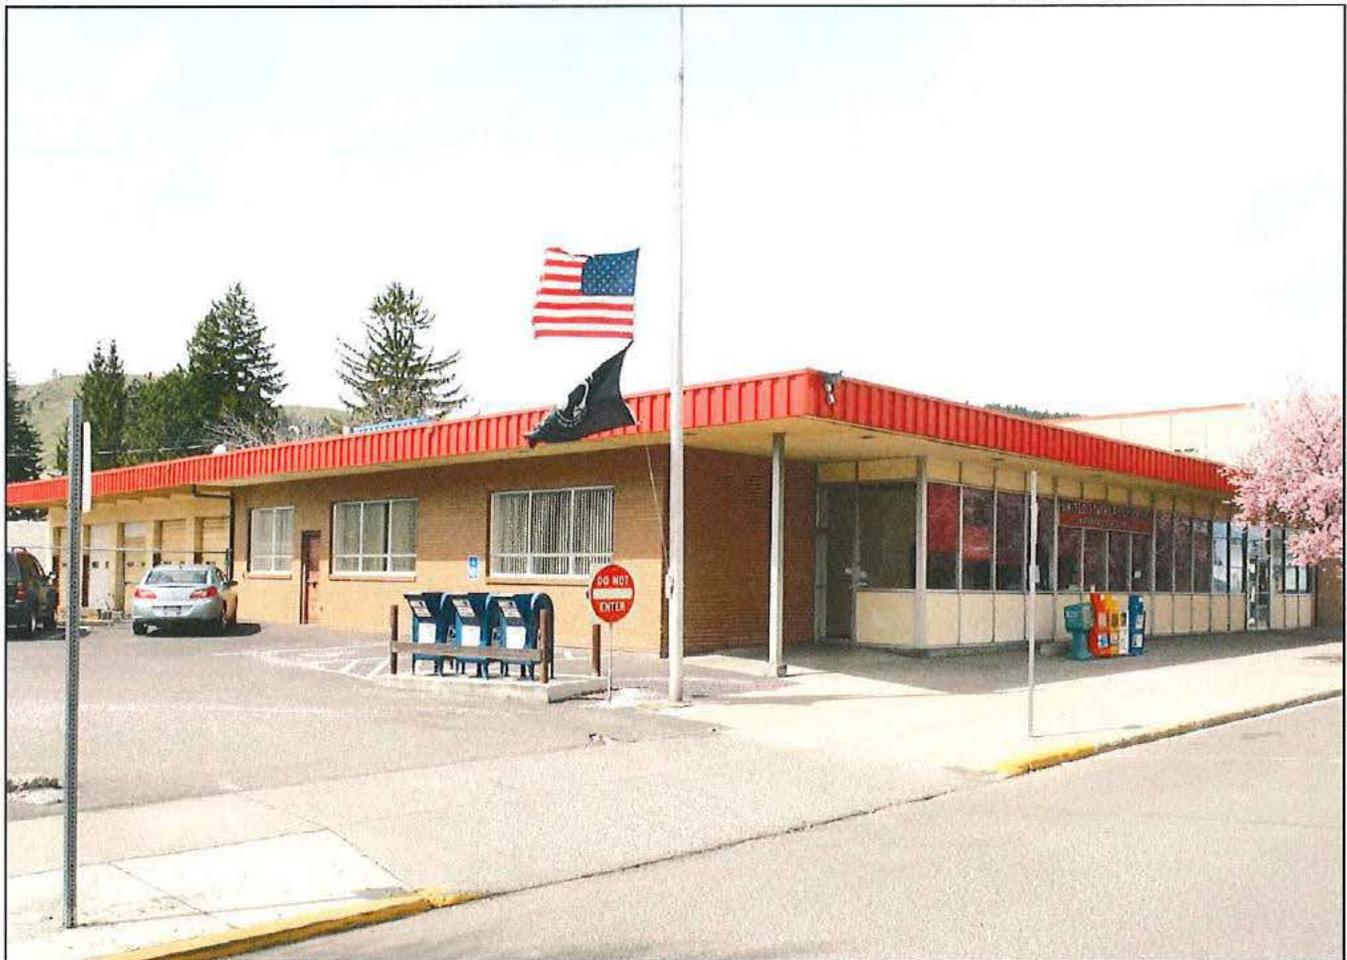
Figure 3: LaGrande Main Post Office (1202 Washington Avenue, La Grande, Union County)

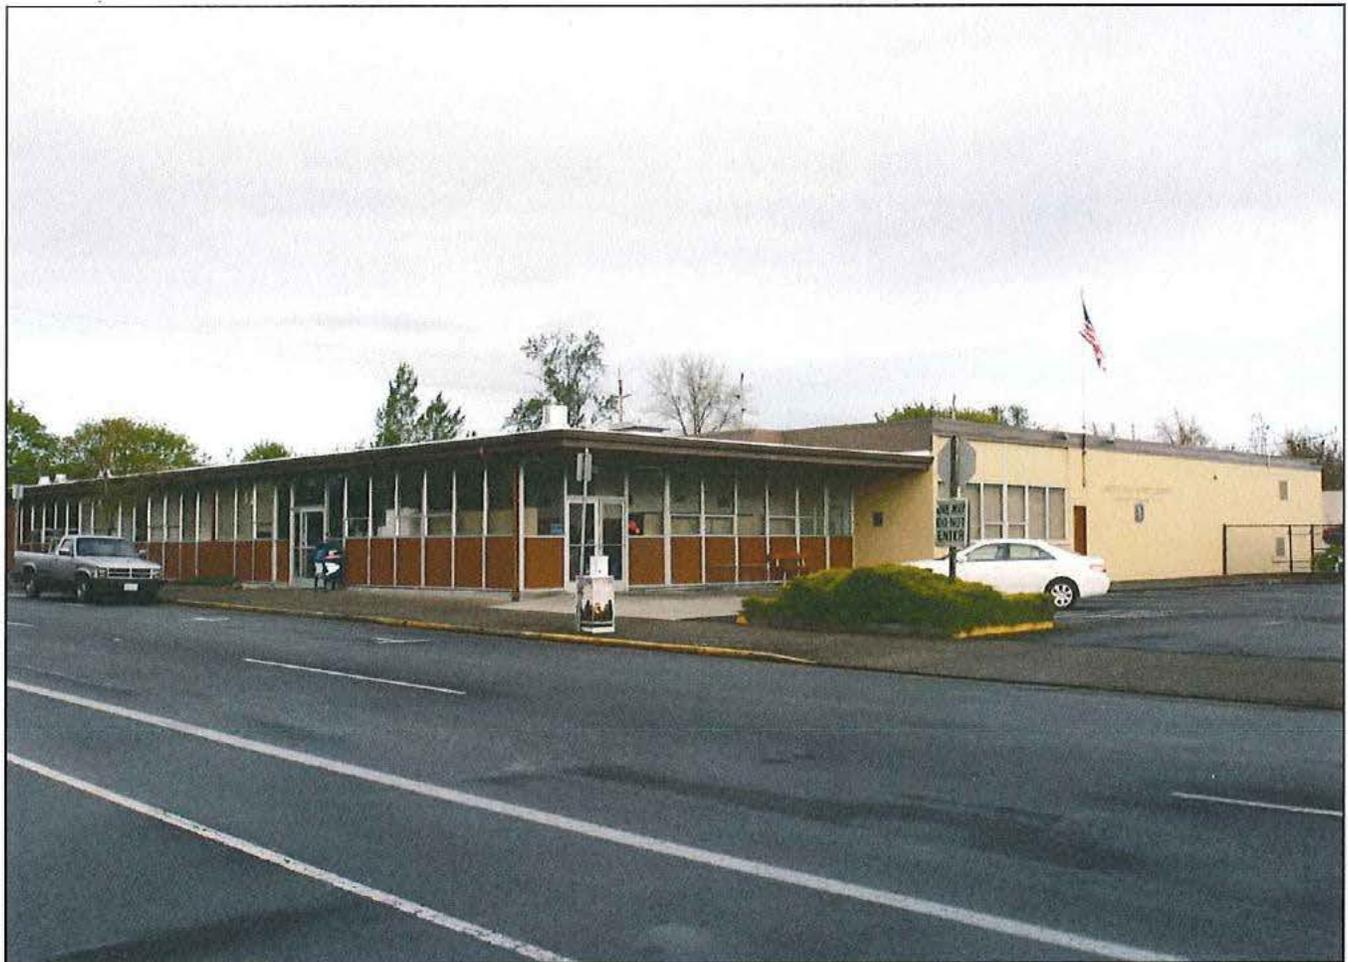
Figure 4: Albany Main Post Office (525 SW 2nd Avenue, Albany, Linn County)

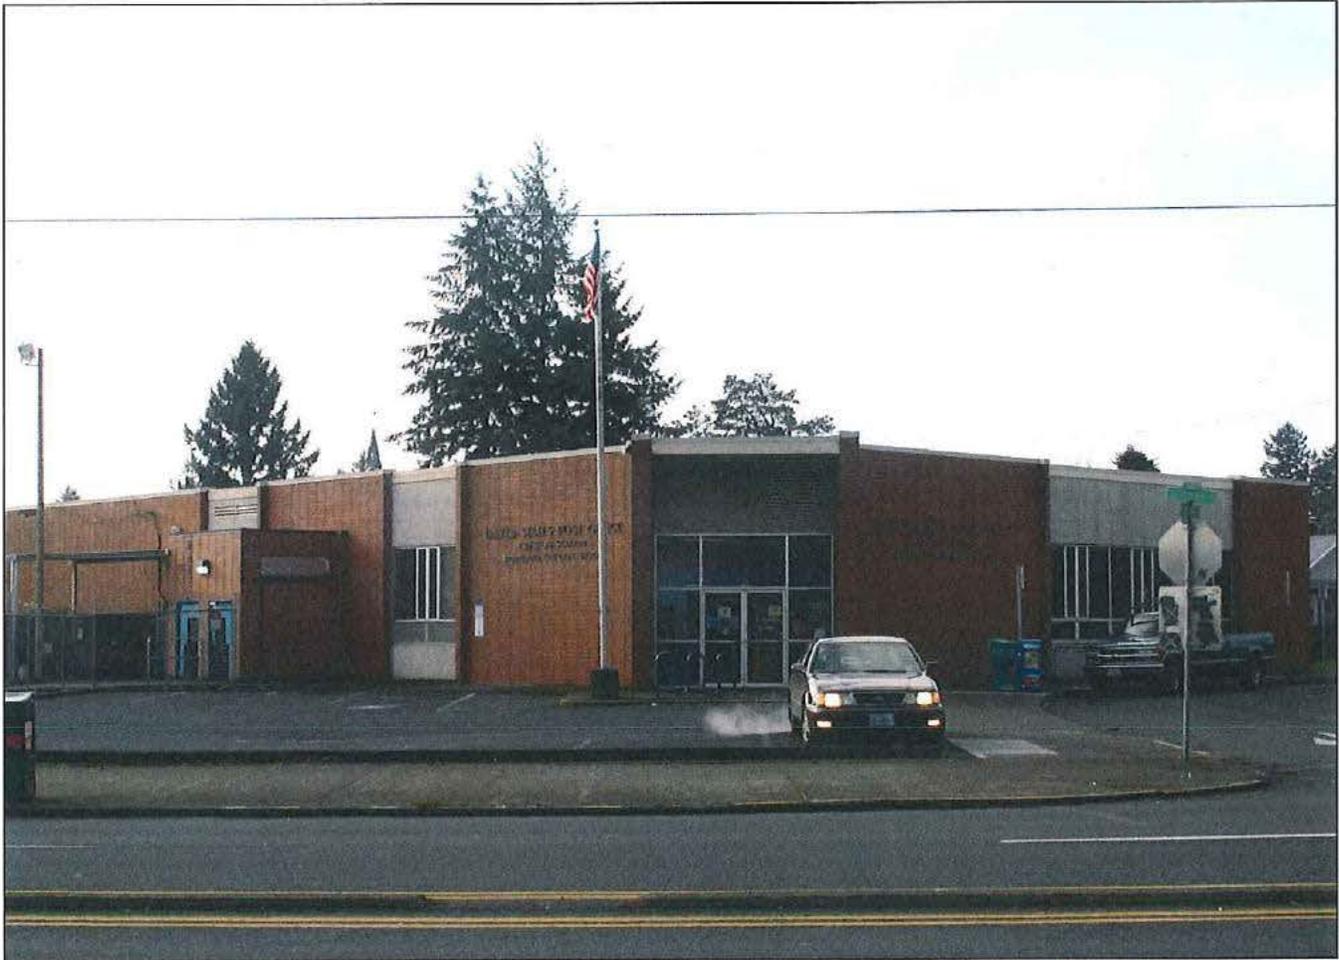
Figure 5: Creston Post Office (5010 SE Foster Road, Multnomah County)

linked to the development of Portland’s street car system. Historically, the intersection of Powell, 50th and Foster was a commercial center that in the 1920s, spurred forward with the completion of the Ross Island Bridge in 1926. Plans for the station date to February, 1965 when the Post Office Department solicited bids for a 7,509 square-foot facility on a parcel of roughly 18,000 square-feet. The solicitation noted that the property would be leased for 10 years with four five-year renewal options. In May, it was announced that builder Dan Davis was the winning bidder with a design by architects Johnston & Koch, comprised of Hollis Johnston and Robert Koch. The firm had formed in February, 1957 and continued until Johnston’s death in 1966. The site was vacant land just south of the Foster Road and Powell Street intersection. Construction on the post office began immediately and the property completed the following year. Over the years, there have been slight changes to the building and to the postal operations there.

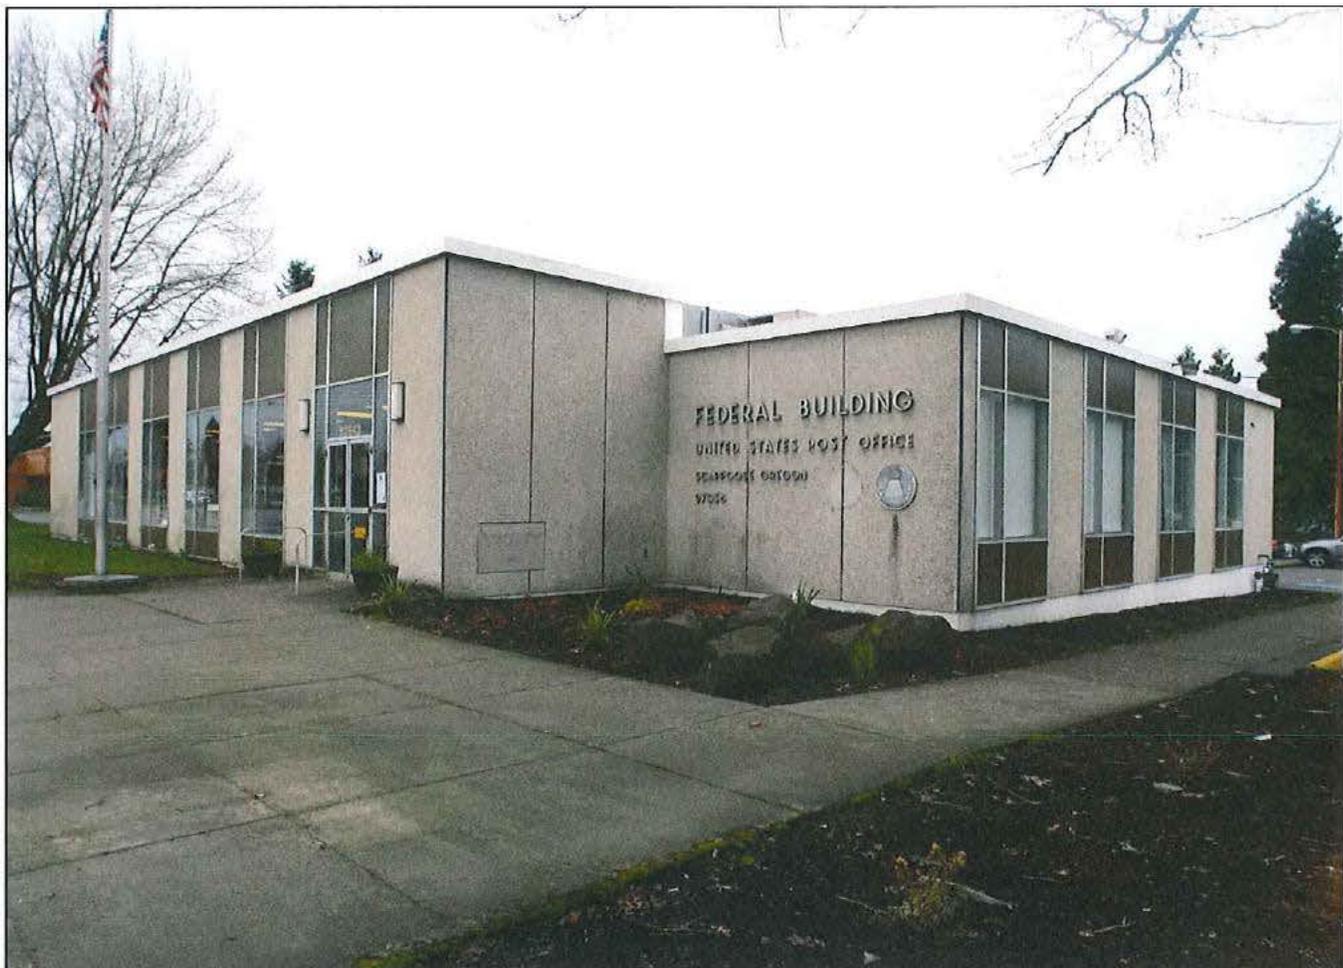
Figure 6: Scappoose Main Post Office (52643 Columbia River Highway, Scappoose, Columbia County)

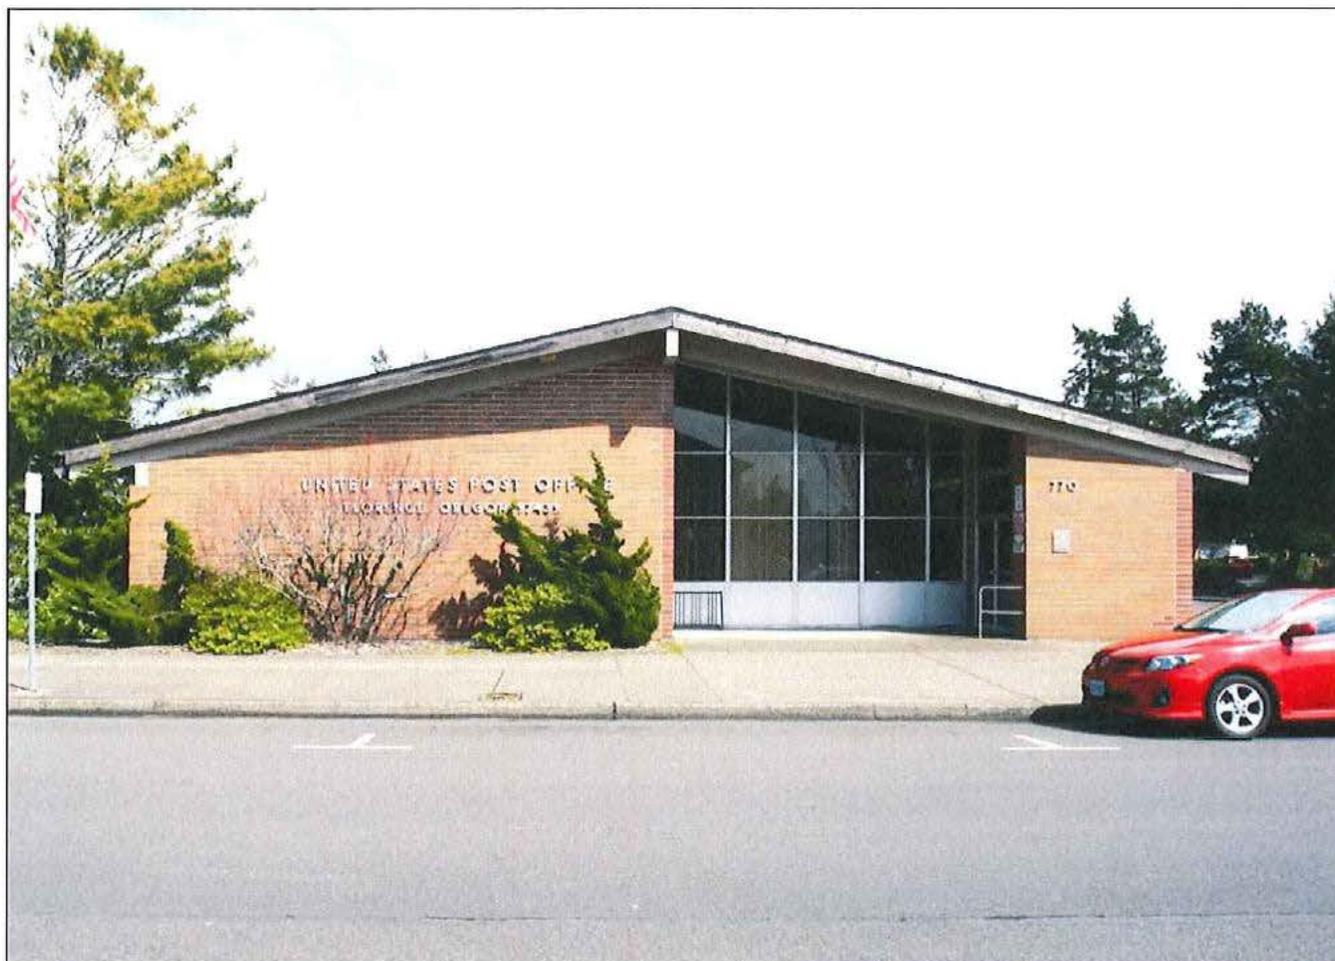
Figure 7: Florence Main Post Office (770 Maple Street, Florence, Lane County)

Exterior: The building is one-story in height with a rectilinear shape. The structure is of minimal design and is considered an example of the Modern style. The building was contractor designed. The building has a low-pitched front-gabled roof with overhanging eaves, poured-concrete slab-on-grade foundation, and is unreinforced-masonry block. Materials are consistent, with the entire building clad in a red brick in stretcher bond facade with "natural" mortar and modular slider and fixed aluminum-framed windows.

Interior: The building is accessed through the main entry off Maple Street. The interior is rectilinear in shape and divided into three zones. The first zone is the public lobby that has three areas for postal boxes along the north and west walls. The southern wall is clad in the same stretcher bond found on the exterior. To the east is where one enters the second zone for retail and customer service. The lobby and retail space have VCT flooring, painted gypsum-board walls, and a combination of exposed wood roof rafters and wood ceiling with painted gypsum board over the postal box areas. The third zone is to the east of the public lobby and customer service desks. This zone is a large open space and has utilitarian finishes.

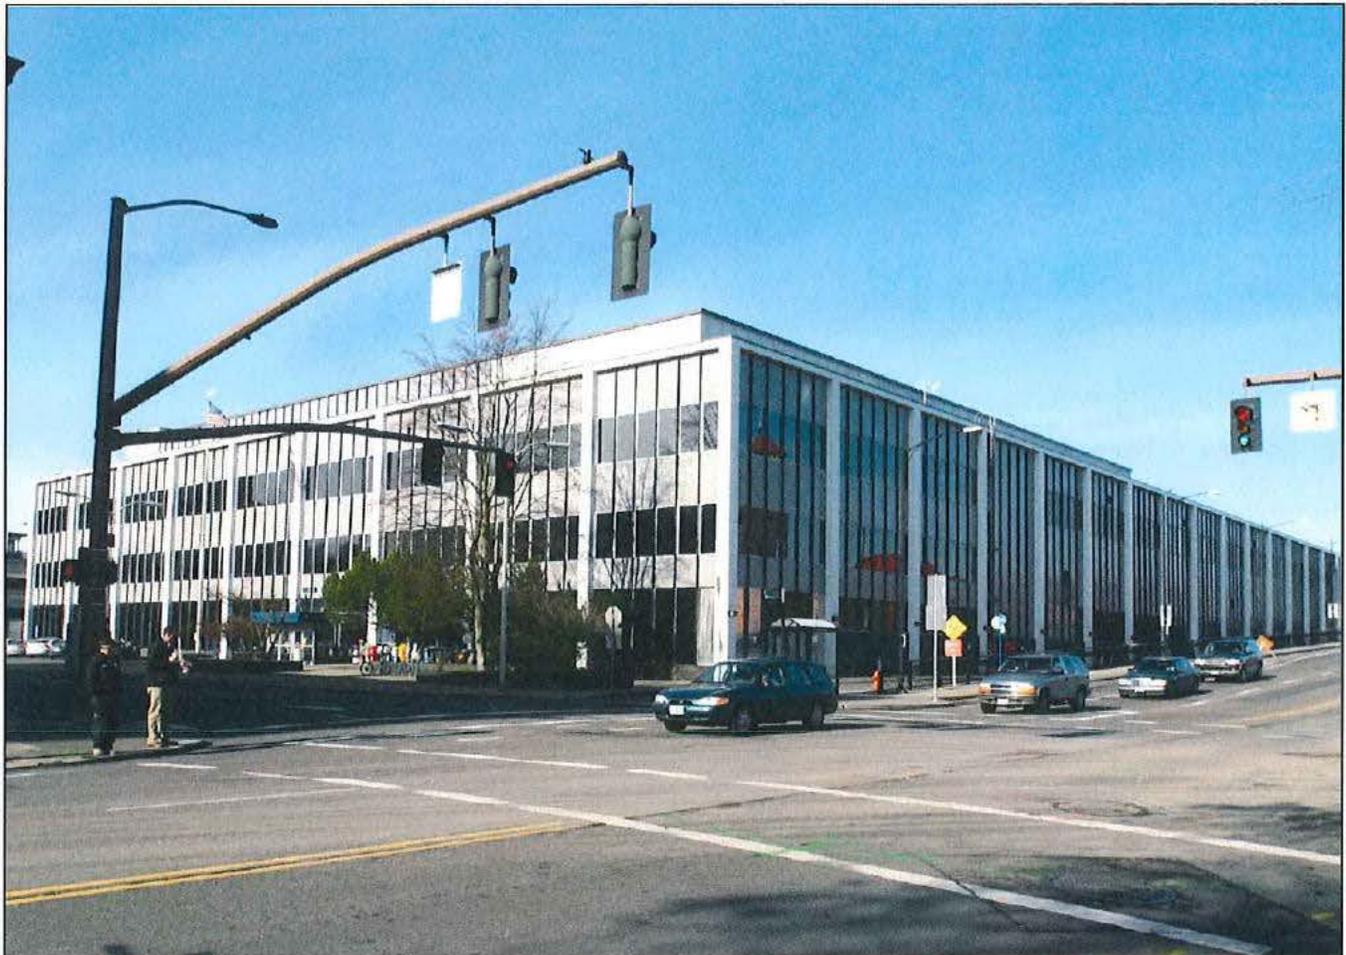
Figure 8: Portland P&DC (715 NW Hoyt Street, Portland, Multnomah)

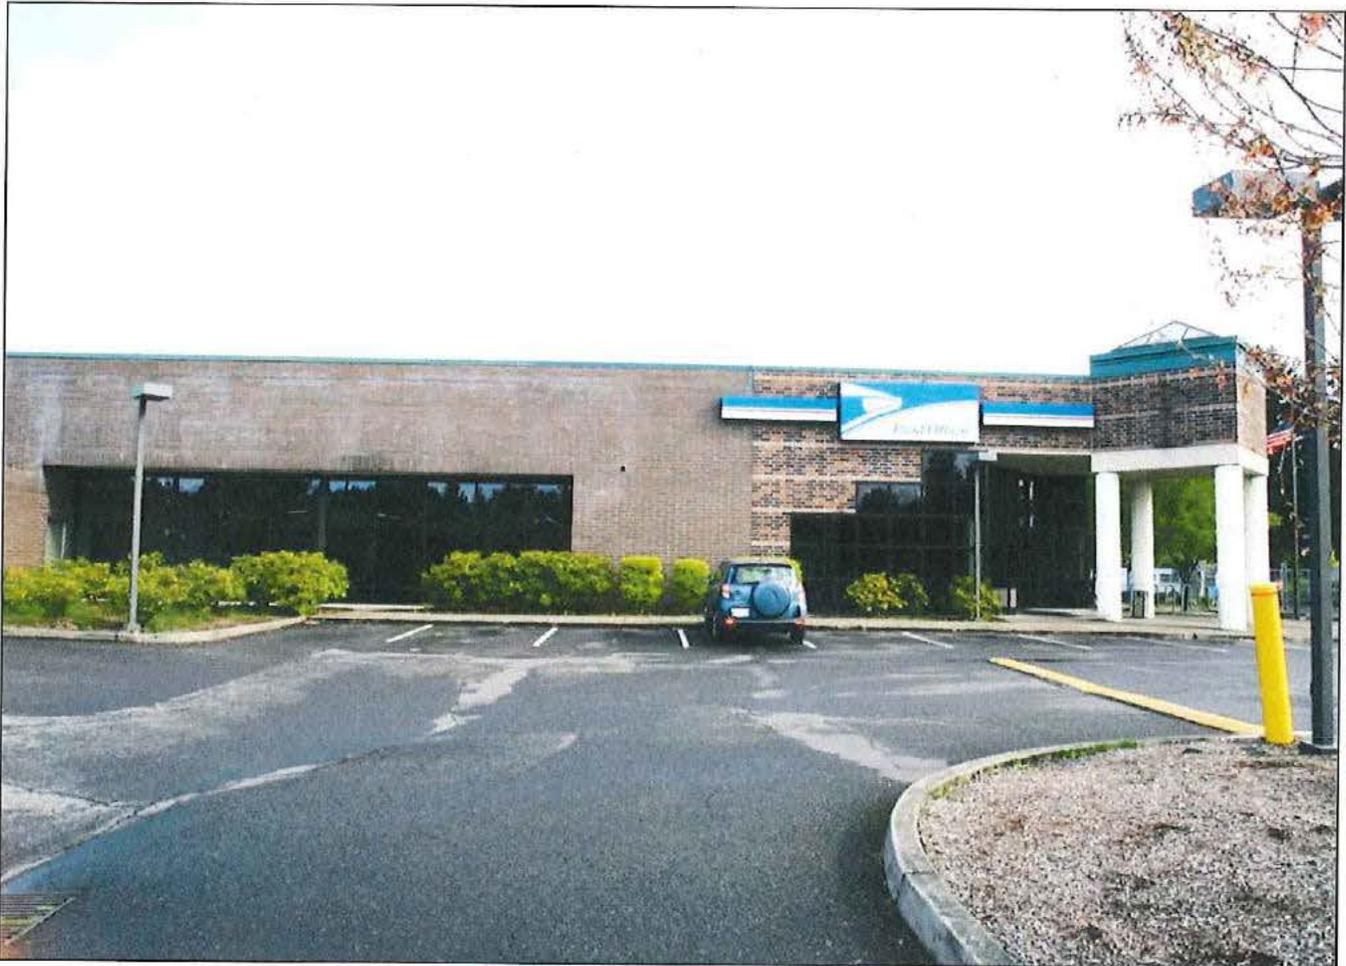
Figure 9: Springfield P&DC (3148 Gateway Street, Springfield, Lane County)

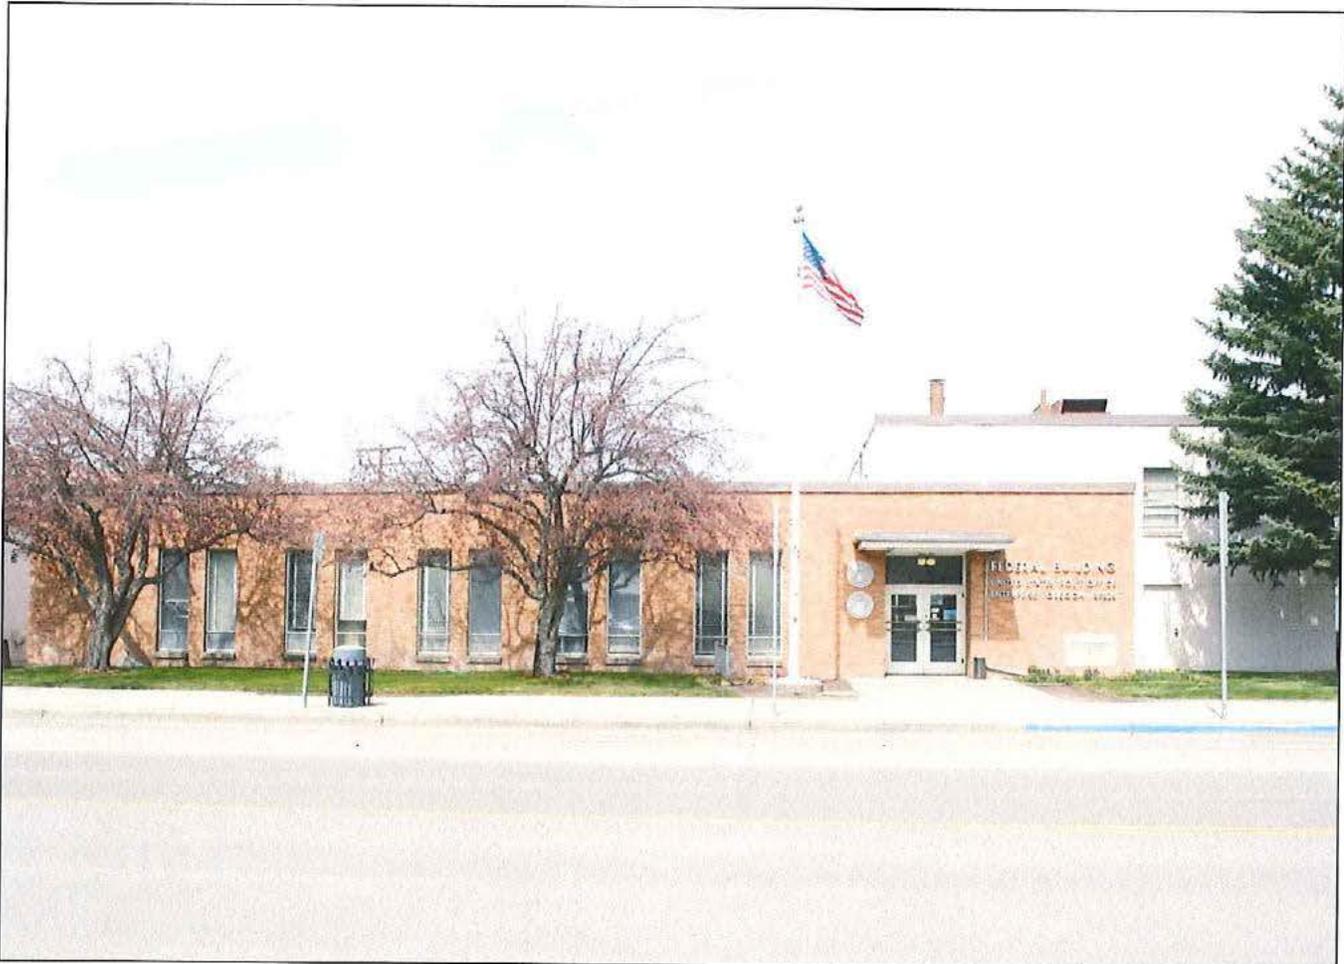
Figure 10: Federal Building/Post Office (201 W. North Street, Enterprise, Wallowa County)

Exterior: Constructed in 1965, the one-story post office is integrated into a two-story federal building at the southeast corner. The structure is of minimal design; "L" -shaped. The building was contractor designed. It has a flat roof, poured-concrete slab-on-grade foundation, and is unreinforced masonry block. Facade materials are red-brick stretcher-bond veneer with "natural" mortar, stucco panels, metal coping, and modular aluminum-framed plate-glass windows; fixed and casement style.
