# National Register of Historic Places Registration Form

historic name Ek, Magnus and Emma, House

street & number 729 S. Water Street

city or town Silverton

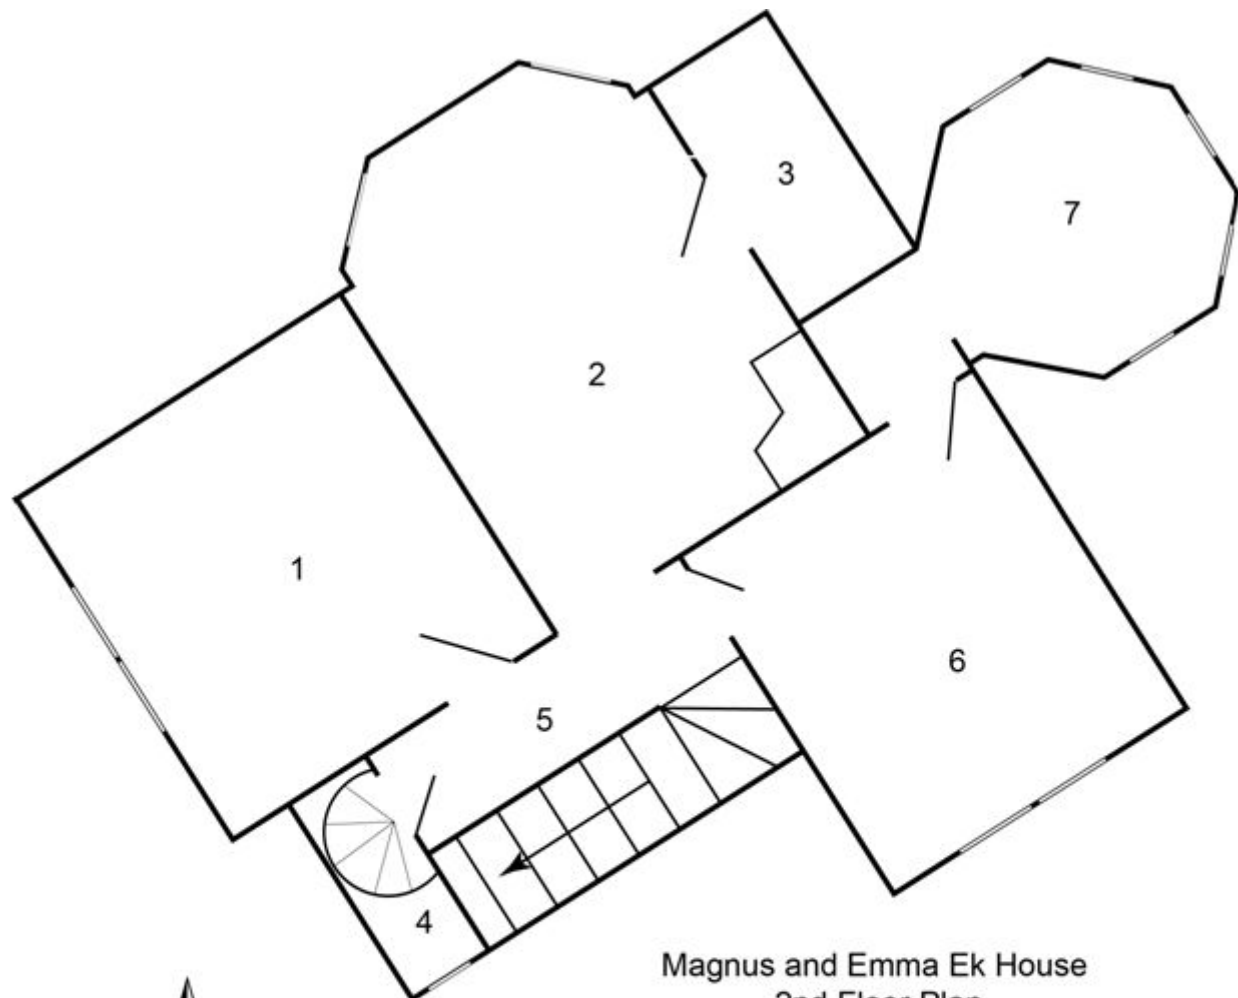
Figure 5: Second Floor Plan

Magnus and Emma Ek House  
2nd Floor Plan

1. Bedroom 1
2. Bedroom 2
3. Bathroom
4. Attic access
5. Hall
6. Bedroom 3
7. Bathroom (Addition)

The second floor of the house includes two bedrooms, a room currently used as library but historically a bedroom, and the large bathroom occupying the octagonal turret visible from the east elevation of the house, above the original rear attachment. The stair rises along the east wall of the hall. The hall itself includes the balustrade, newel post at the turn of the rail, a matching, engaged newel at the west wall, heavy baseboards matching those found elsewhere in the house, crown molding, and a beaded tongue-and-groove ceiling. The hall provides access to bedroom 1 (currently used as a library) at the north end of the north wall, bedroom 2 at the center of the north wall, and bedroom 3 at the east wall; the attic access is on the west wall. All four doors are original four-panel doors with heavy, molded trim as seen elsewhere in the house, without corner blocks (except the door providing access to the attic, which was originally designed as a closet and so has simpler molded trim). The room now provides access to the semi-finished attic via a steel spiral stair set in the room, which includes an original window with original trim, corresponding to that seen on the second floor south elevation, beneath the small cross-gable at the west end of the elevation.

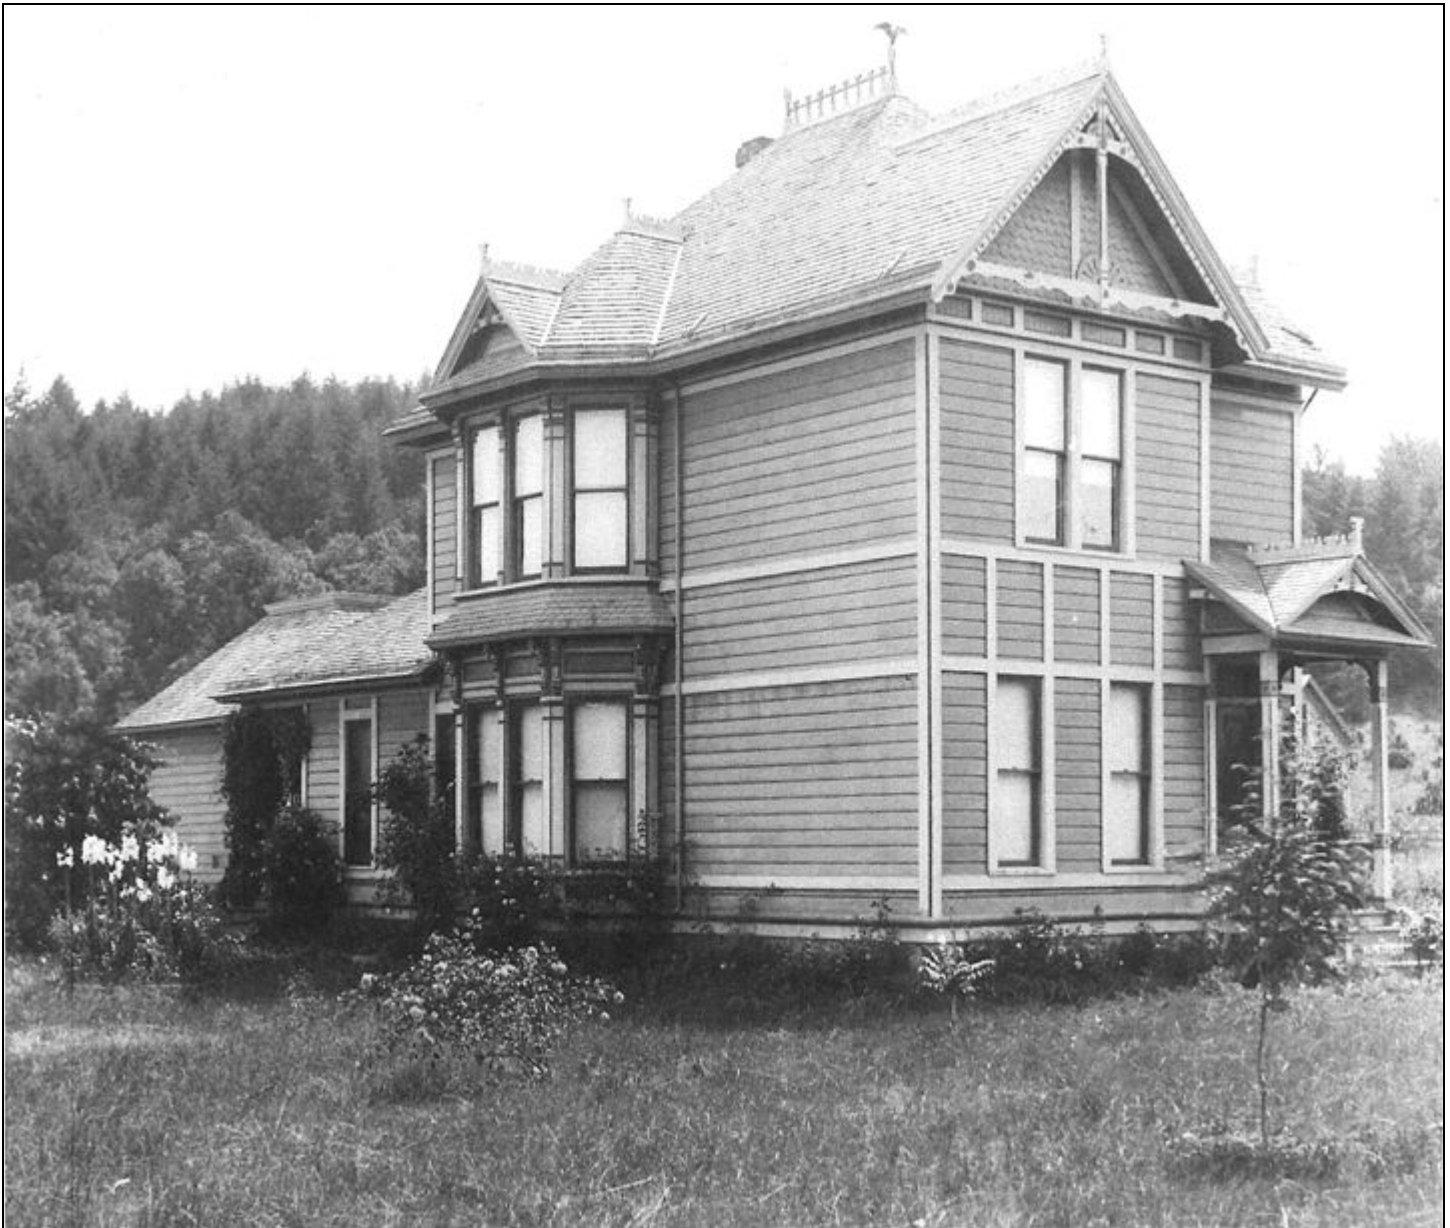
Figure 6: Ek House, ca.1895, prior to addition of front porch and third window on first floor.<sup>35</sup>

<sup>2</sup> The 1922 Sanborn Fire Insurance Map shows both the carriage house and the wrap-around front porch. The addition was likely completed before 1900, as historic photos show the carriage house addition present before the wrap-around porch was added (see Figure 6).

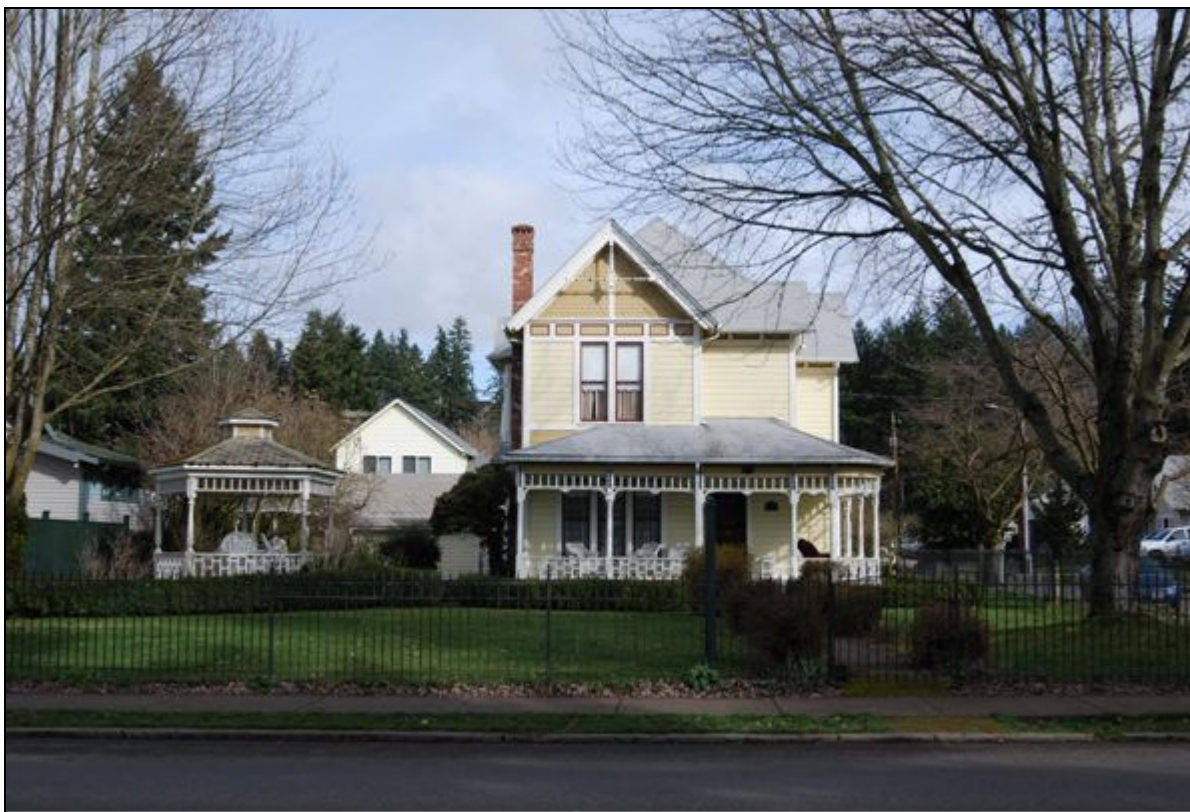
Photo 1 of 14: Southwest elevation of house, gazebo and garage visible. View to the northeast.

The west (front) elevation of the Ek House is characterized by the full-width wrap-around porch and the prominent projecting gable raising the full height of the house on the north side of the elevation. Much of the stickwork that characterized the early Stick-style design of the building (modified to more closely resemble a standard Queen Anne style around the turn of the twentieth century, likely between 1900 and 1905) remains intact, especially the vertical and horizontal fascias that create the characteristic panels and subdivisions across the façade.

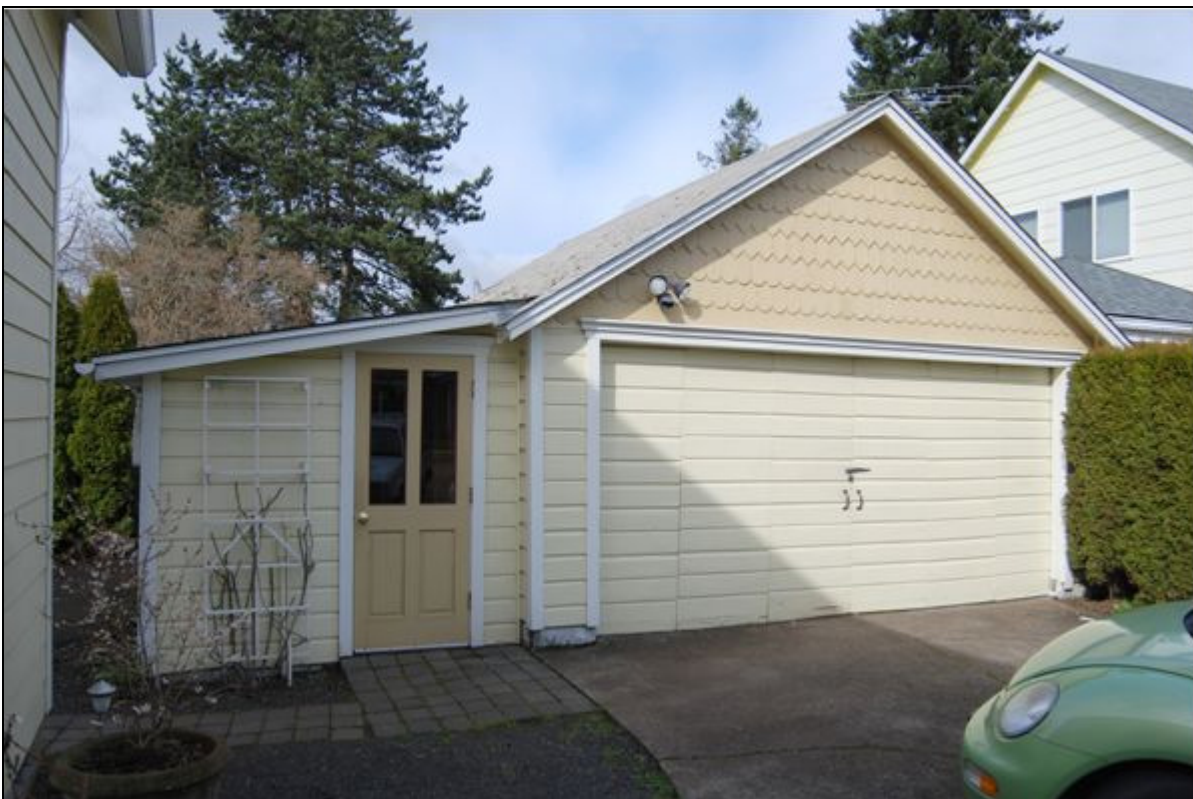
Photo 6 of 14: Southeast elevation of garage, view to the northwest.

The Magnus and Emma Ek House has two associated non-contributing accessory structures within the nominated boundary. To the northeast of the house is a detached ca. 1920 two-car garage. The garage is a front-gabled structure with a shed attachment on the west elevation. The building sits on a concrete pad foundation and is clad with coved shiplap (drop) siding similar to that found on the house and varied shingle in the south (front) gable end. The south (front) elevation has a paired, side-rolling double-wide vehicle door. Each of the two doors is in three parts, which are designed to roll around the inside of the corner of the building. The shed attachment is on the west elevation of the main structure of the garage. It extends from the south face of the garage to approximately 3 feet short of the north face of the main massing of the garage. It features corner boards, an entry door on the south (front) elevation, a one-over-one wood-sash window with molded surround centered on the west (side) elevation, and decorative turned spandrels attached at the corners of the west elevation (apparently salvaged from elsewhere). The main massing of the garage has corner boards only on the southeast and southwest corners, and a four-light window with no trim on the north (rear) elevation. A garage appears on the 1922 Sanborn Map to the northwest of the house, but on the 1939 Sanborn Map that structure has been removed and a dwelling sits in its place. No garage is shown for the Ek House in 1939. It is likely that this ca. 1920s garage was moved to the site at some later time.

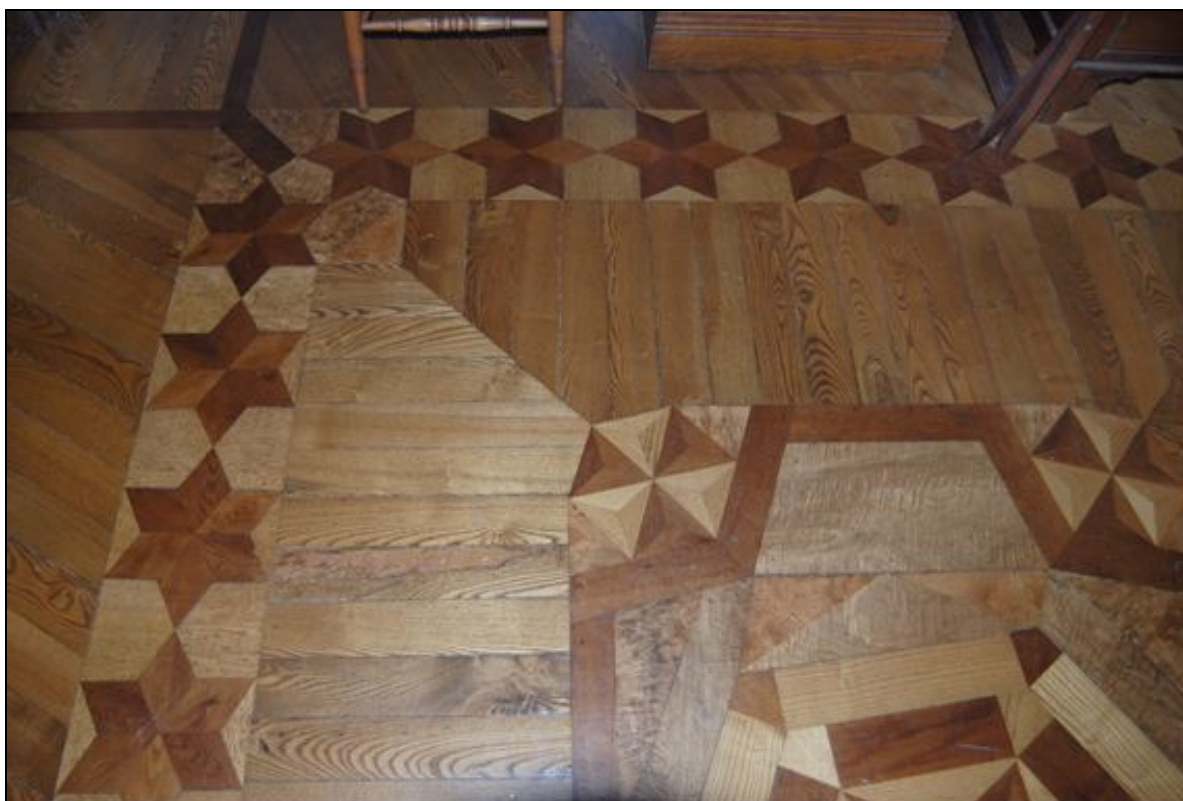
Photo 10 of 14: Detail of study floor, view to the north.

drawer, apparently incorporating the lower reaches of a chimney that may have once supplied exhaust for a stove. The highly elaborate floor is composed of varying species of wood, arranged to form a central shield area with hexagons and a large hexagonal rosette with a central six-pointed star, surrounded by a border composed of six-pointed stars. A bathroom is attached to the east of the study and is accessed through a standard doorway with trim matching that found elsewhere in the house, with no corner blocks. The bathroom is L-shaped and extends to the east and south from the door. At the east is the furnace area. At the south is a claw-foot tub with shower, above which is a window corresponding to the exterior, first-floor, south elevation, first window east of the projecting cross-gable. The window and door have original trim that matches that seen elsewhere in the house, without corner blocks. The bathroom also includes a high-tank toilet at the northwest corner of the room.
