National Register of Historic Places Registration Form

historic name Christian, Daniel and Catherine, House

street & number 170 E. 12th Avenue

city or town Eugene

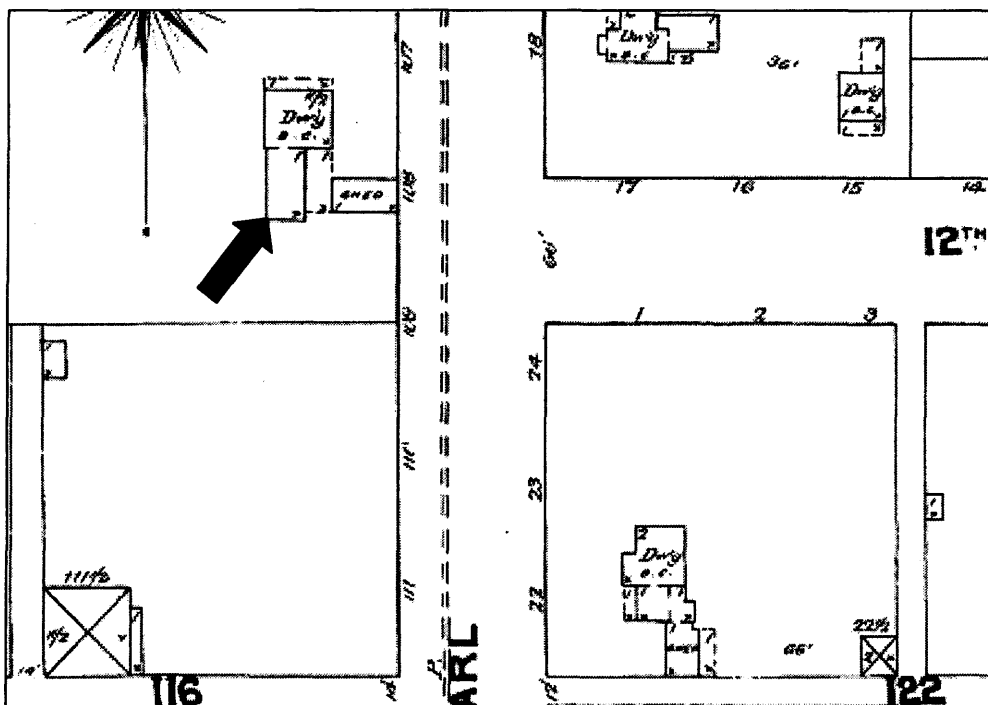
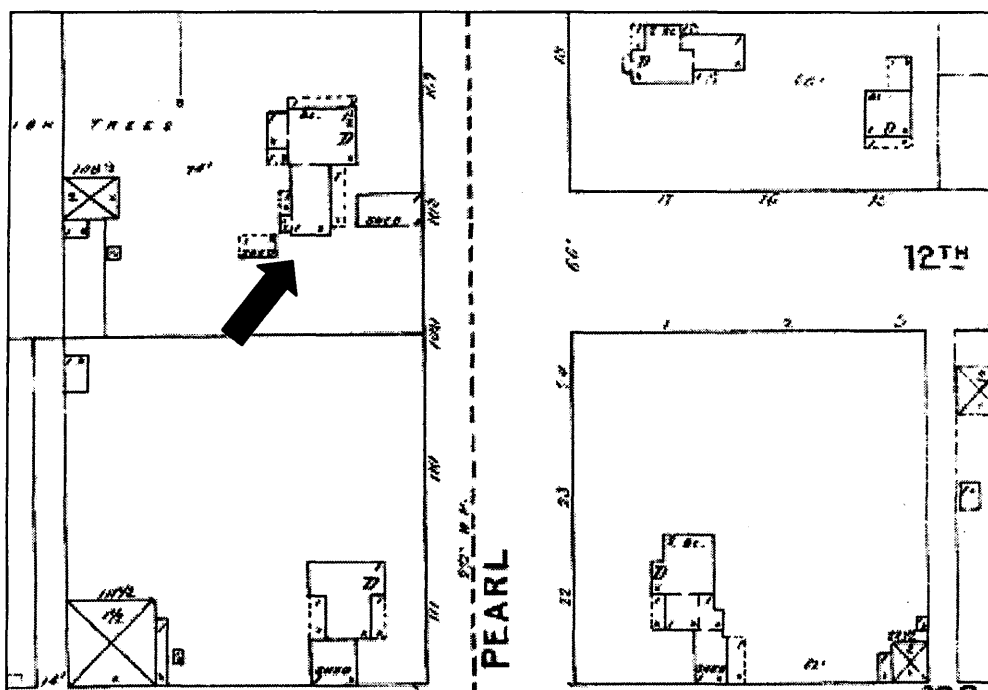
Figures 6 and 7. 1890 and 1895 Sanborn maps.

The earliest drawing available (1890 Sanborn map) indicates a main square-ish footprint with a full-width front porch and a rectangular wing extending from the back. This basic configuration appears to remain relatively unchanged for many years. Later maps (1895-1902) show the appearance (and subsequent disappearance a decade later) of a small addition on the west side of the main portion of the house. The addition and subtraction of this appendage likely account, at least in part, for the now-jumbled fenestration pattern on the west elevation. (Photo 13; Figs. 6-9)

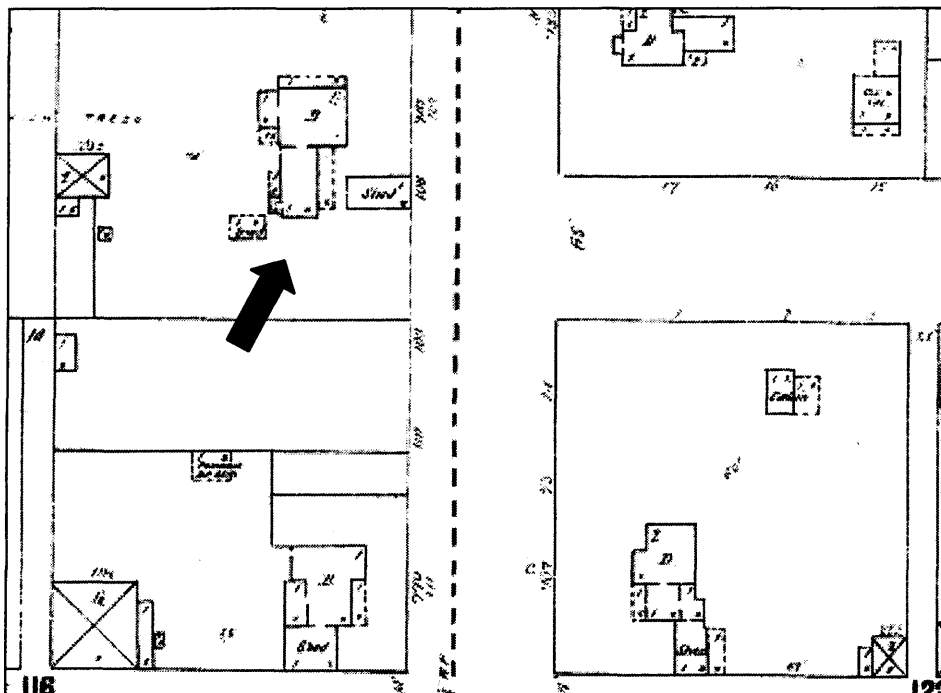
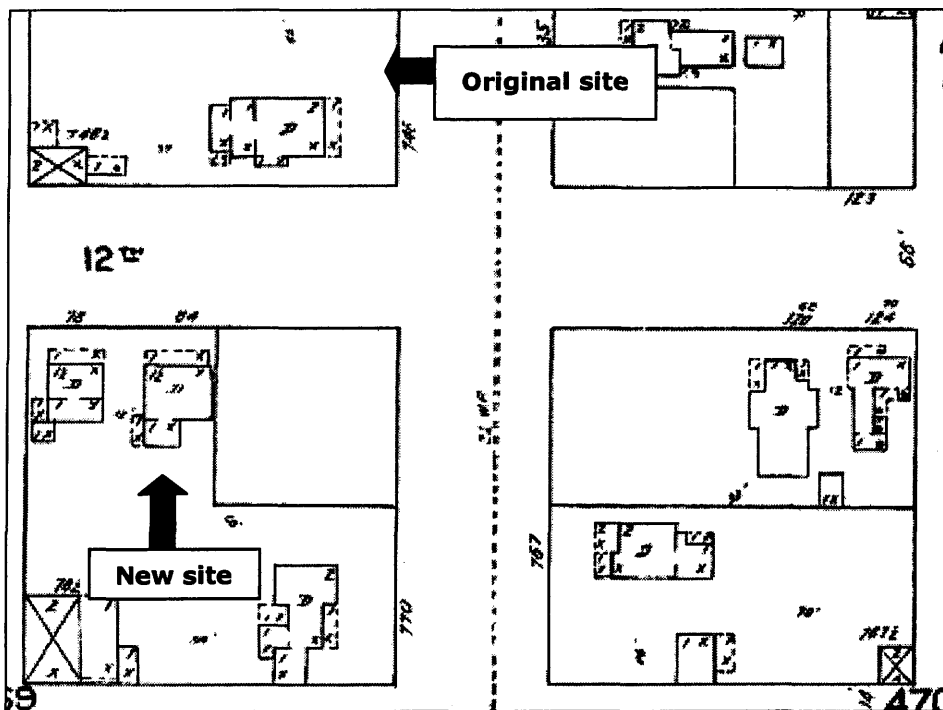
Figures 8 and 9. 1902 and 1912 Sanborn maps.

Modifications to this original plan occurred with the early 20th century addition that added an extension to the southeast corner of the house; at approximately the same time it appears that the kitchen wing was lengthened. (Figs. 8-11) Further modifications provided accommodation for a bathroom (adjacent to the kitchen) and converted the front bedroom to an entrance vestibule, adding a staircase to provide the attic apartments. (Fig. 16; Photos 33-36) No indication of the original attic access has yet been found. It is possible that access was gained from either an interior pull-down ladder, or perhaps an outside ladder or stair.⁹

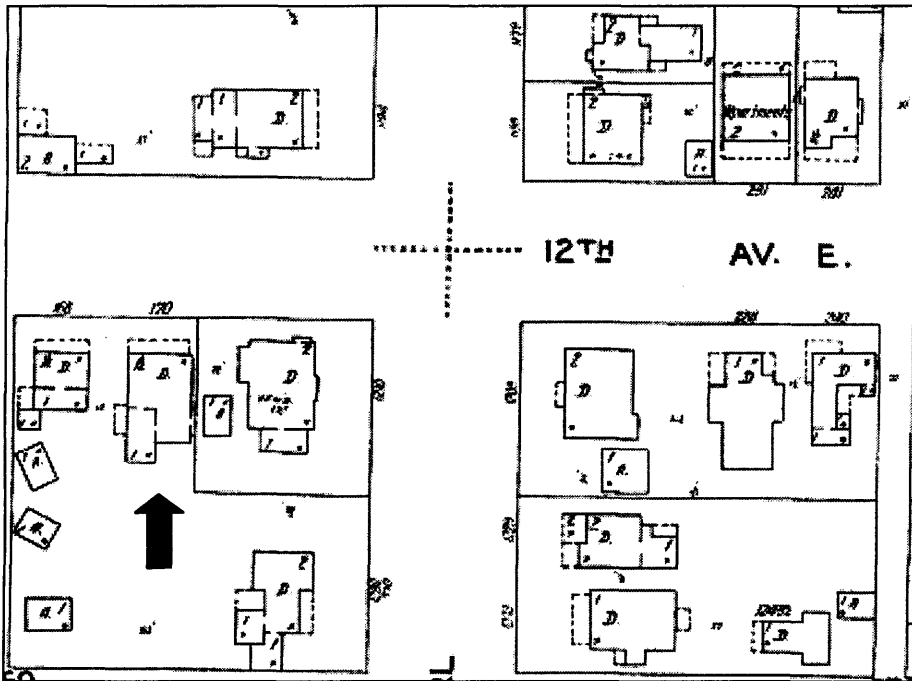
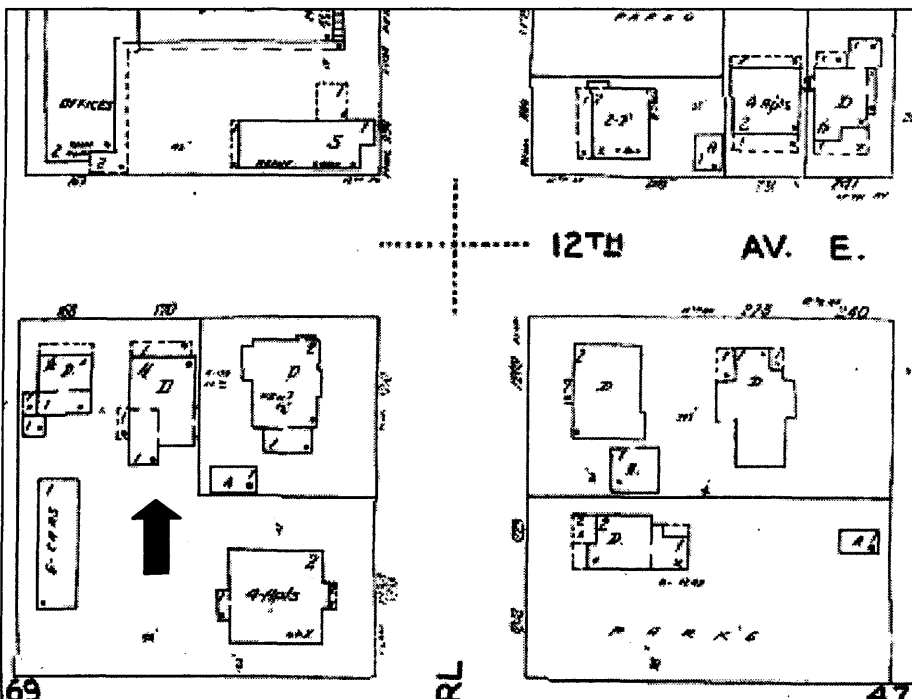
Figures 10 and 11. 1925 and 1925-60 Sanborn maps.

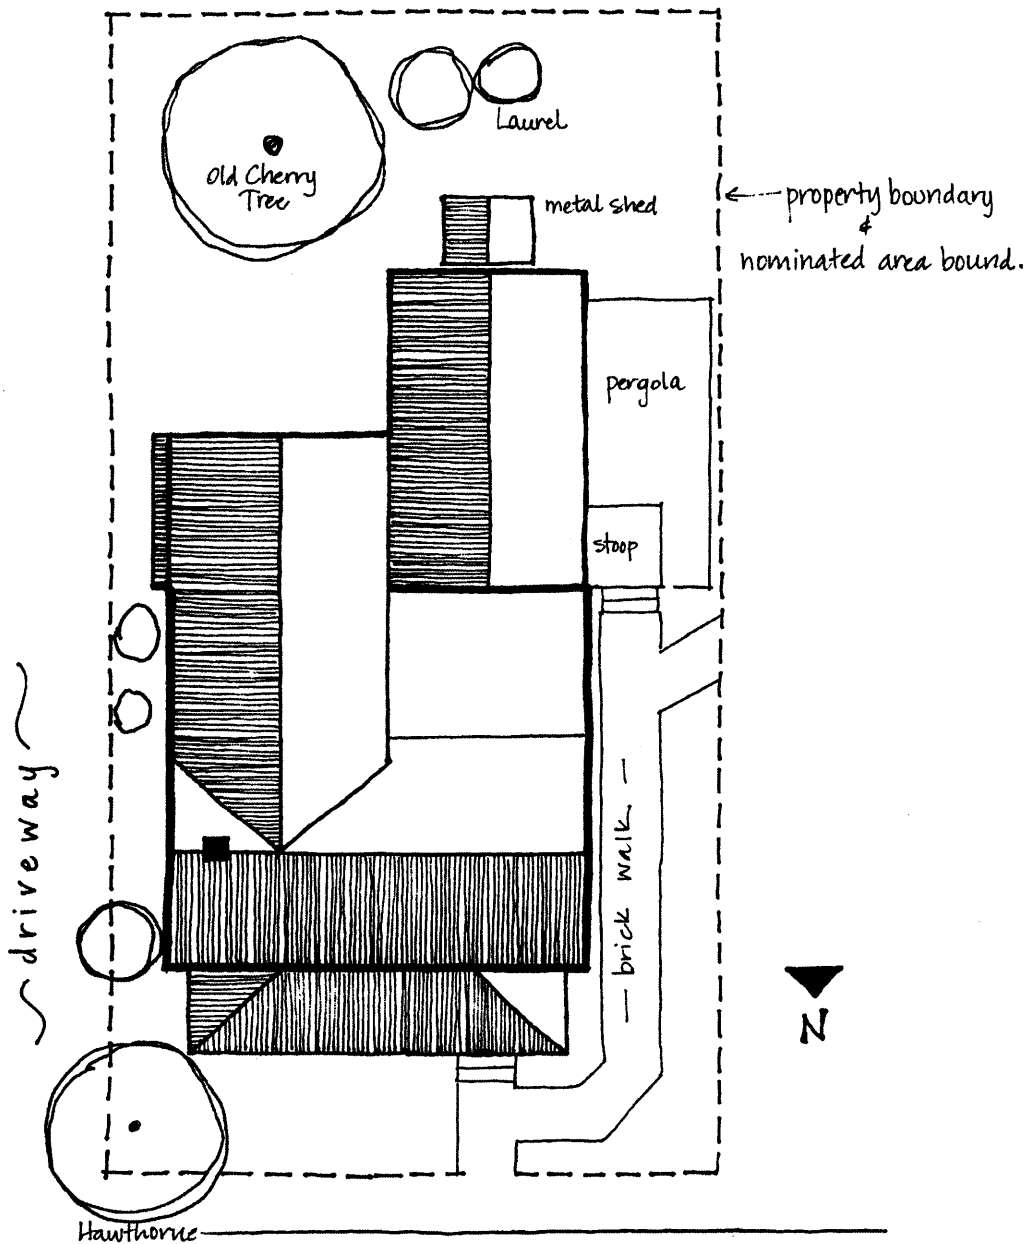
Figure 15. Christian House site plan.

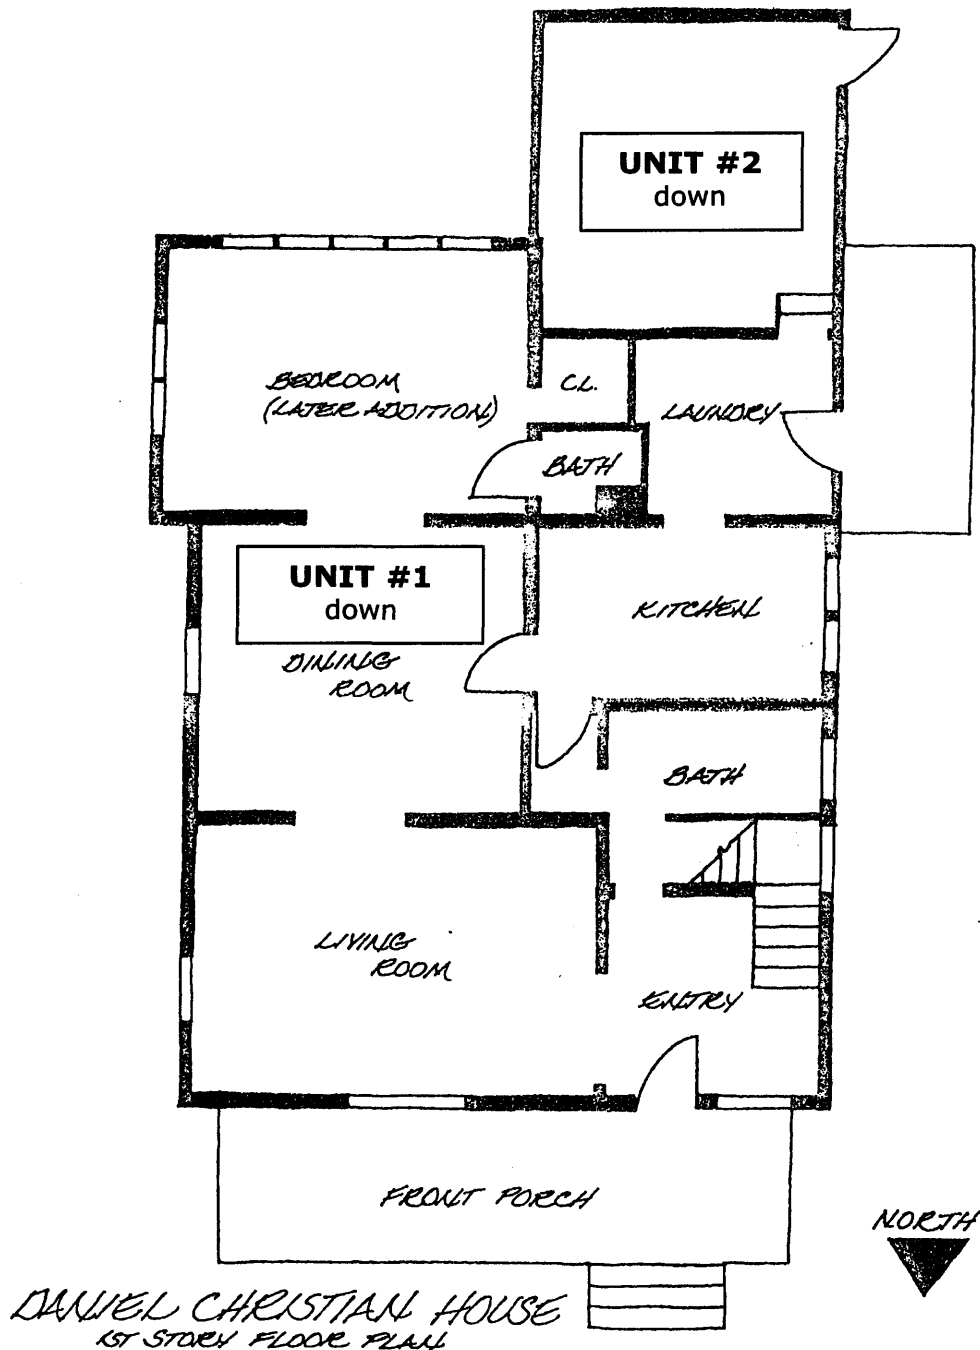
Figure 16. First floor plan (courtesy City of Eugene)

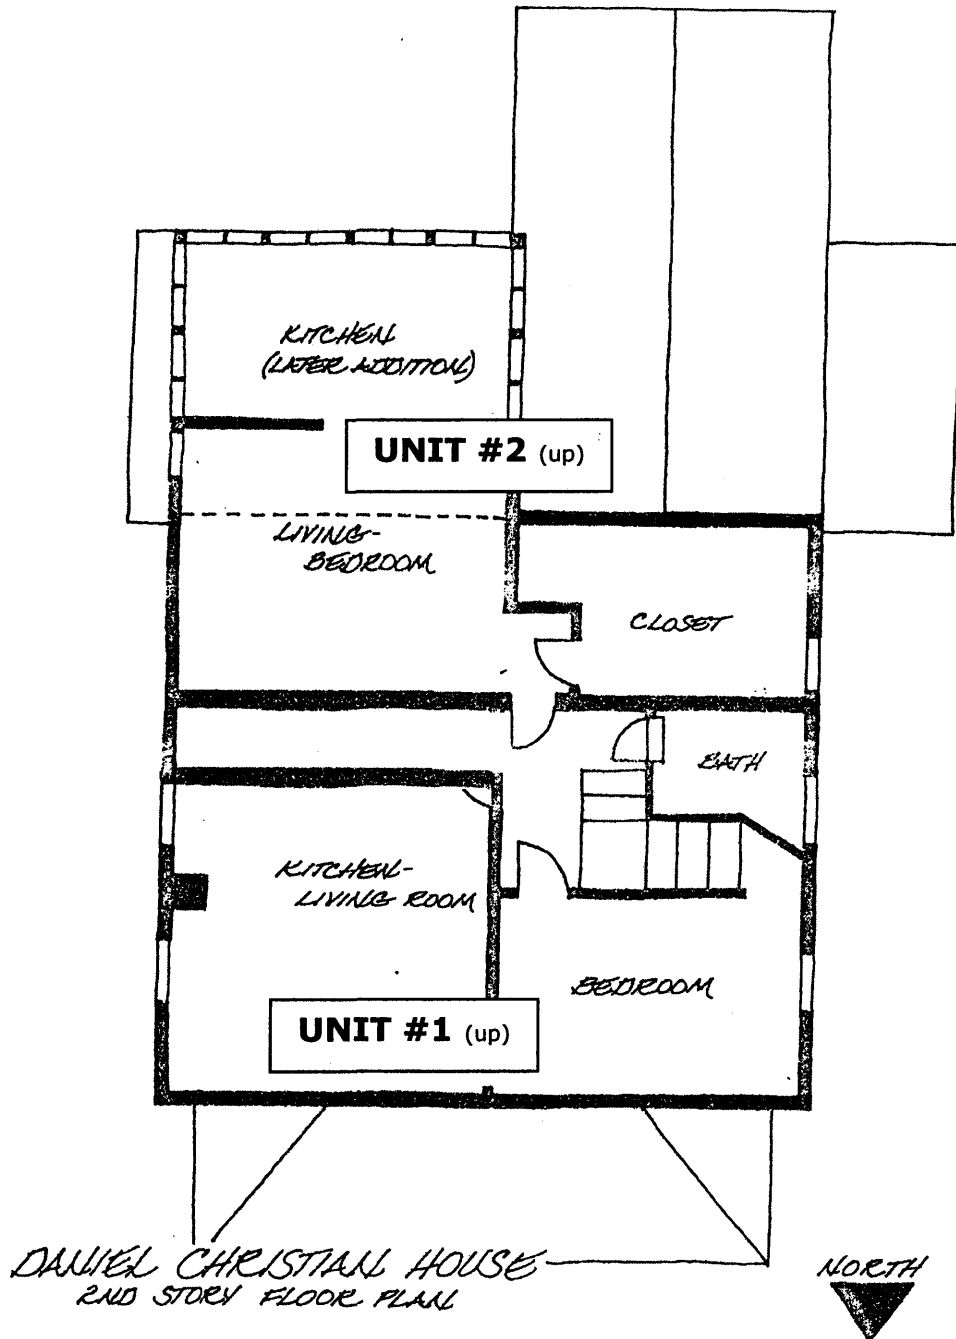
Figure 17. Second floor plan (Courtesy City of Eugene; revised by author)

The entry and stairway to the upper floor display the same early twentieth century detailing that is found in the rest of the house. The stair is a three-run split stair with wood treads and risers and a railing with simple square balusters and molded handrail. (Photos 34, 35) The upstairs space, probably originally one large attic room, has been divided into two small apartments, a stair landing/hallway, and a common bathroom. (Fig. 17)

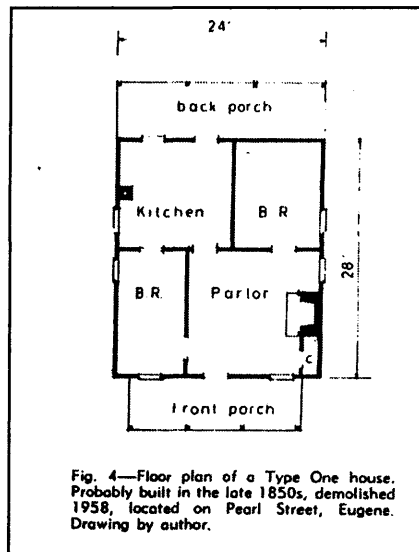
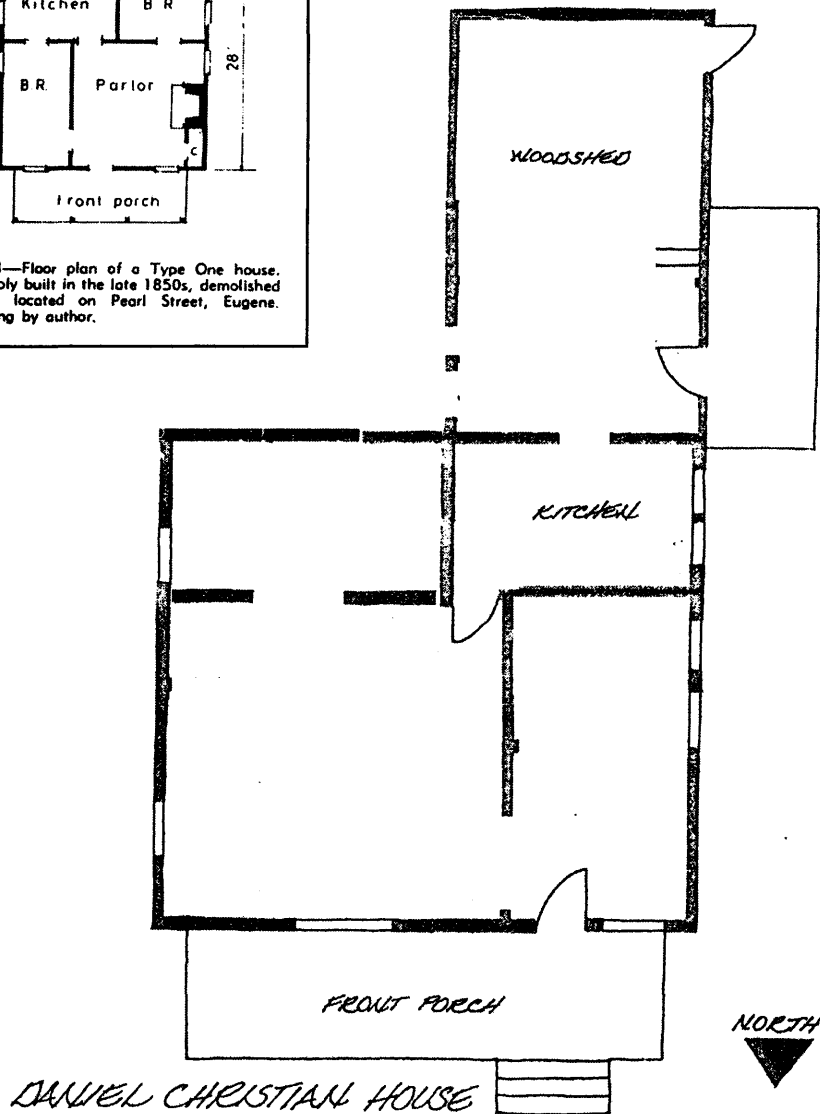
Figure. 18. Possible original configuration of first floor plan based on substructure arrangement and comparison to similar house described by Dole.
Inset: Drawing from Dole's article "Farmhouse & Barn in Early Lane County" showing Type 1 house floor plan.

In University of Oregon Professor Philip Dole's article "Farmhouse and Barn in Early Lane County" published in 1965 in the *Lane County Historian*, the author states that "Examination of the farmhouses between 1850 and 1865 reveals that in terms of size, height, basic plan and general proportions there were a half dozen types, found in other counties too." The article dilates on three of these types, labeled "Type One," "Type Two" and "Type Three;" the Christian House is categorized as a Type One building.

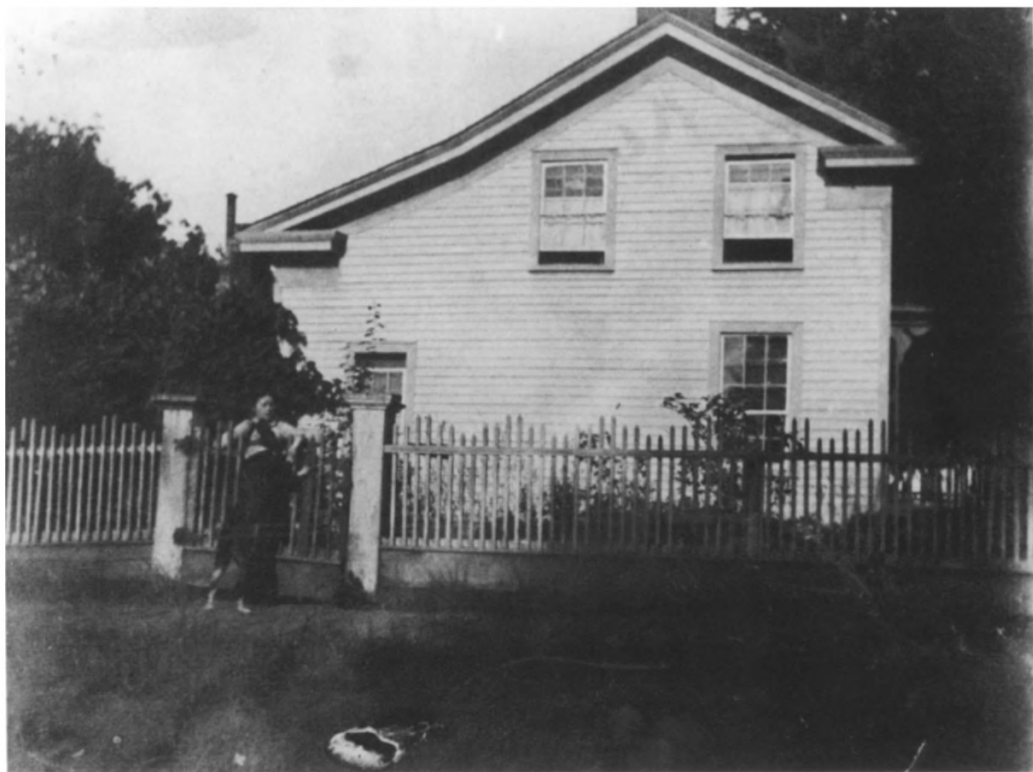
4 of 11

² The porch does not appear in this form on an undated historic photograph, which indicates a smaller, centered porch with Gothic Revival or perhaps Queen Anne details. See Photo 4.

⁴ Wall patches made visible during interior rehabilitation work indicate the opening was moved. Measurements extrapolated from historic photographs were compared to measurements of the current opening. See Photo 4.

The low-pitched side-gable roof has a longer rear, double-pitch slope, giving a lean-to or saltbox appearance in profile from the east and west side elevations. (Photos 4, 8, 12) The boxed eaves are detailed with wide frieze boards and simple bed molding. The house displays the full entablature – albeit simplified – that is typical of the Classical Revival style, complete with the substantial eave returns wrapping approximately 32" around the corners of the building. The fenestration pattern on the east elevation consists of two windows each on the first floor and attic levels. The placement of all windows but one on this elevation appears to be original; the southern lower opening has been moved about 6" to the north and slightly enlarged.⁴ The west elevation window pattern appears to have been altered from what was likely similar to that on the east elevation. (Photo 13, 14) Fenestration is now irregular, including single and paired one-over-one windows and a single, six-pane sash that may be the only remaining original sash in the house.

This lack of curvilinear detail appears to be somewhat unusual in the remaining examples of this type in Eugene and Lane County, but clearly the desired effect is achieved using only planed moldings. (Photos 4, 14 & 16)

¹³ Williams, *Reminiscences...*, 19. See Photo 4 for view of "picket gate."

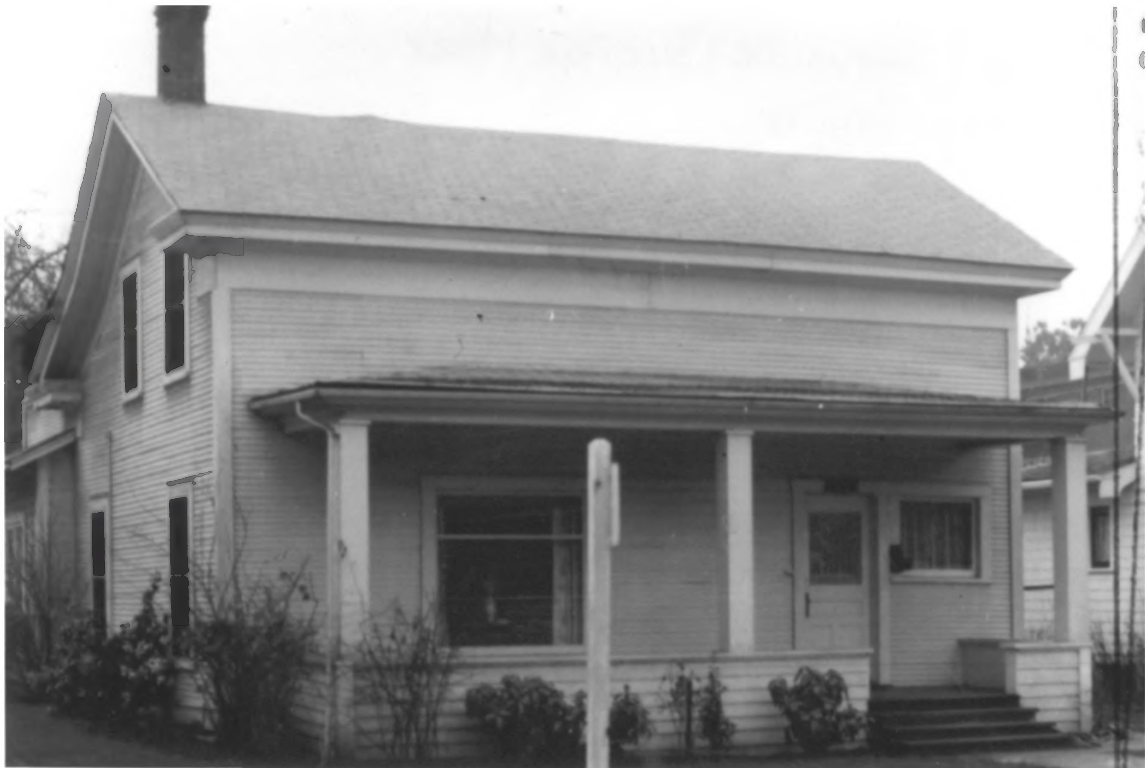
6 of 41

The front (north) elevation is dominated by a full-width front porch. Under the porch are a large picture window and an off-centered half-light entrance door flanked by a square fixed window. (Photos 6, 7 & 18) The porch itself has a closed rail clad in cedar shingles, and three large, equally spaced square posts support the shallow hipped roof. This is not the original construction, but the dimensions, design and massing of this porch are compatible with the house.² Other buildings of this period display porches with similar characteristics, particularly the regularly-spaced square posts with simple molding, suggesting that this porch may be similar to the original design.³

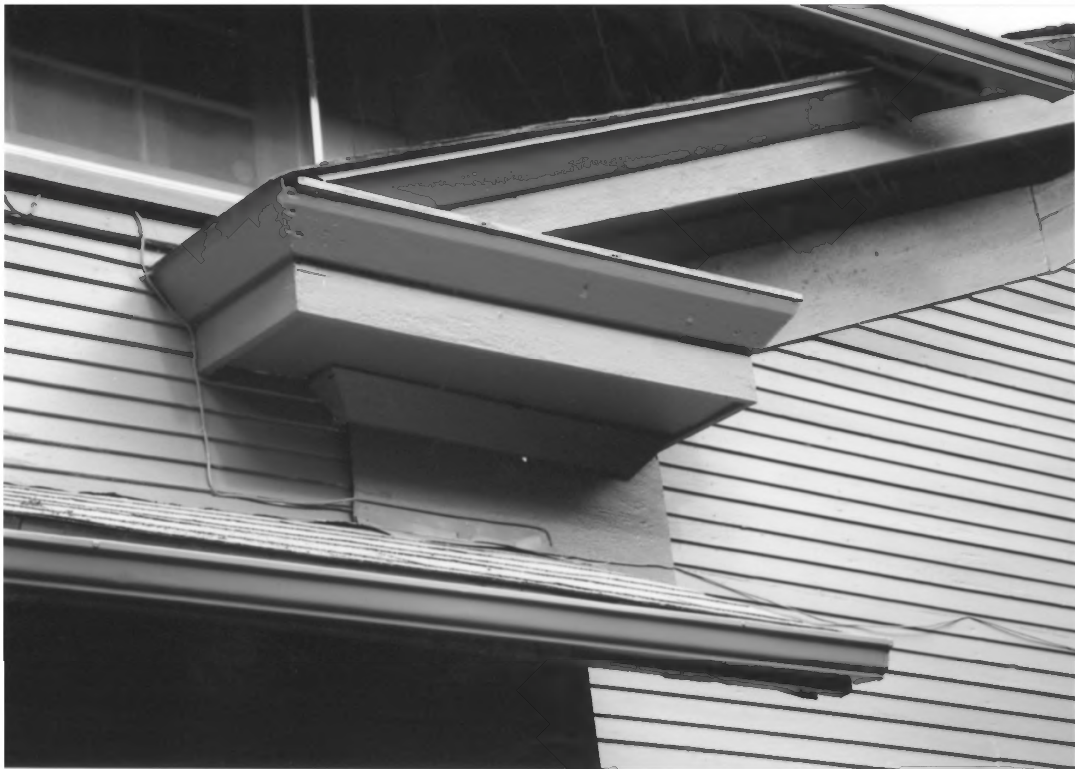
- 16 of 41 Christian House, east elevation eave detail.
- 17 of 41 Christian House, northwest corner, foundation and siding treatment detail.
- 18 of 41 Christian House, west elevation, porch and entrance detail.
