NATIONAL REGISTER OF HISTORIC PLACES INVENTORY -- NOMINATION FORM

~~Saint~~, James Lutheran Church

1315 S.W. Park Avenue

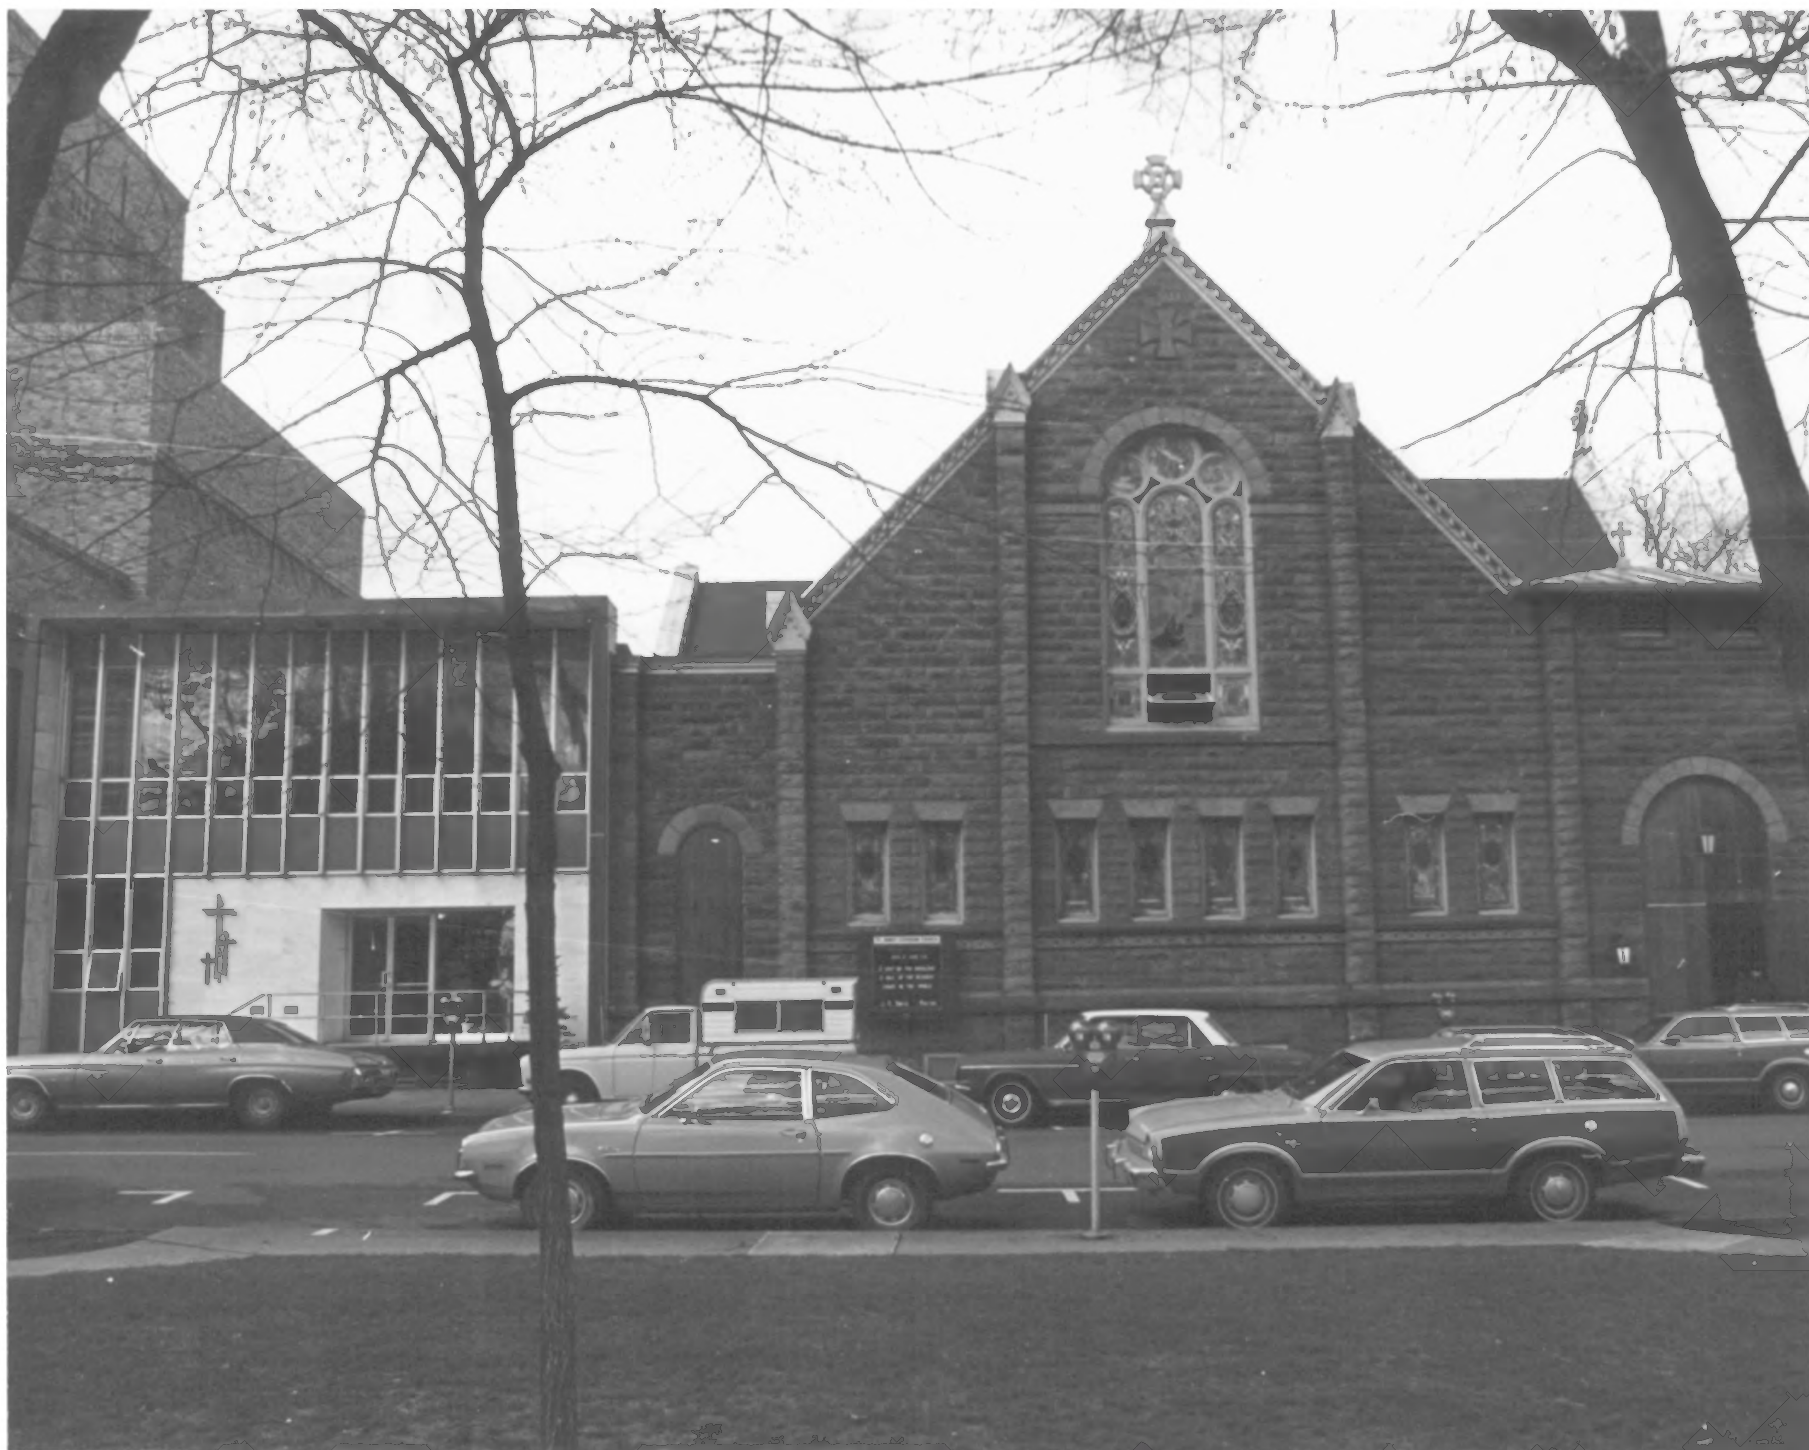
1

Educational Unit and Main Church, looking west

EAST AND NORTH WALL - CORNER PARK AND
JEFFERSON ST. Picture taken Dec 1974
SHOWS ALTERATION AFTER TOWER REMOVED

There have been two major alterations to the church since the construction in 1907-08. In the original main church there was a tower at the northeast corner. Because of carpenter ants and damage by natural elements, it was necessary to remove the tower in 1951. The congregation hopes to restore the tower with coursed Ashlar sandstone sometime in the future. The other major alteration is the education-office complex completed in 1958. This building is attached to the main church and chapel but does not conform to either in style or materials. The walls are of reinforced concrete with marble veneer on the east side.

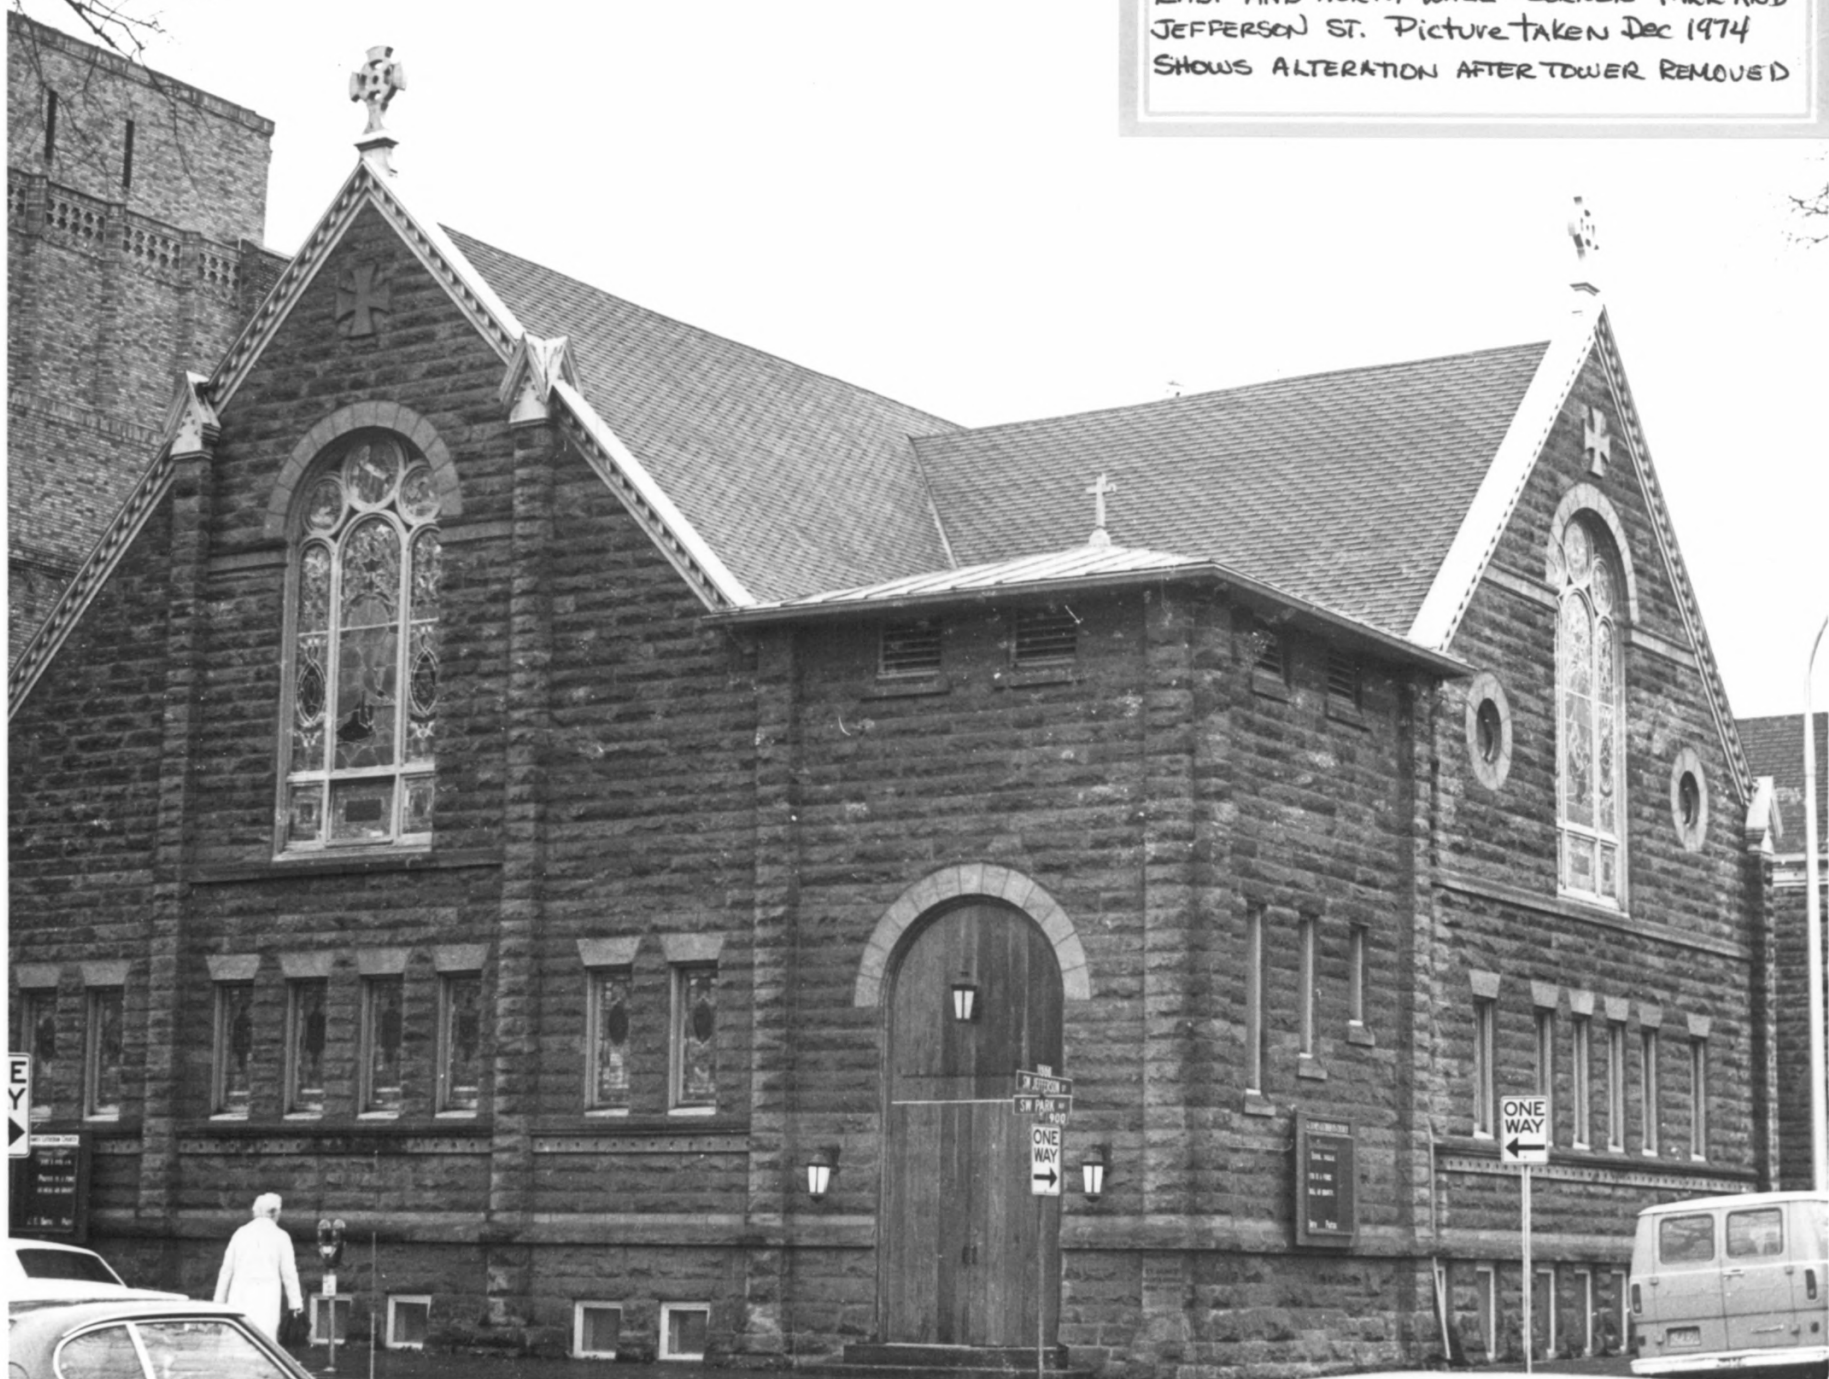
2

Front entrance of church, looking southwest

The main church connects with the chapel on the east end of the latter. It is a wood frame building with a stone veneer faced of coursed Ashlar sandstone (split face). The veneer around the openings is of cut faced stone. Around the building, at about eye level, there is a belt course with detail carving on the stone. The stone veneer on both buildings is Tenino sandstone quarried in the state of Washington.

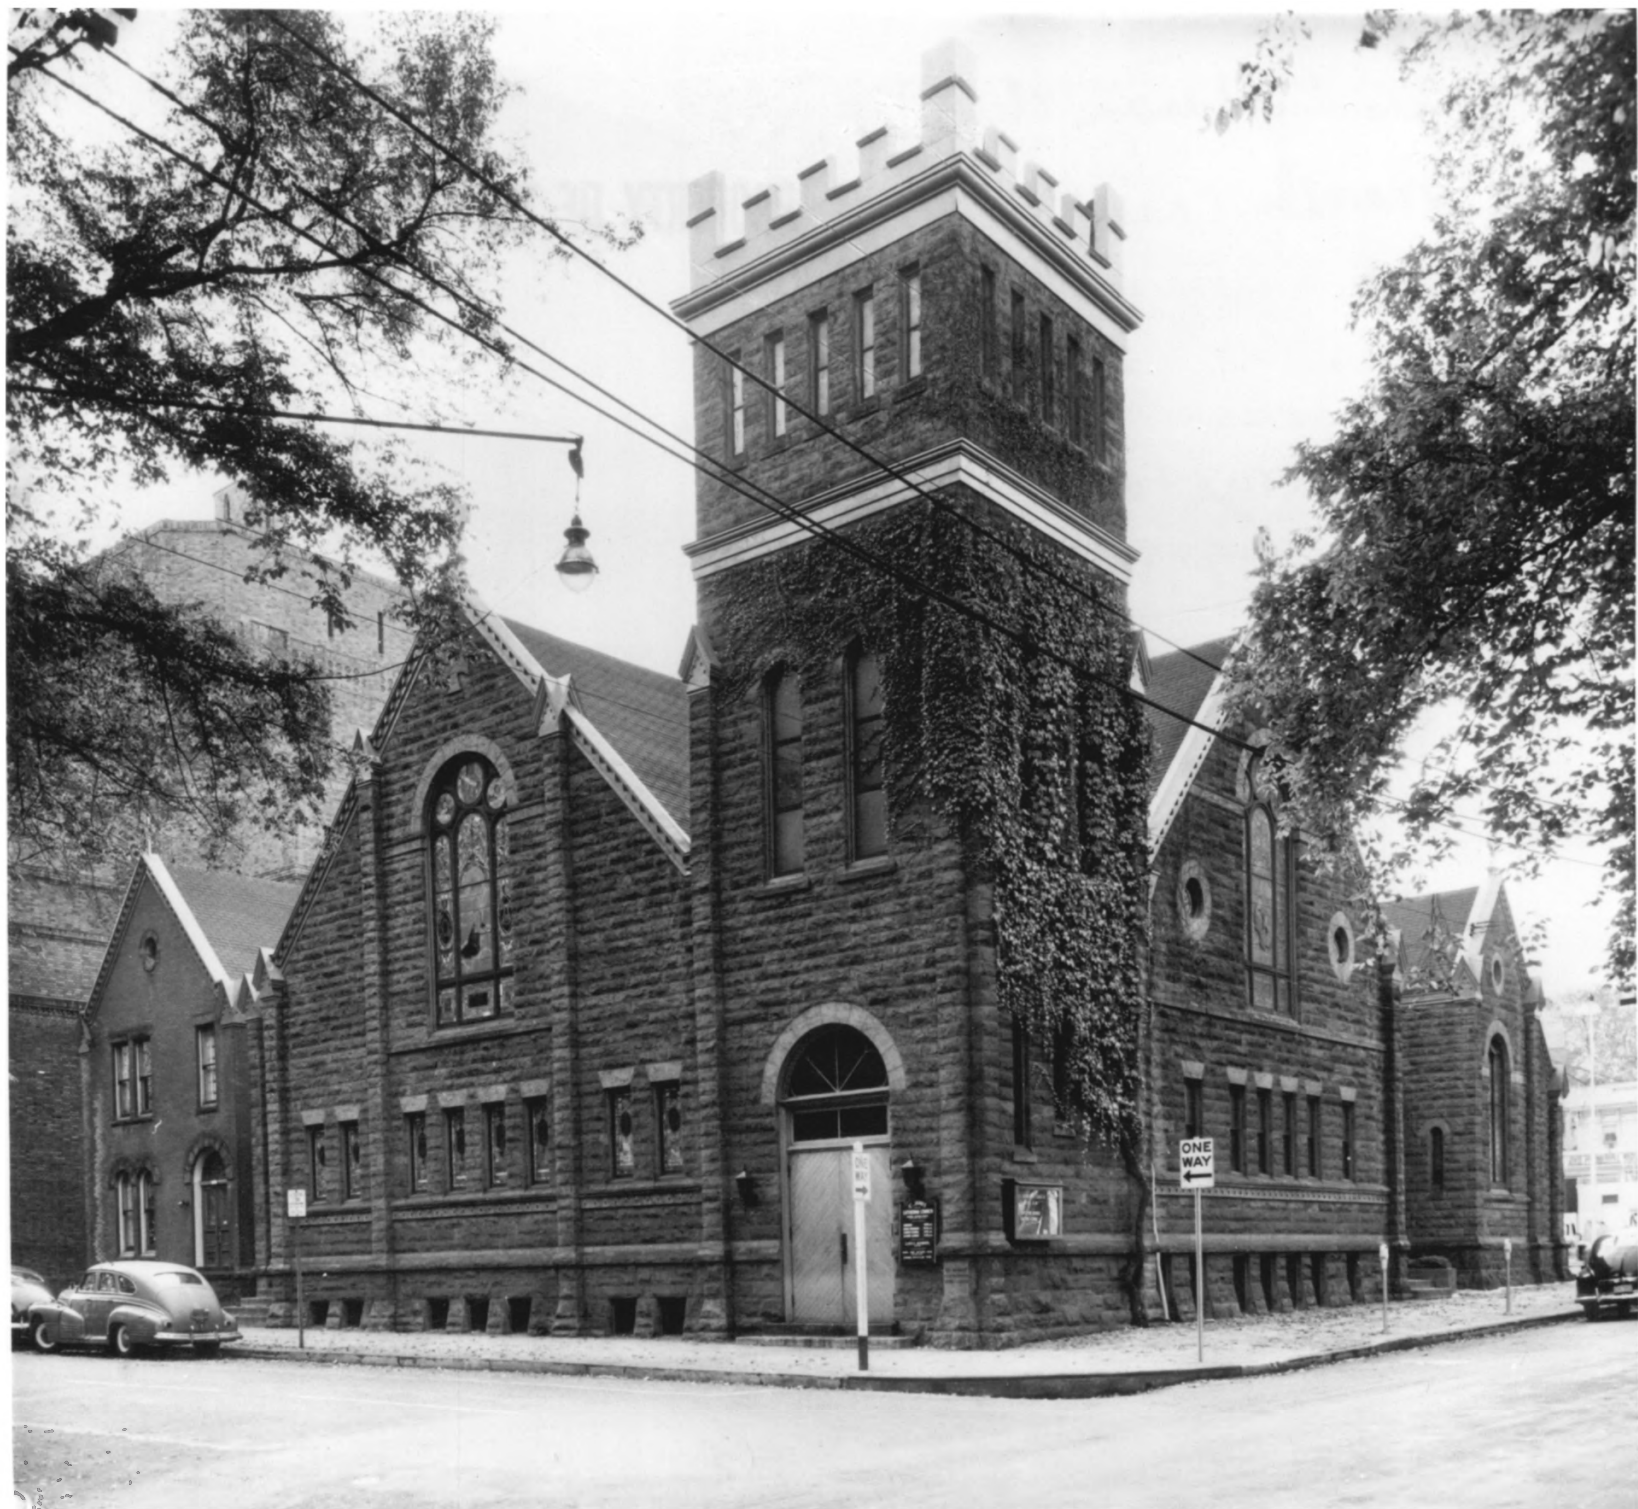
3

Historic view of Tower before its removal in 1950s,
looking to southwest
