**NATIONAL REGISTER OF HISTORIC PLACES  
INVENTORY -- NOMINATION FORM**

HISTORIC NEW LOGUS BLOCK

STREET & NUMBER 523-535 S. E. Grand Avenue

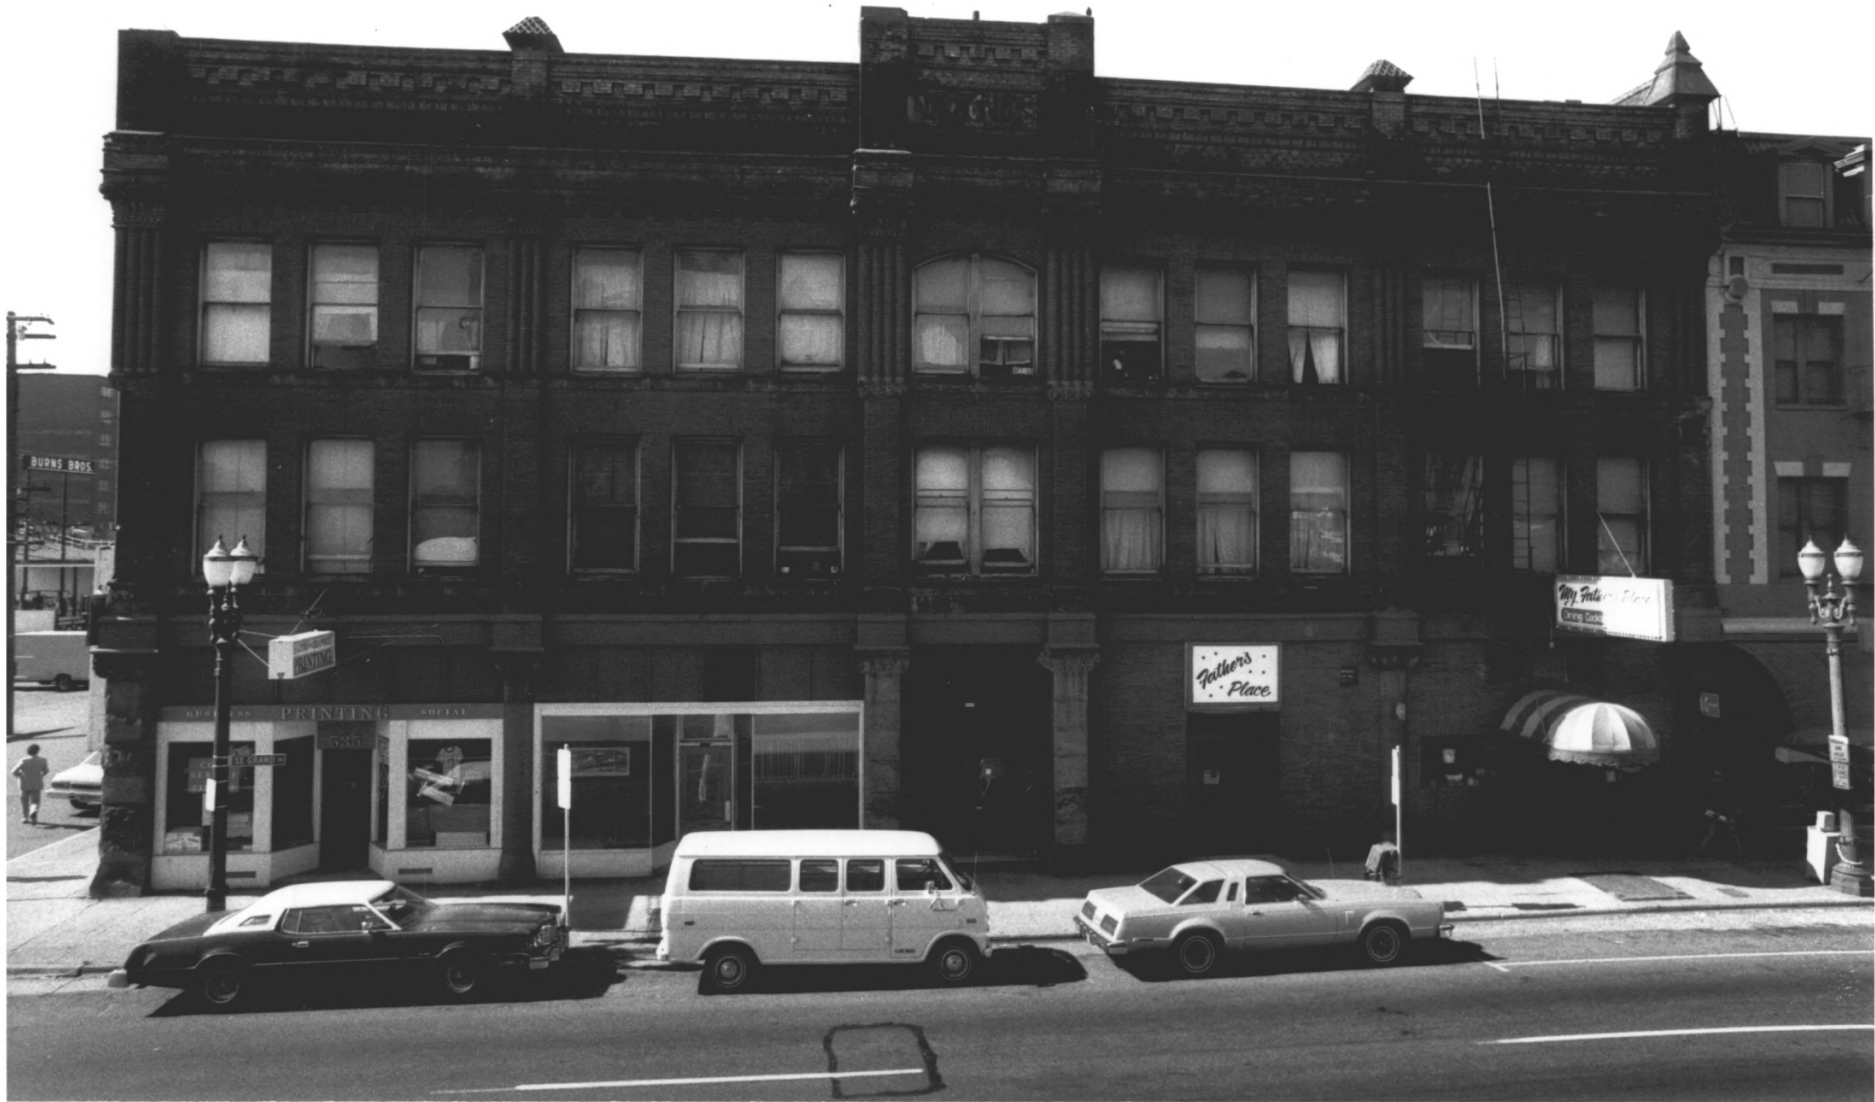
- New
1. Logus Block  
523-1535 S.E. GRAND AV.
  2. Portland, OR  
MULTNOMAH COUNTY
  3. Leonard Gionet  
PHOTO
  4. Oct. 1979
  5. L. Gionet  
5315 NE MALLORY  
PORTLAND, OR. 97211
  6. Ext. looking west
  - 7.\* 1. of 14

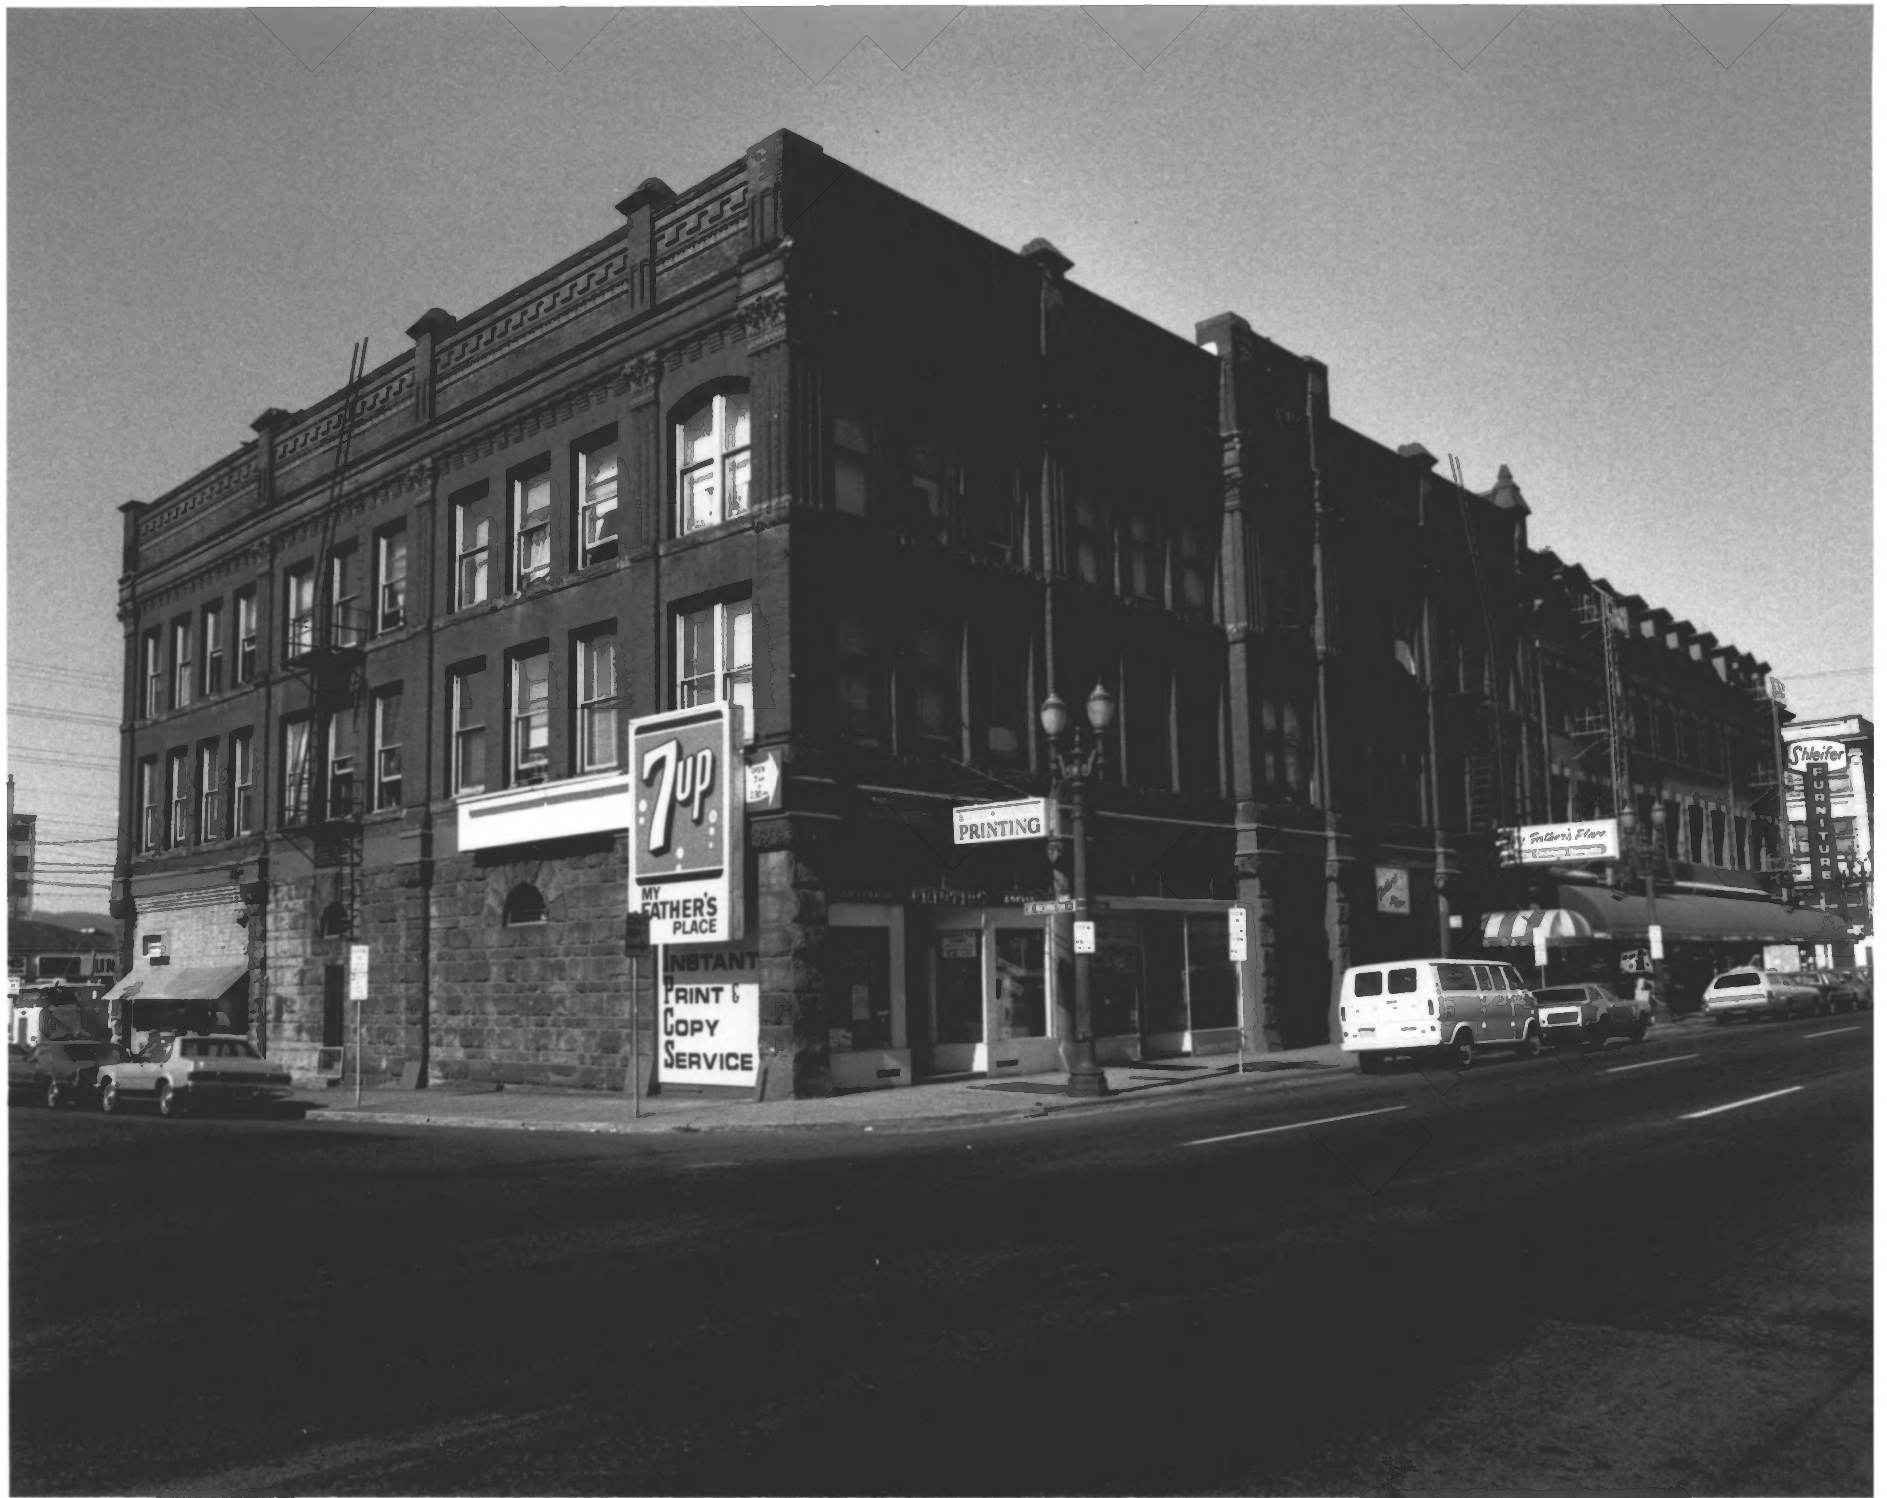
1. Logus Block  
523-535 S.E. GRAND AV.
2. Portland, OR.  
MULTNOMAH COUNTY
3. Leonard Gionet  
PHOTO
4. Oct. 1979
5. L. Gionet  
5315 NE MALLORY  
PORTLAND, OR. 97211
6. Ext. looking NW
7. # 2 of 14

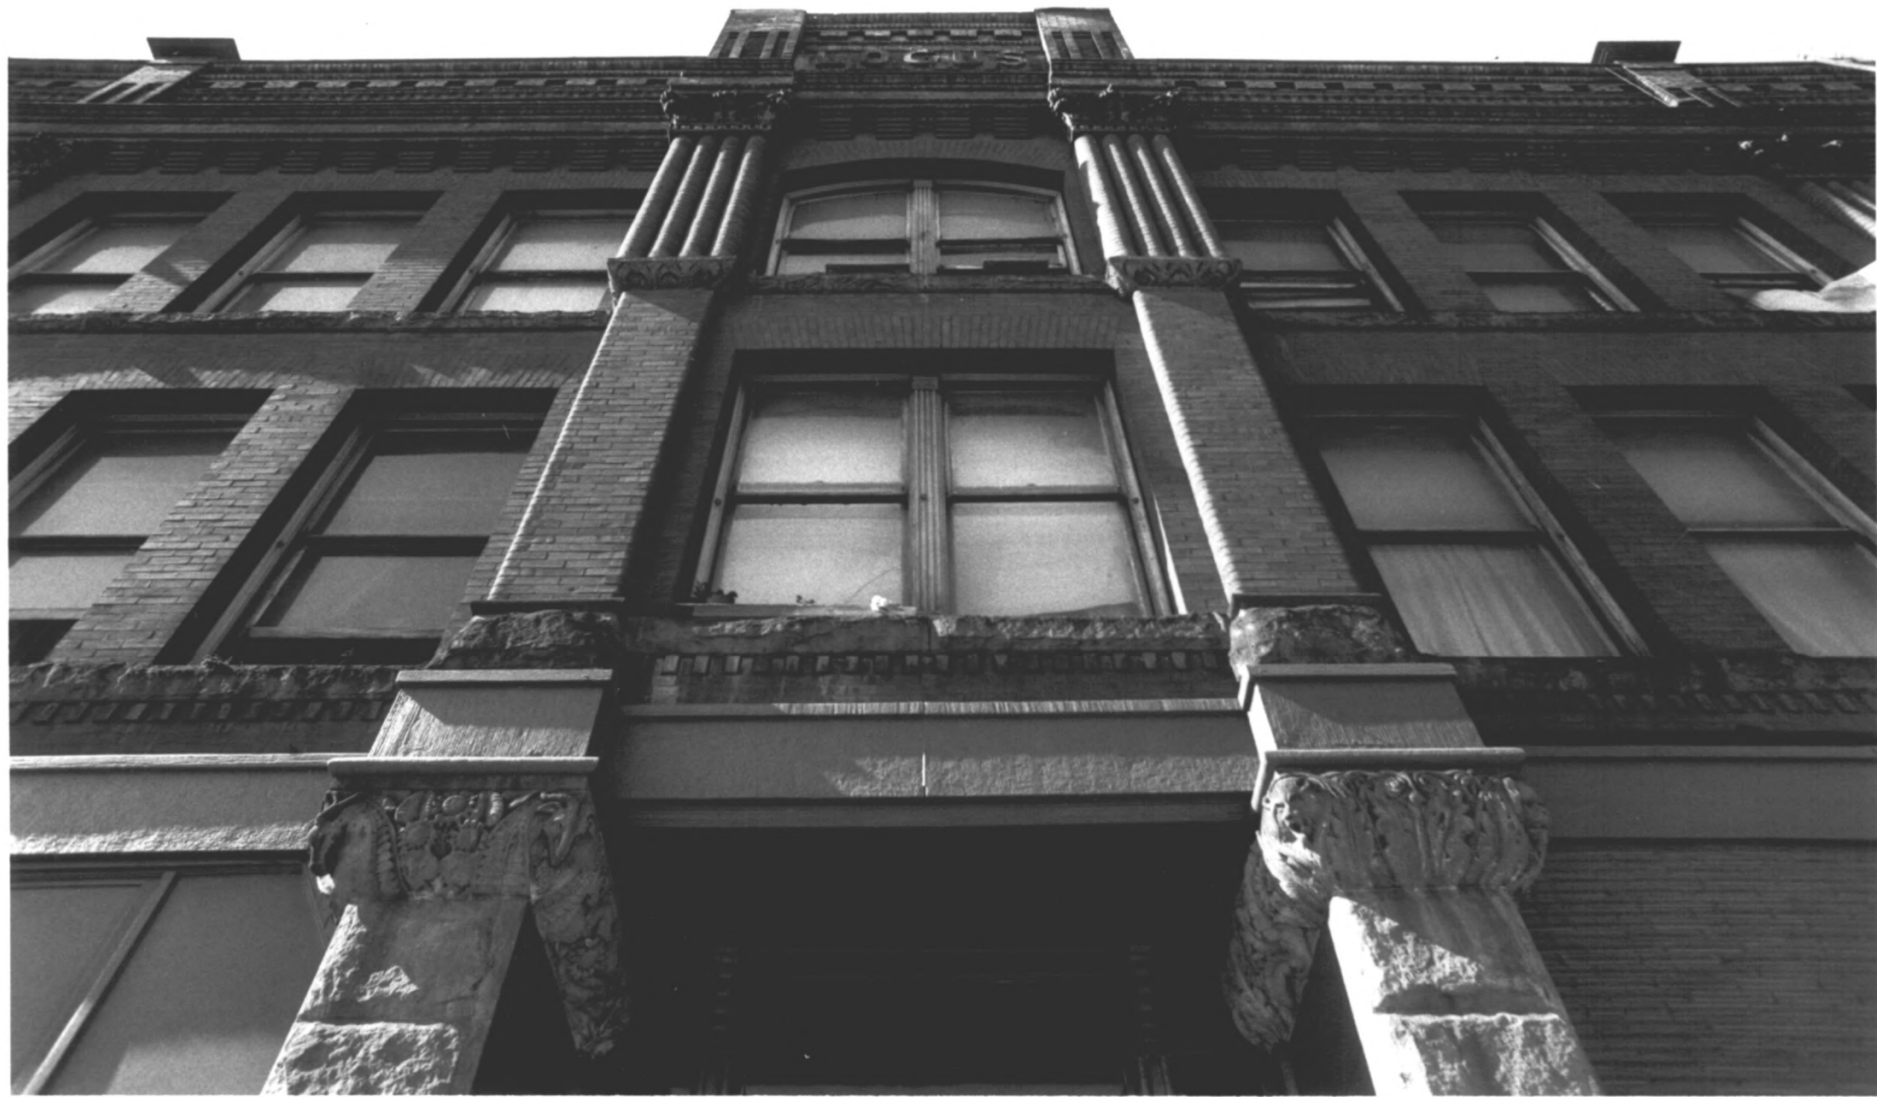
- NEW
1. Logus Block  
523-535 S.E. GRAND AV.
  2. Portland, OR  
MULTNOMAH COUNTY
  3. Leonard Gionet  
PHOTO
  4. Oct 1979
  5. L. Gionet  
5315 NE MALLORY  
PORTLAND, OR. 97211
  6. Ext + front pavilion  
looking west

The narrow central entrance bay projects slightly as a pavilion, and is framed by pilasters that continue through to the parapet, as do pilasters at adjacent bays. Rectangular entrance bay and corner pilasters are of stone with rock faced fronts and vertically tooled sides, and have tooled battered bases and richly carved capitals. Each of the stone capitals is different in detail within a common theme -- foliage and floral patterns, and most with animal heads or "grotesques" at mid-capital or at the corners -- all good adaptations of Romanesque designs. Intermediate pilasters have similar capitals but the shafts are half-round with a vertical tooled face.

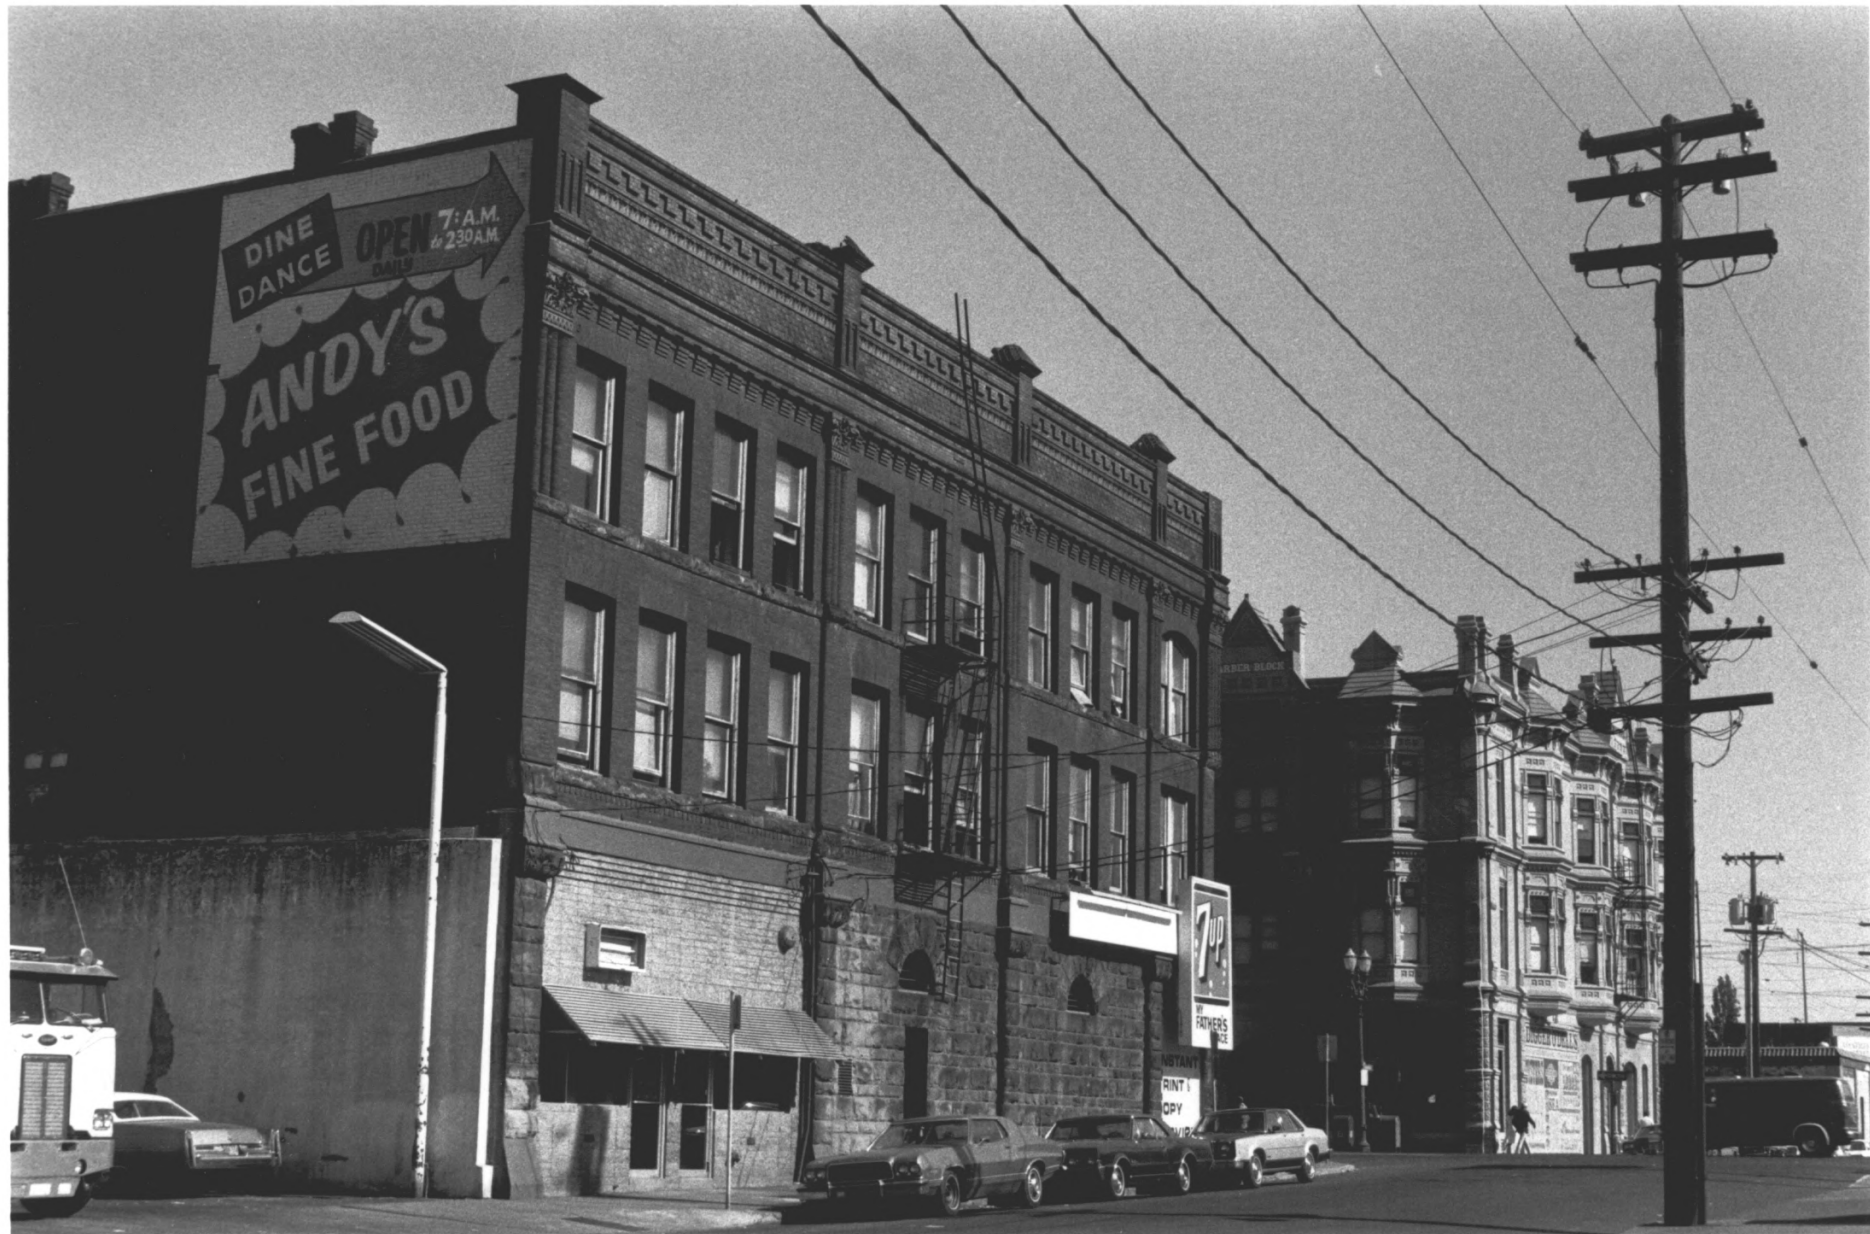
1. Logus Block  
523-535 S.E. GRAND AV.
2. Portland, OR  
MULTNOMAH COUNTY
3. Leonard Cionet  
PHOTO
4. Oct. 1979
5. L. Cionet  
5315 N.E. MALLORY,  
PORTLAND, OR. 97211
6. Ext. - looking  
N.E.  
Barber Block in  
Background
7. # 4 of 14

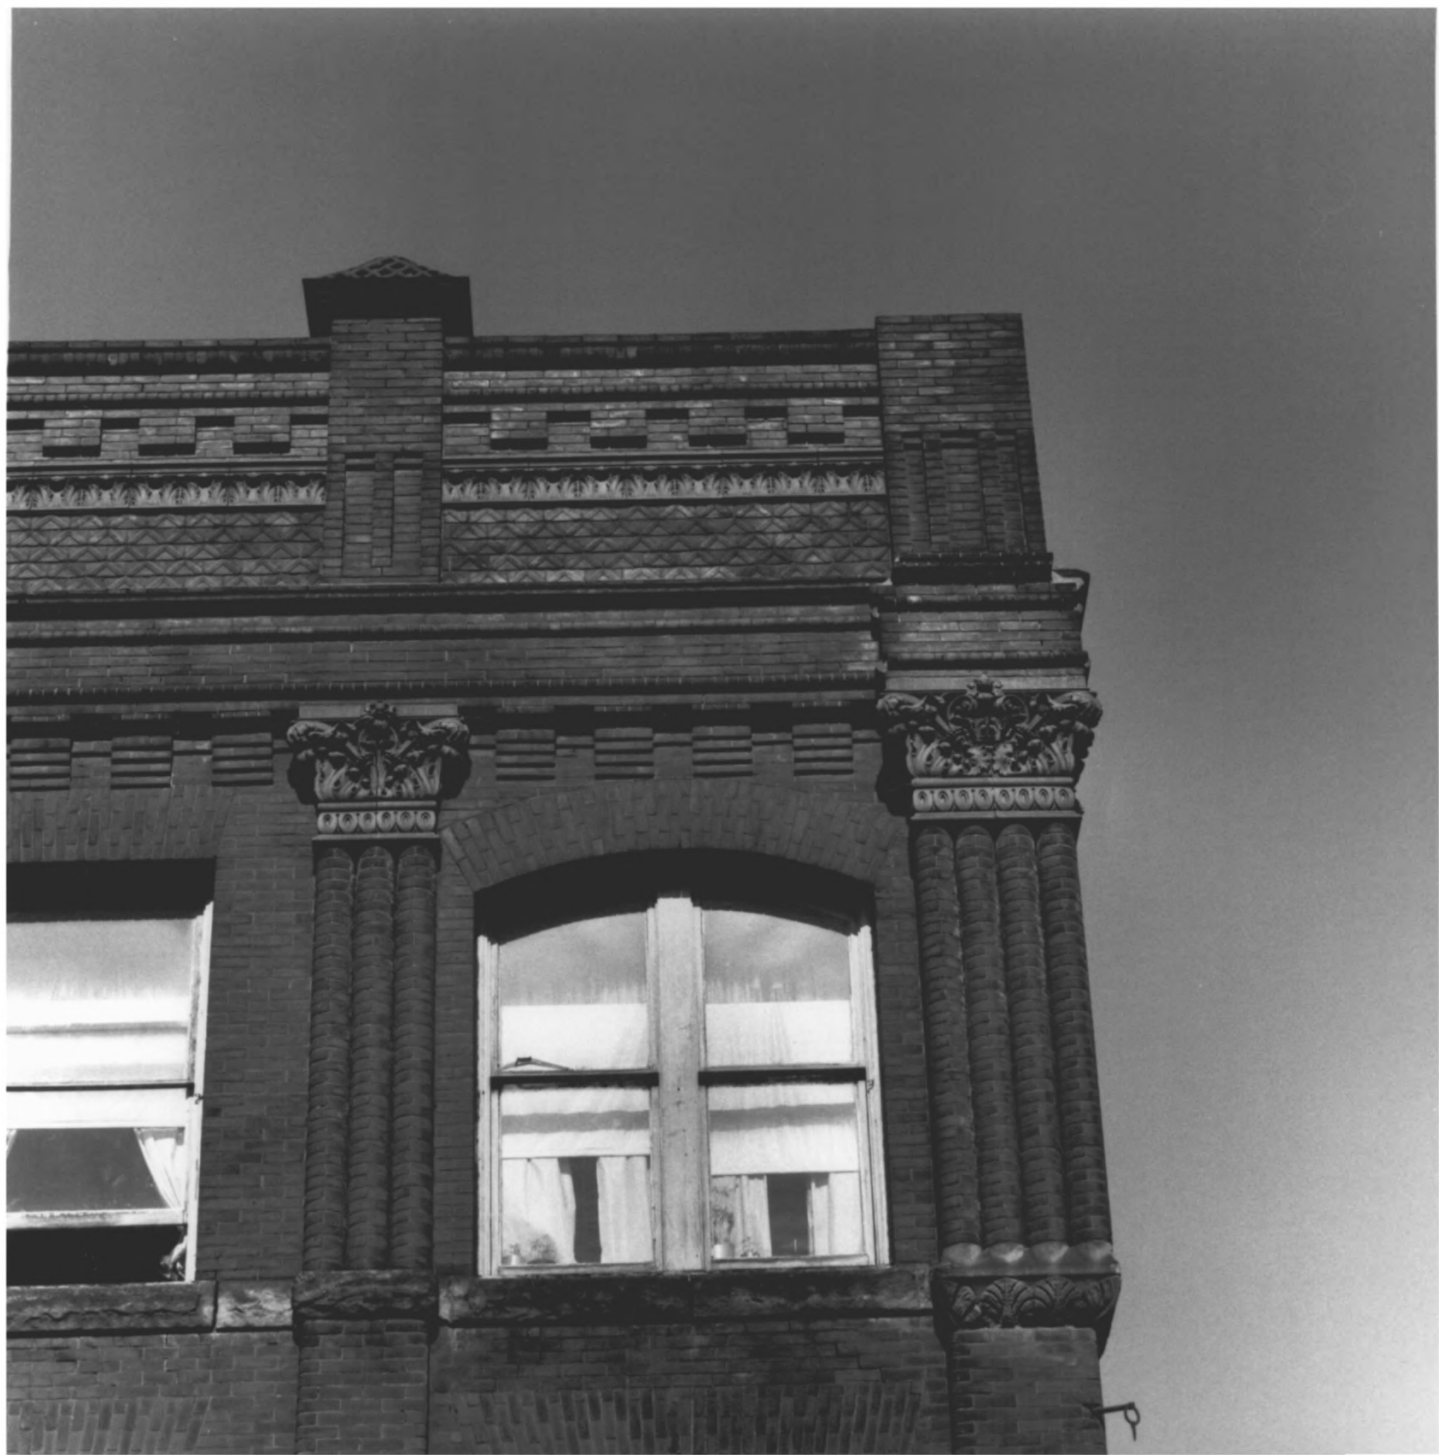
- New
1. Logus Block  
523-1535 S.E. GRAND AV.
  2. Portland OR  
MULTNOMAH COUNTY
  3. Leonard Cionet  
PICTO
  4. Oct. 1979
  5. L. Cionet  
5315 NE. MALLORY  
PORTLAND, OREGON 97211
  6. Ext. Detail  
upper corner  
looking east
  7. # 5 of 14

Third floor pilasters consist of clustered half-round brick colonettes, a grouping of four at the center bay and at the corners, and three at the intermediate pilasters. Capitals are unglazed terra cotta, similar in color to the brick, and feature acanthus leaves and small volutes somewhat in the Corinthian manner. Atop the capitals is the corbeled brick cornice, projecting at corner and center bay pilasters, and continuous between. Bead moldings and other calssical forms in pressed brick adorn the cornice.

Corner pilasters had stepped pyramid cap members in sheet metal -- only one remains in place. (The cap for the southeast corner has been removed and is being stored for reuse.) Intermediate pilasters have smaller pyramid shaped cap members with a pressed diamond pattern -- all are intact but in need of repair.

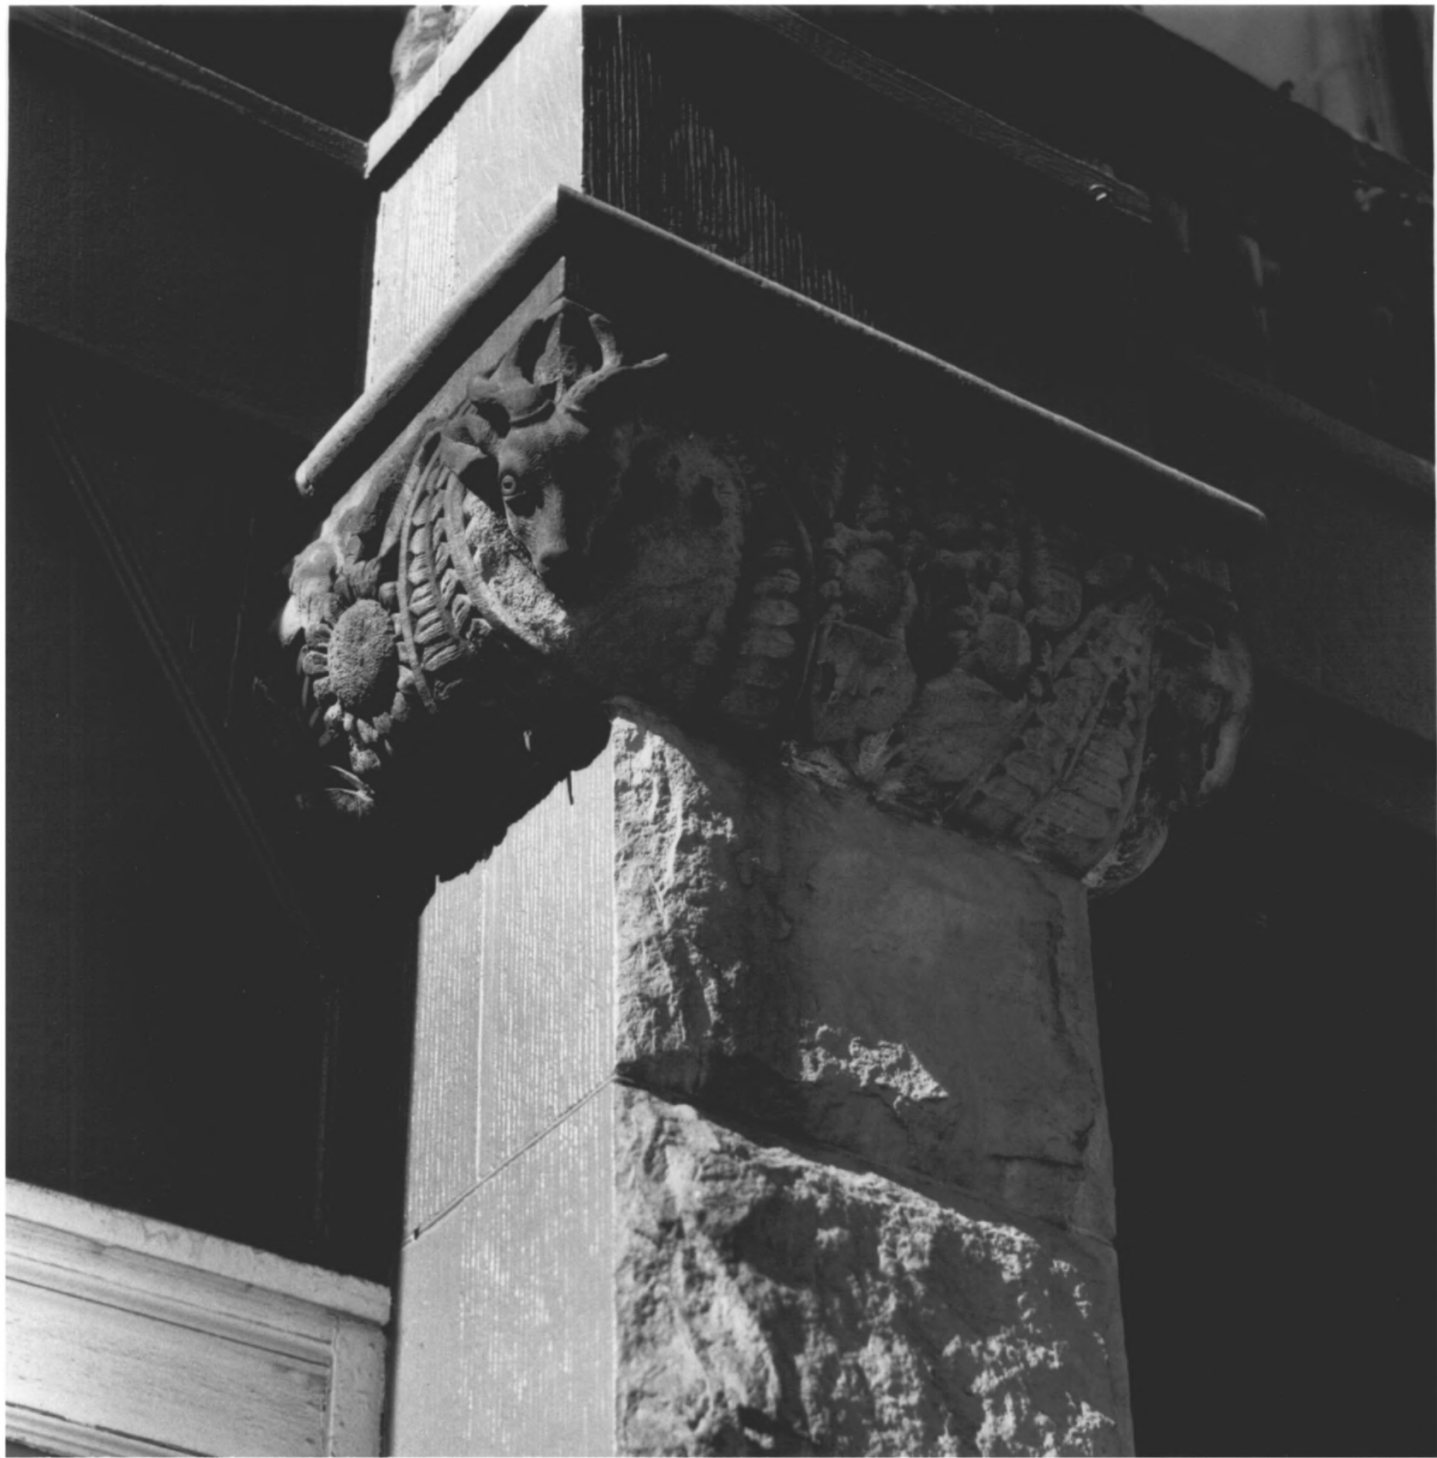
- New
1. Logos Block  
523-535 S.E. GRAND AV.
  2. Portland 1 OR  
MULTNOMAH COUNTY
  3. Leonard Gionet  
PHOTO
  4. Oct. 1979
  5. L. Gionet  
5315 N.E. MALLORY  
PORTLAND, OR 97211
  6. Col. capital
  7. # 6 of 14

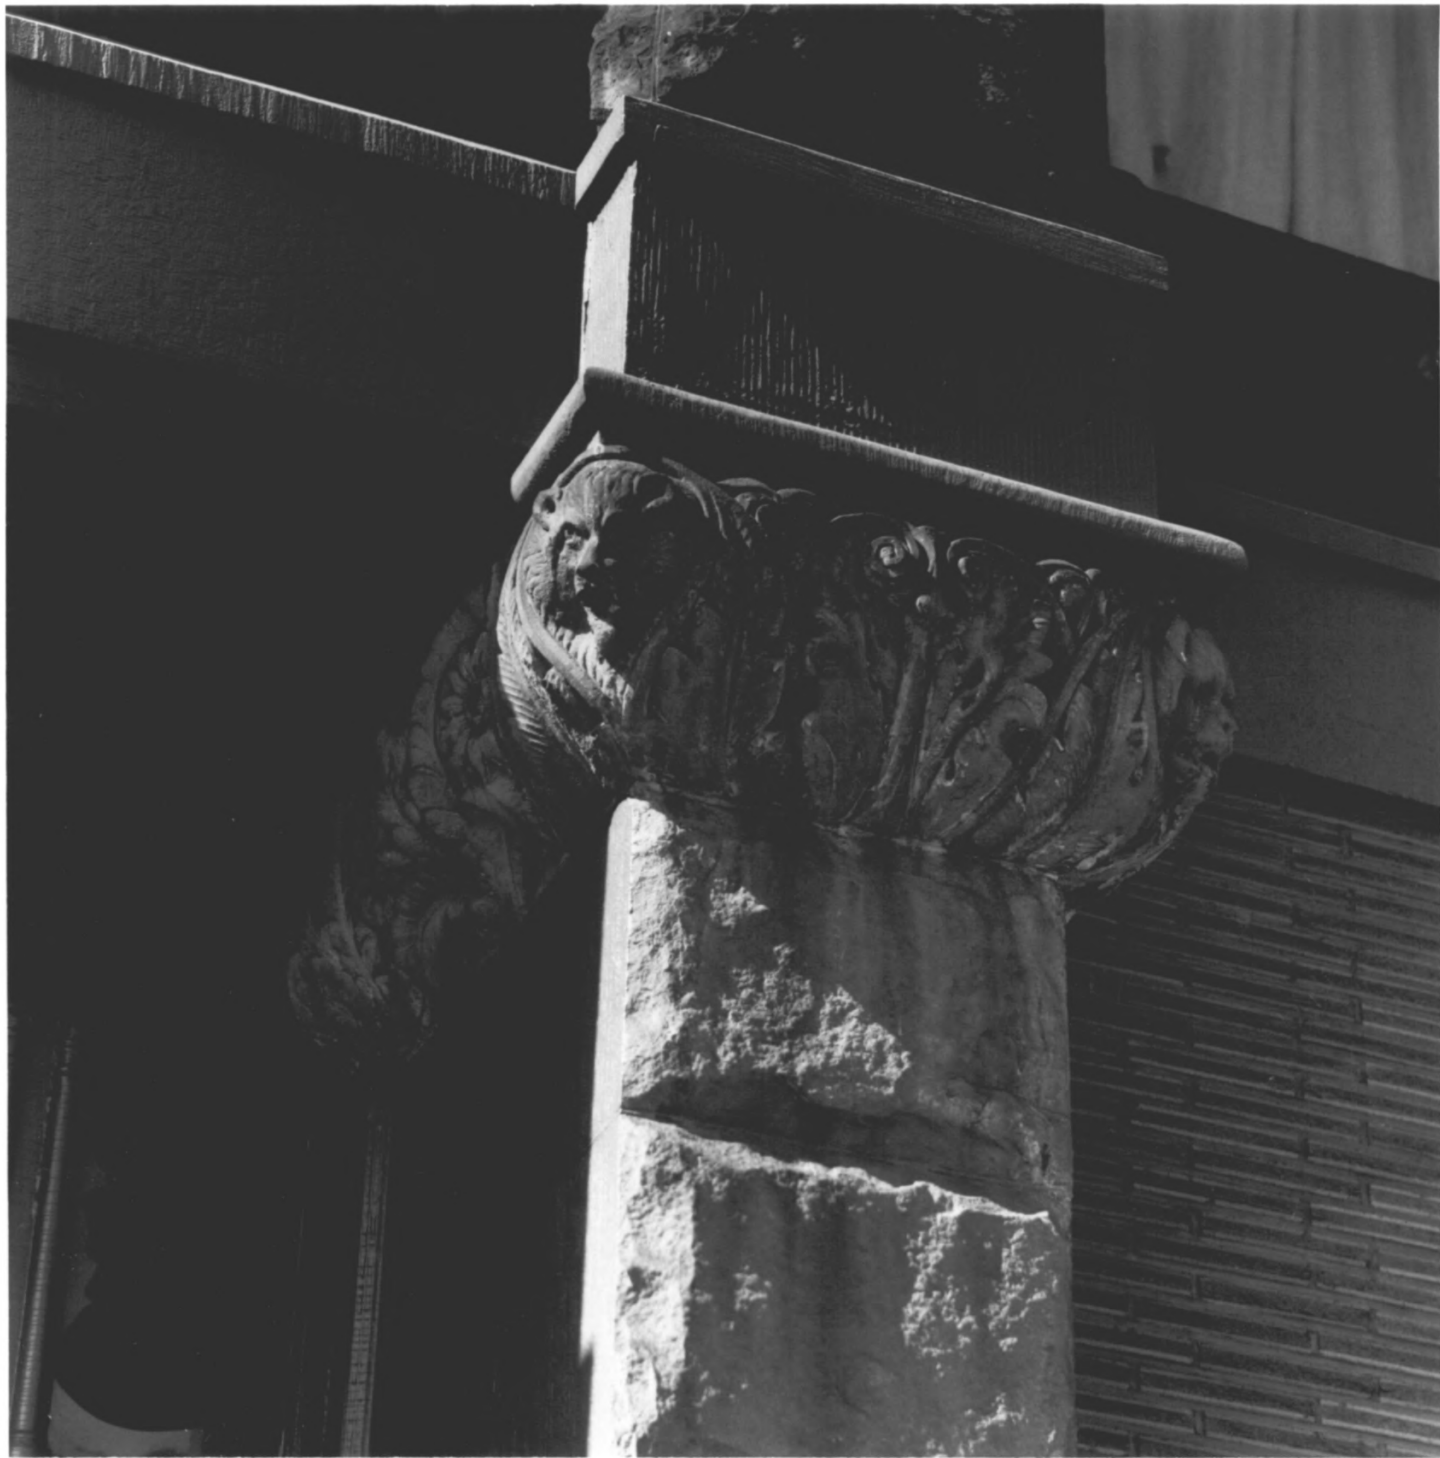
1. Logus Block  
523-1535 SE. GRAND AV.
2. Portland, OR  
MULTNOMAH COUNTY
3. Leonard Gionet  
PHOTO
4. Oct 1979
5. L. Gionet  
5315 NE. MALLORY  
PORTLAND, OR. 97211
6. Col. capital  
@ entry.
7. # 7 of 14

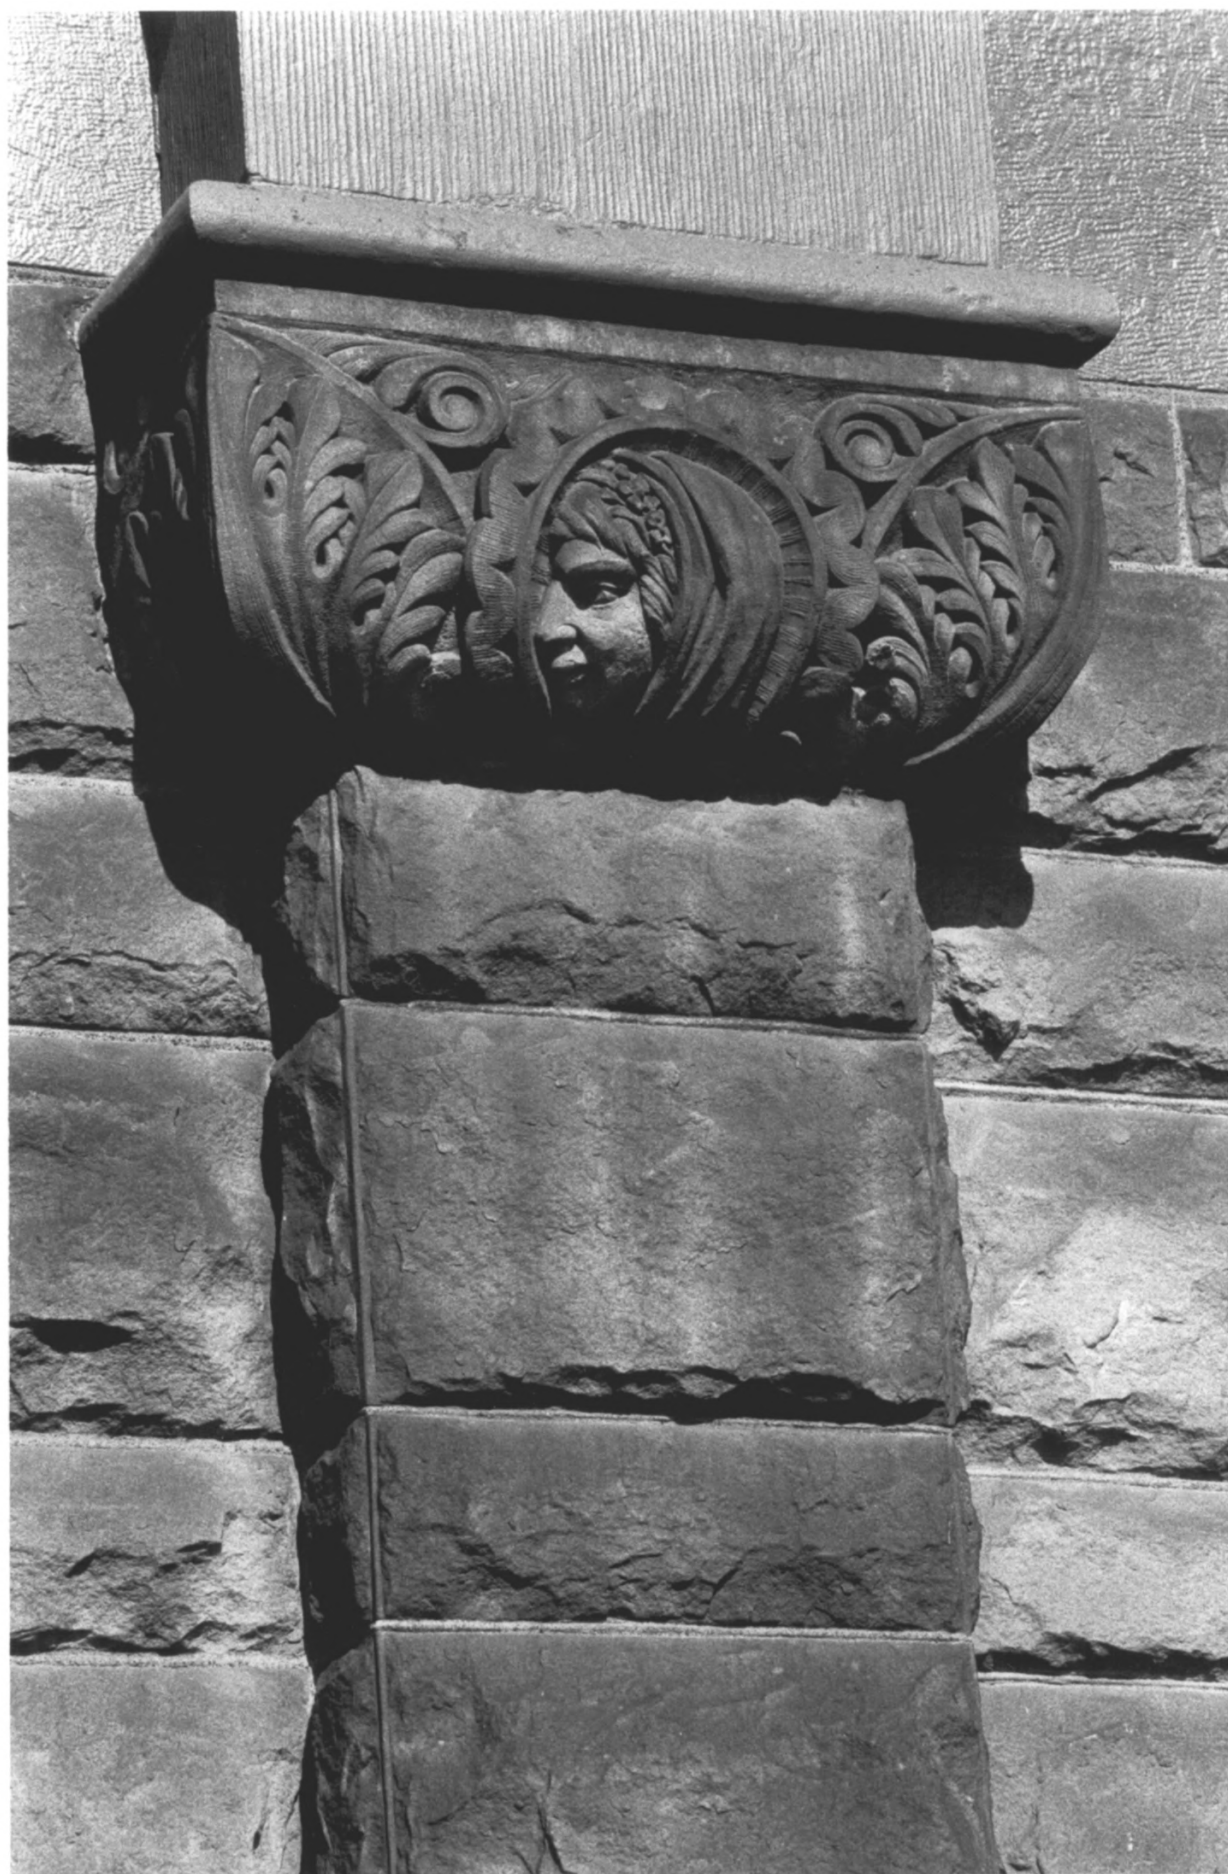
- NEW
1. Logus Block  
523-535 S.E. GRAND AV.
  2. Portland OR  
MULTNOMAH COUNTY
  3. Leonard  
Cionet PHOTO
  4. Oct. 1979
  5. L. Cionet  
5315 N.E. MALLORY,  
PORTLAND, OR. 97211
  6. Col. capital
  7. # 8 of 14

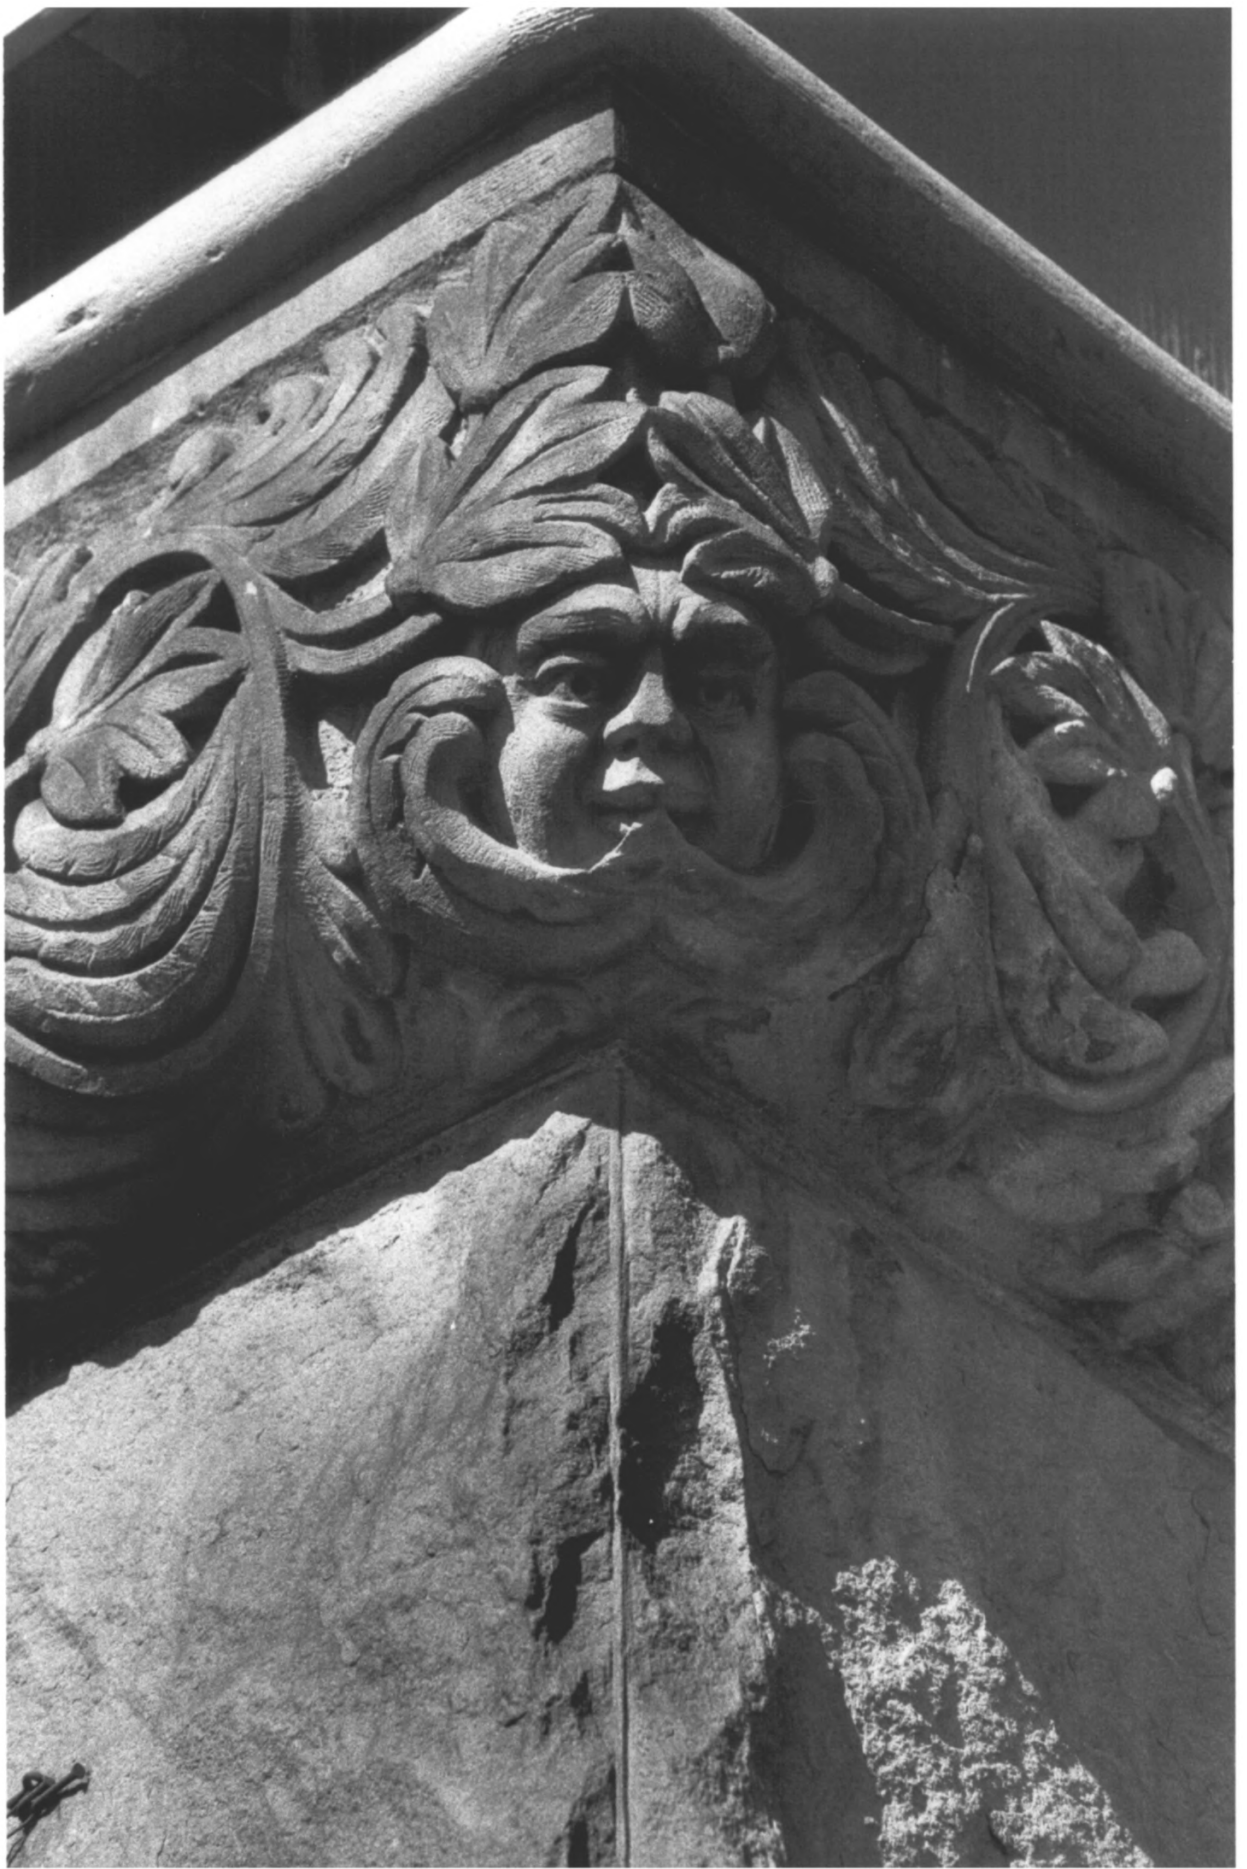
7. # 9 of 14

6. part of  
col. capital
