**NATIONAL REGISTER OF HISTORIC PLACES  
INVENTORY -- NOMINATION FORM**

HISTORIC NEW LOGUS BLOCK

STREET & NUMBER 523-535 S. E. Grand Avenue

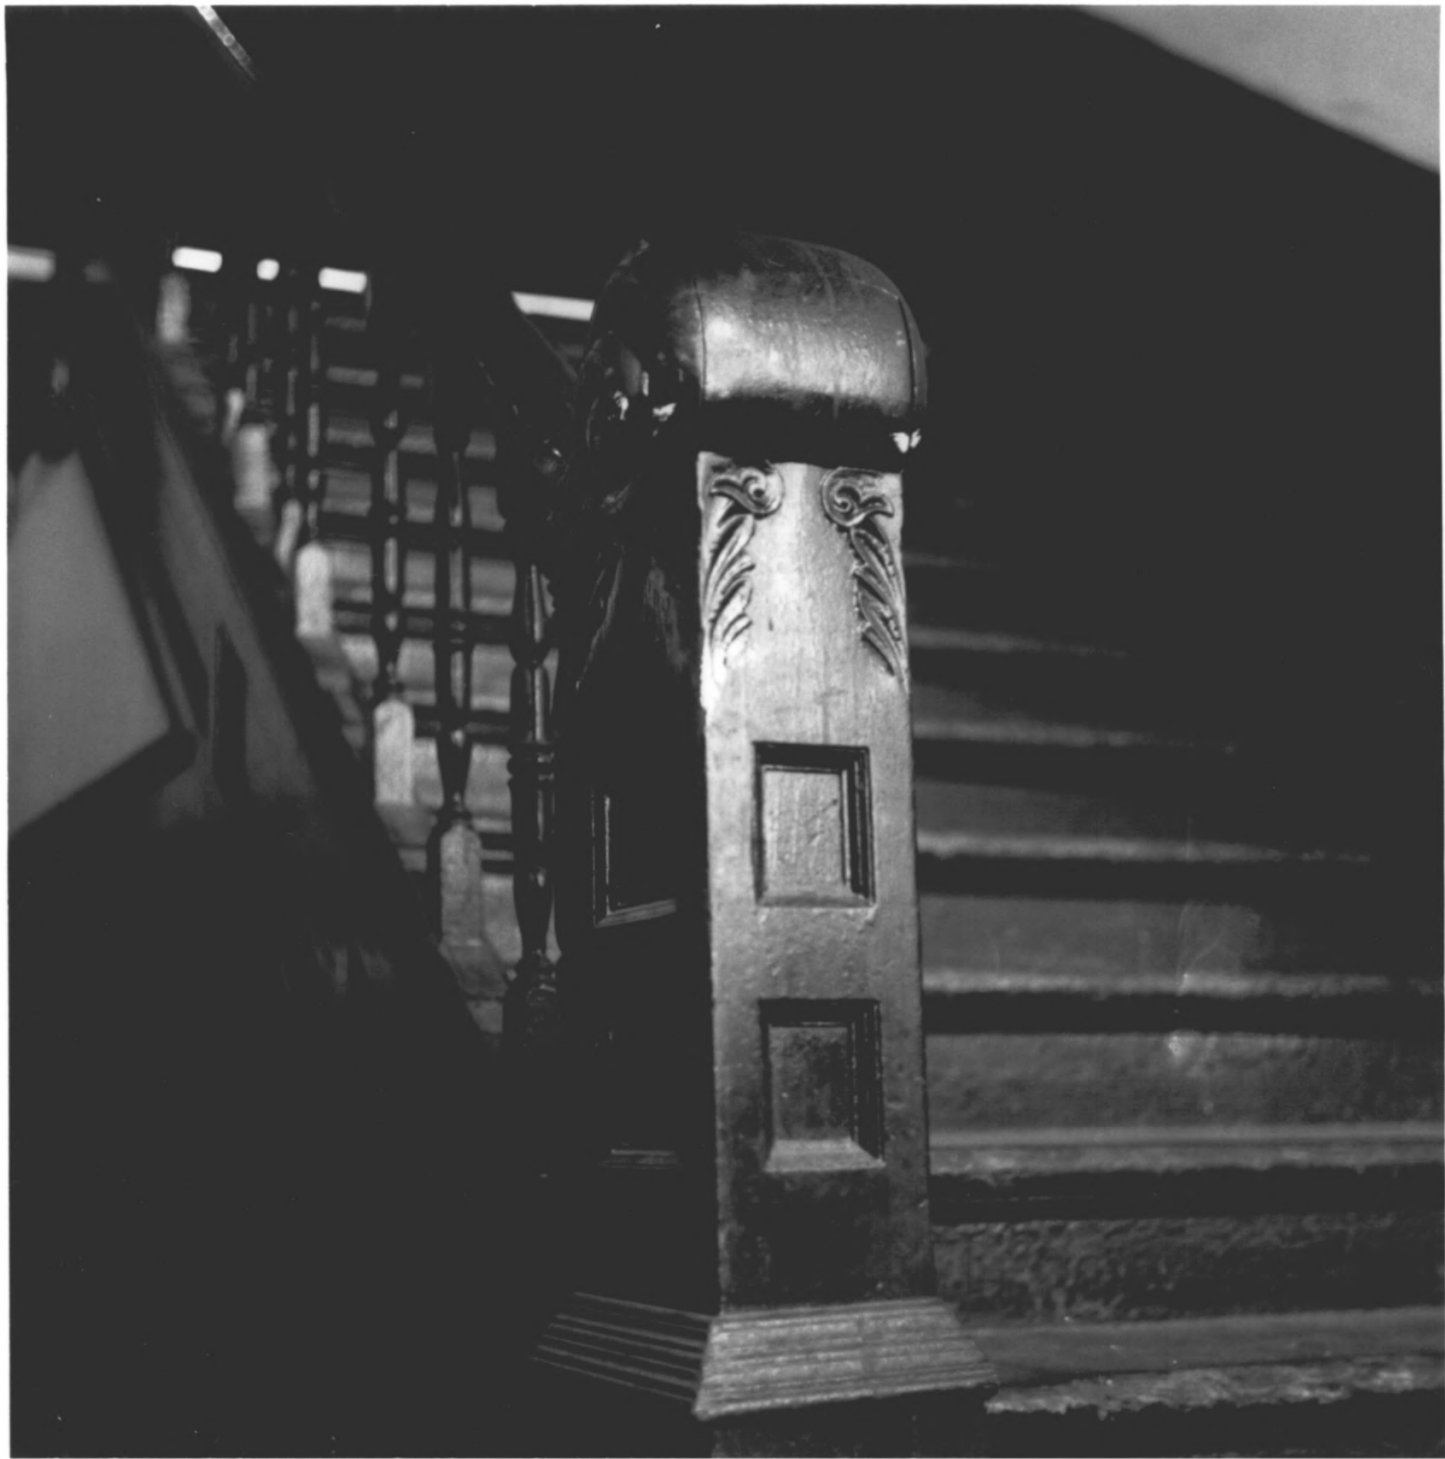
7. # 10 of 14

1. Logus Block  
5231-535 SE. GRAND AV.
2. Portland, OR  
MULTNOMAH COUNTY
3. Leonard Gionet  
P/HOTO
4. Oct. 1979
5. L. Gionet  
5315 NE. MALLORY  
PORTLAND, OR. 97211
6. Interior.

Entry newel  
post.

The stairway has a straight run with an intermediate landing to the second floor, and has a half turn with landing to the third floor. Stair details include fir treads and risers, an oak balustrade with turned balusters (some missing), and a formed handrail that terminates in a volute atop the newel post. The square newel sets on a pedestal and has leaf carvings at the edges near the top. At the mid landing newel posts have a curved pyramid finial and inset panels, both carved with floral and leaf decoration. Carriage trim, which continues to the third floor, is paneled in a manner similar to the wainscot.

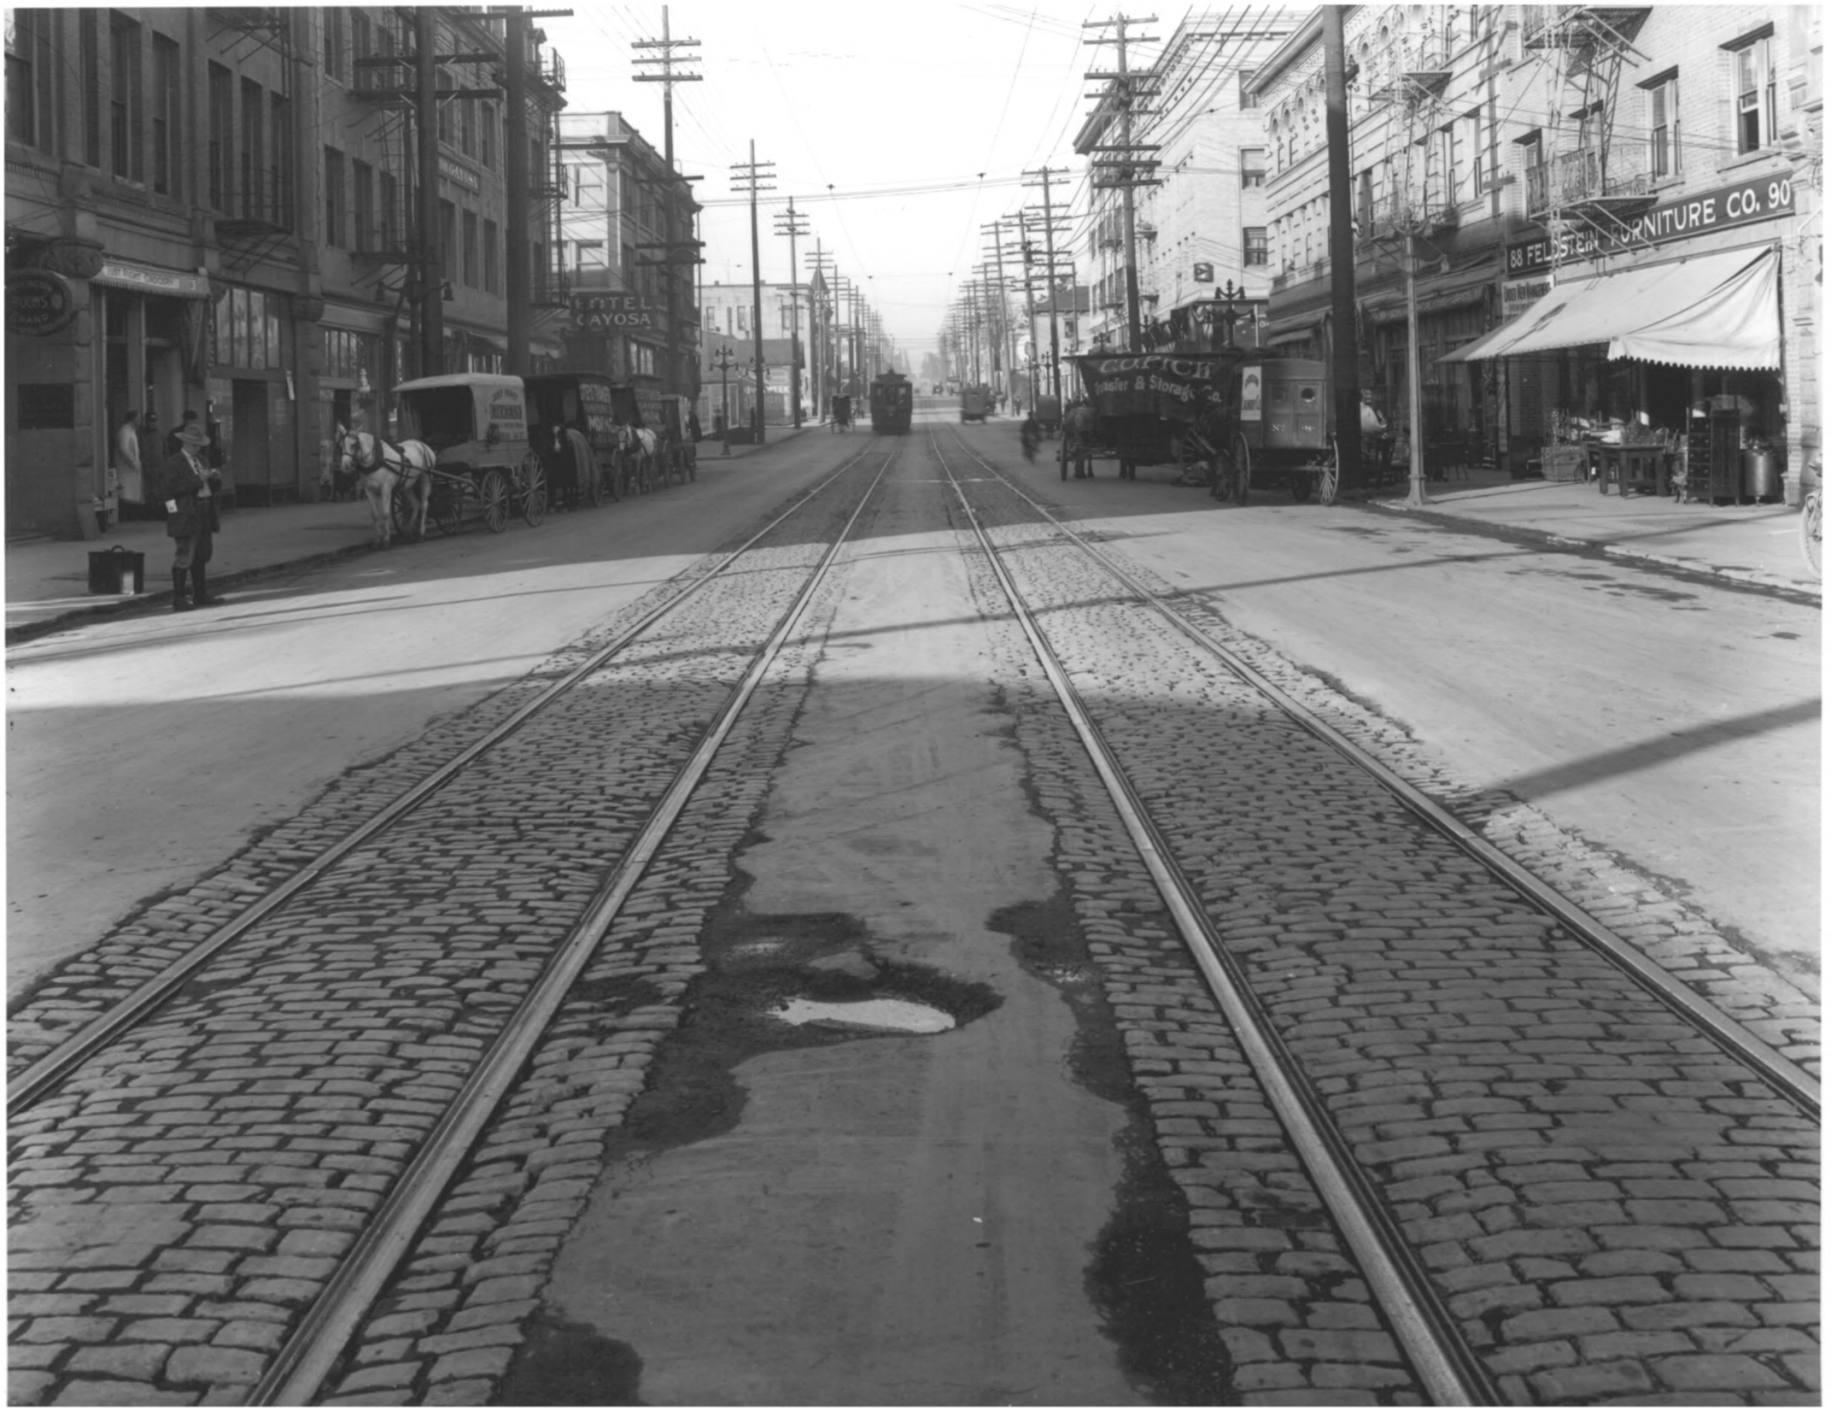
7. # 11 of 14

6. Looking north on  
Grand Ave.  
Northerly half of  
1st + 2nd floors  
visible on left  
of photo

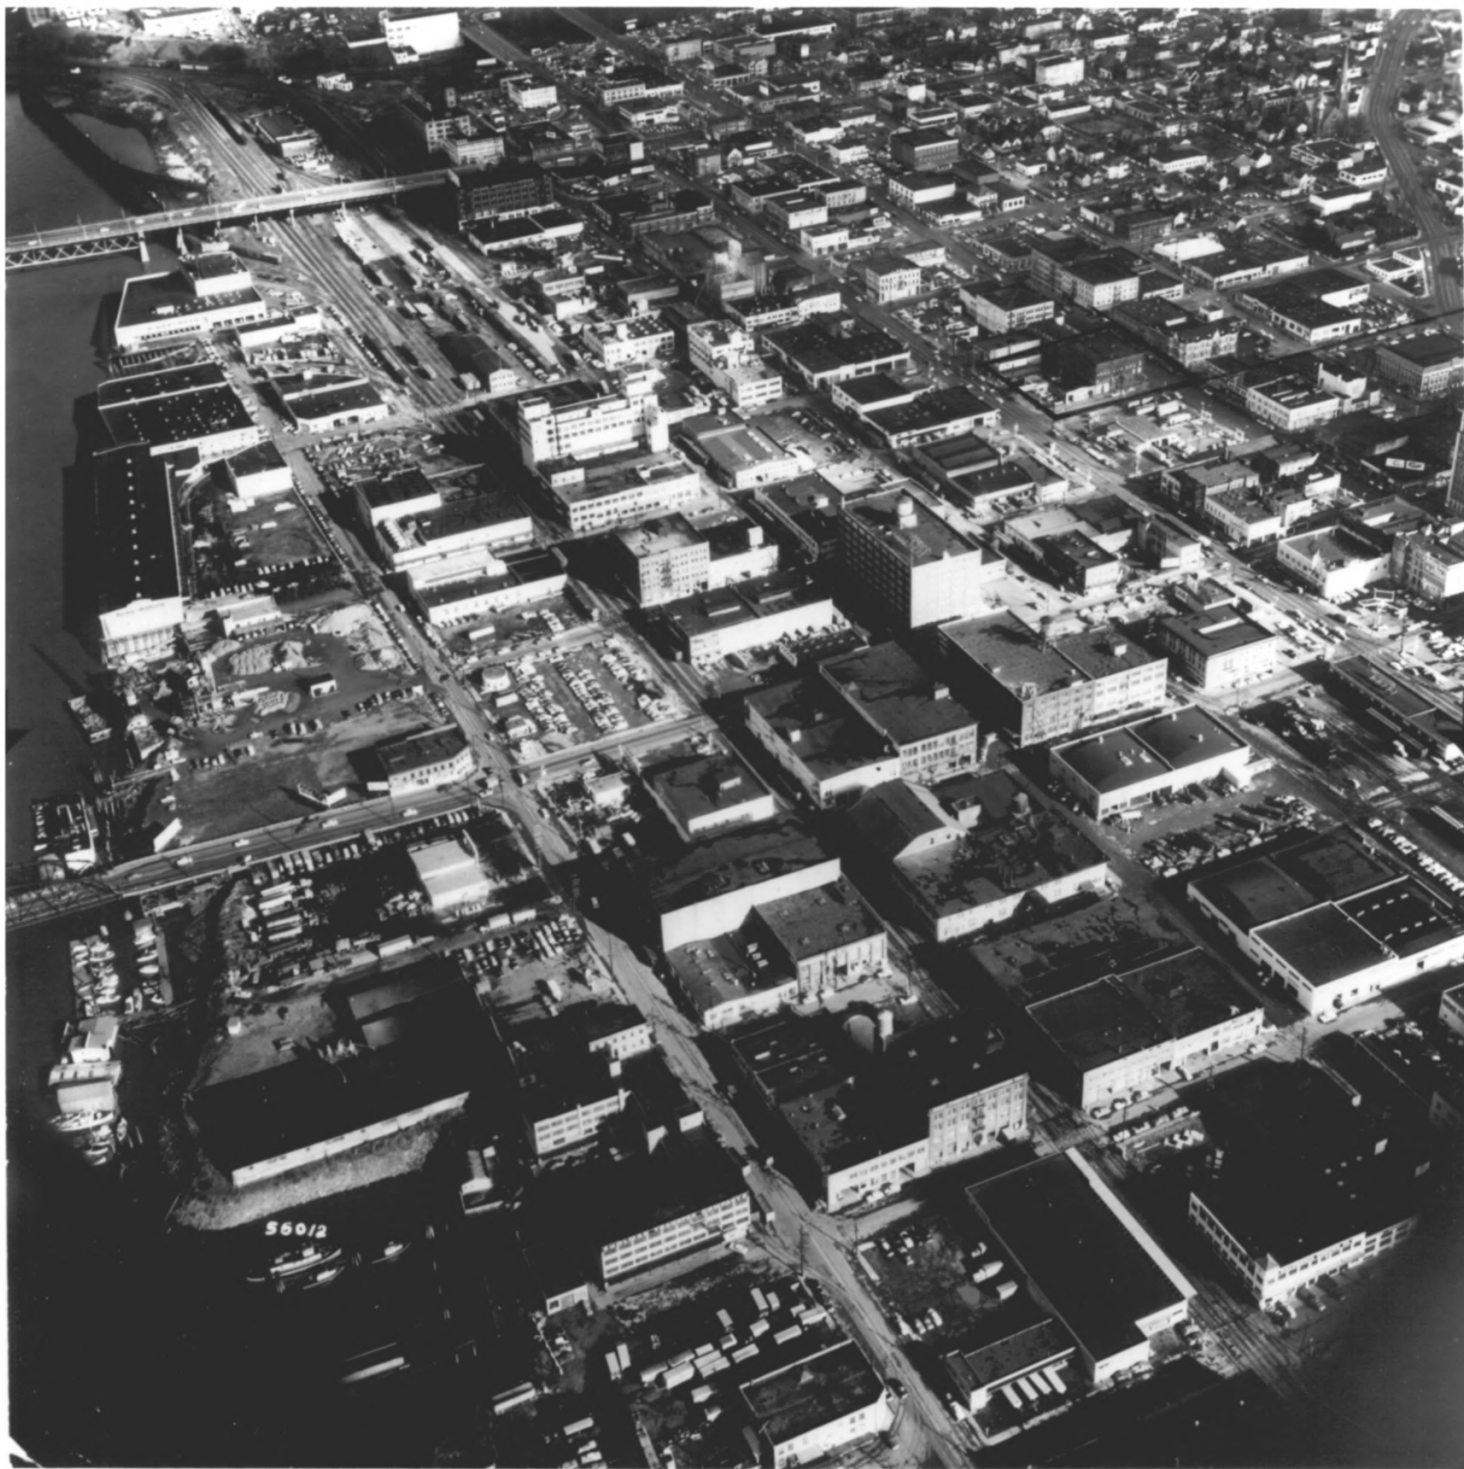
- New
1. Logus Block  
523-525 S.E. GRAND AV.
  2. Portland, OR  
MULTNOMAH COUNTY
  3. Unknown
  4. c. 1950
  5. Ore. Hist Soc.  
# 56732  
1230 S.W. PARK AVENUE  
PORTLAND, OR., 97205
  6. Aerial view  
looking N.E.
  7. # 12 of 14

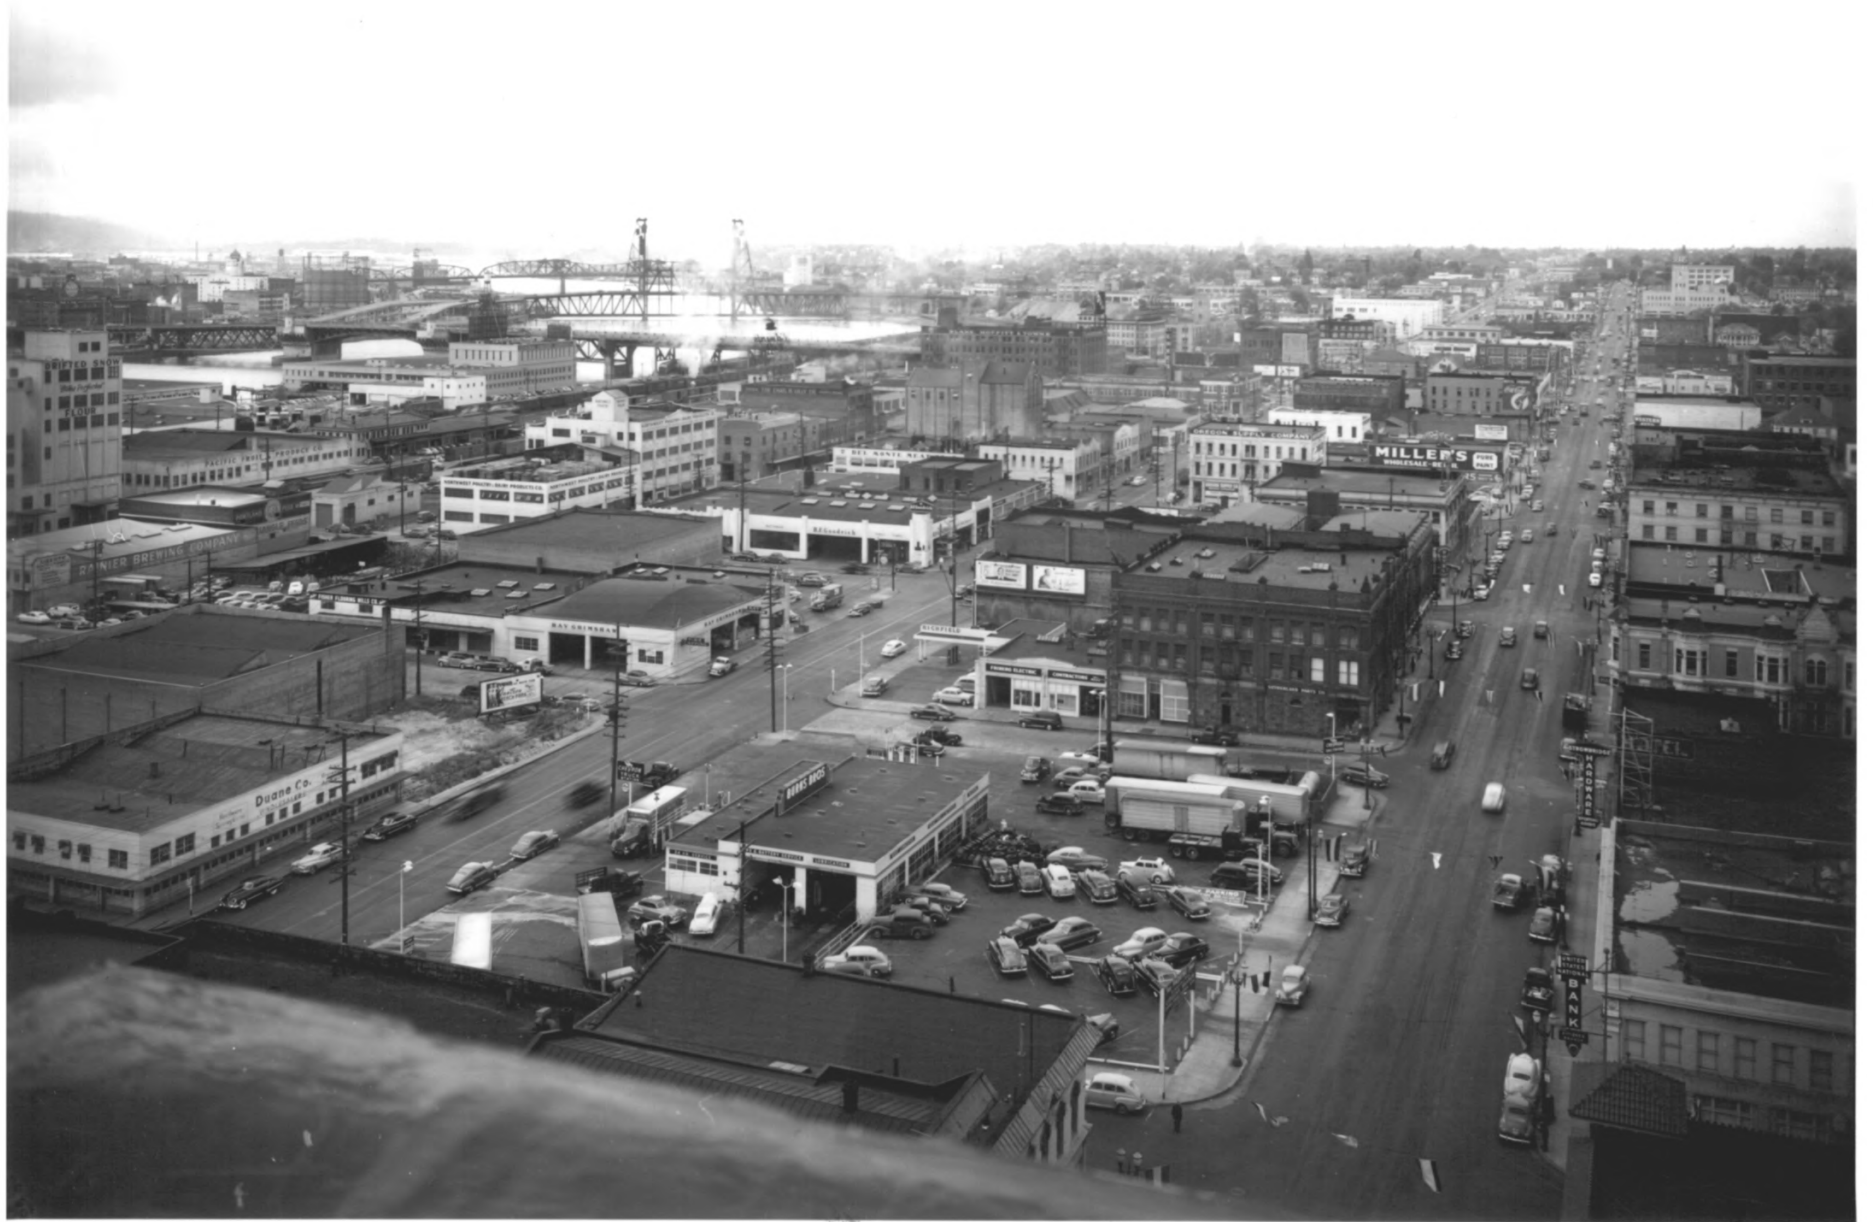
- NEW
1. Logus Block  
523-0535 S.E. GRAND AV.
  2. Portland OR  
MULTNOMAH COUNTY
  3. Unknown
  4. Jan. 6, 1950
  5. Ore. Hist. Soc  
#26440  
1230 SW PARK AVENUE  
PORTLAND, OR 97205
  6. Aerial View  
Looking north  
on Grand Ave
  7. # 13 of 14

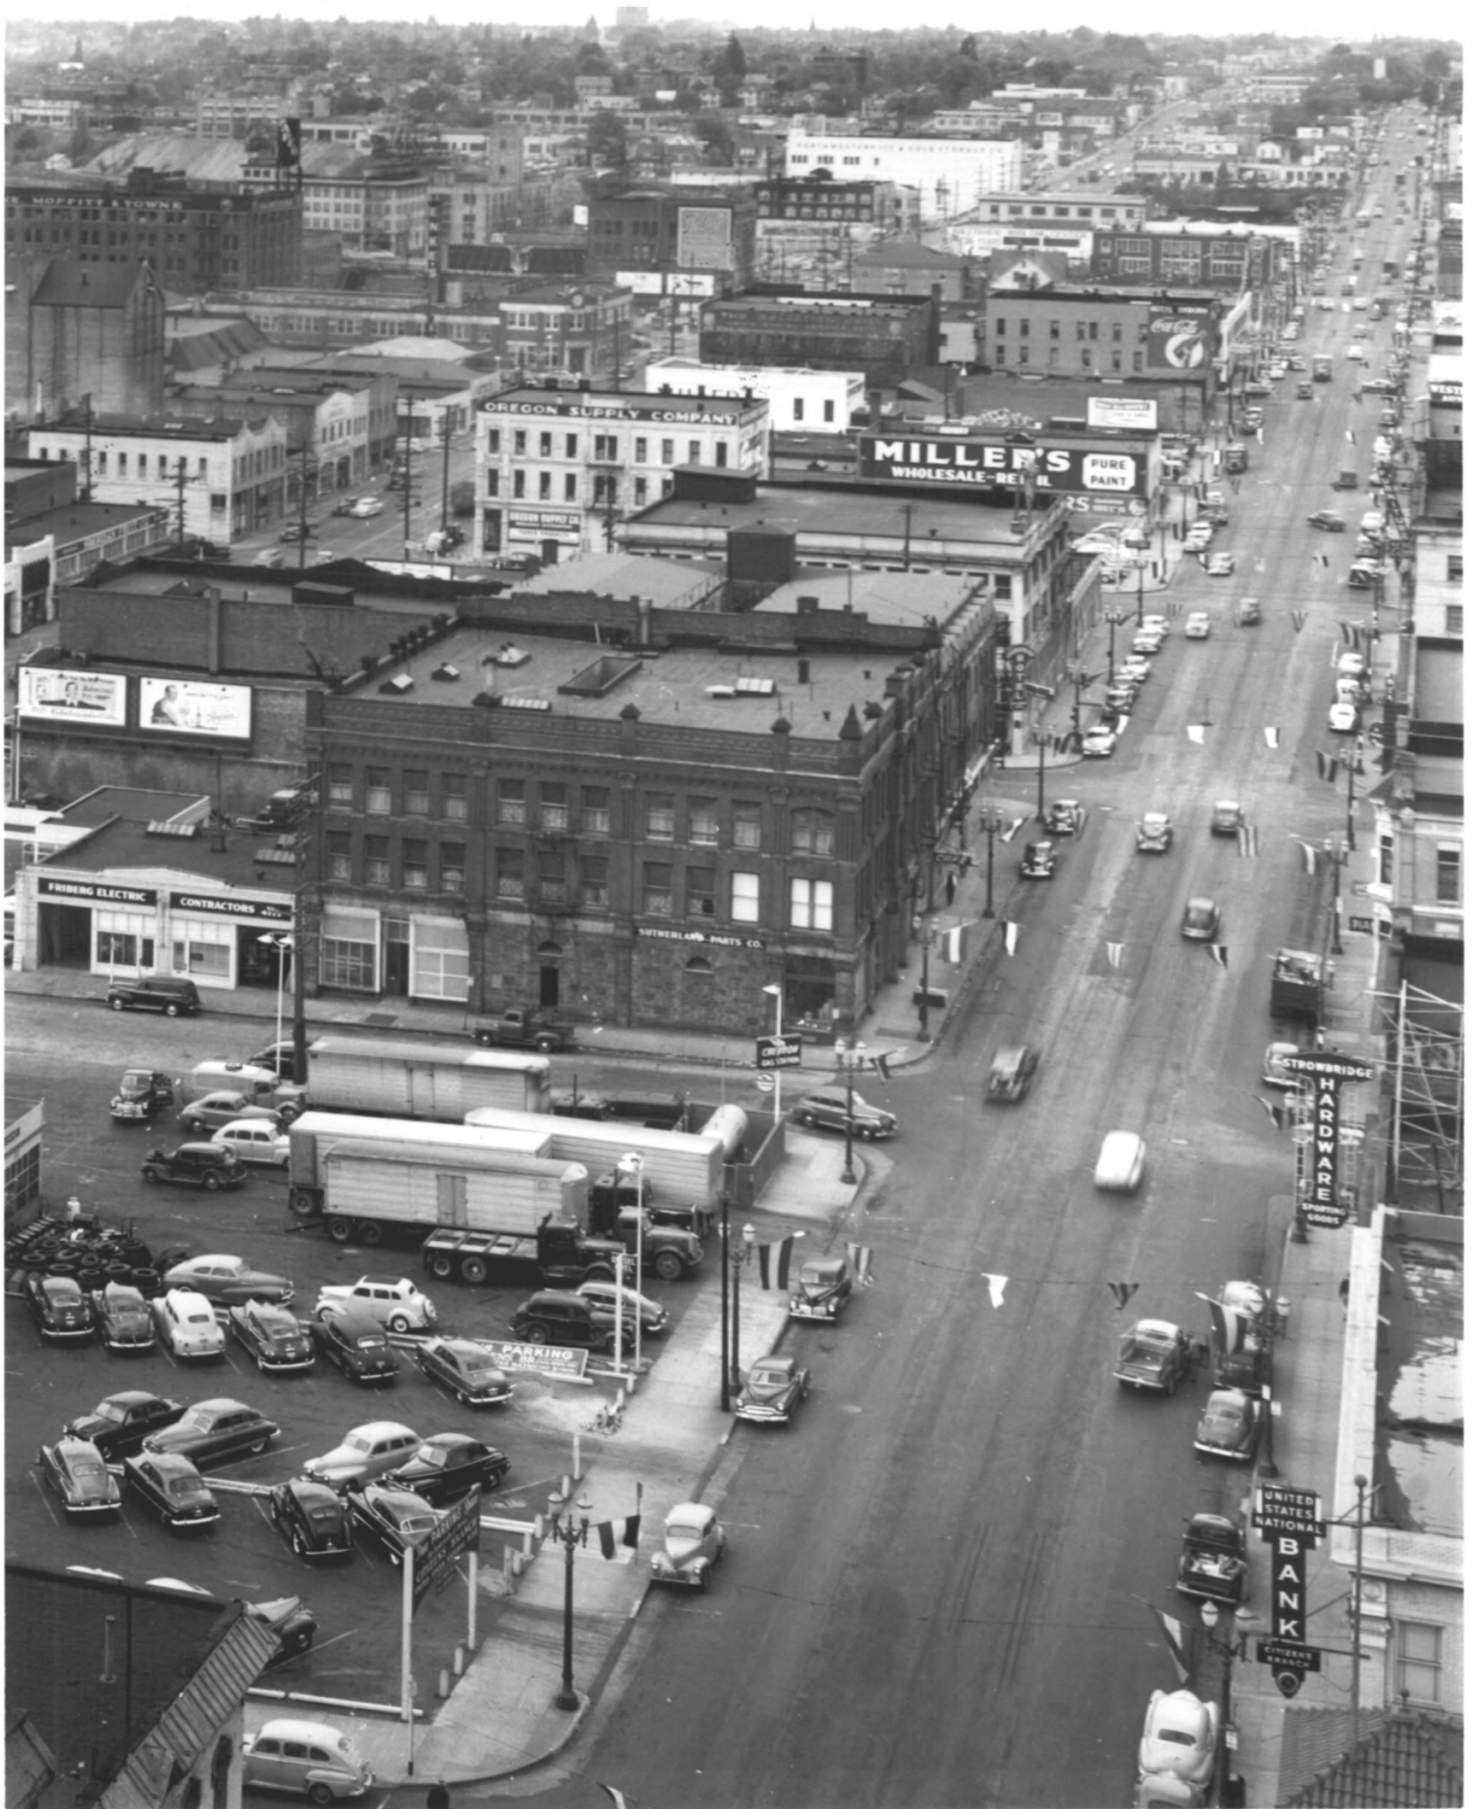
7. # 14 of 14

6. Blowup of  
# 13
