# National Register of Historic Places Inventory—Nomination Form

historic Tanner, Albert H., House

street & number 2248 N. W. Johnson Street N/A not for publication

The Albert H. Tanner House, built in 1893, is a two and a half-story frame house in the Stick Style, rectangular in plan, with hipped roof, bracketed eaves, and shiplap siding. Oriented longitudinally on its 60 by 100-foot lot, the house has the conventional side entry-stairhall plan of its period. The facade faces north onto Northwest Johnson Street and is distinguished by a veranda with pairs of turned and decorated posts which wraps around the northeast corner, and by a gable-roofed, rectangular projecting second-story bay window section, the pediment of which is clad with shingles with scalloped butts and pierced by a bull's-eye window. Features above the eaves are three brick chimneys with intact corbelled caps, a jerkin-headed gable over a projecting section on the east face, a small attic dormer, also on the east elevation, and a gable-roofed wall dormer atop a projecting section on the west face. A belt cornice divides first and second stories. The frieze is set off by molding and is unadorned except where di

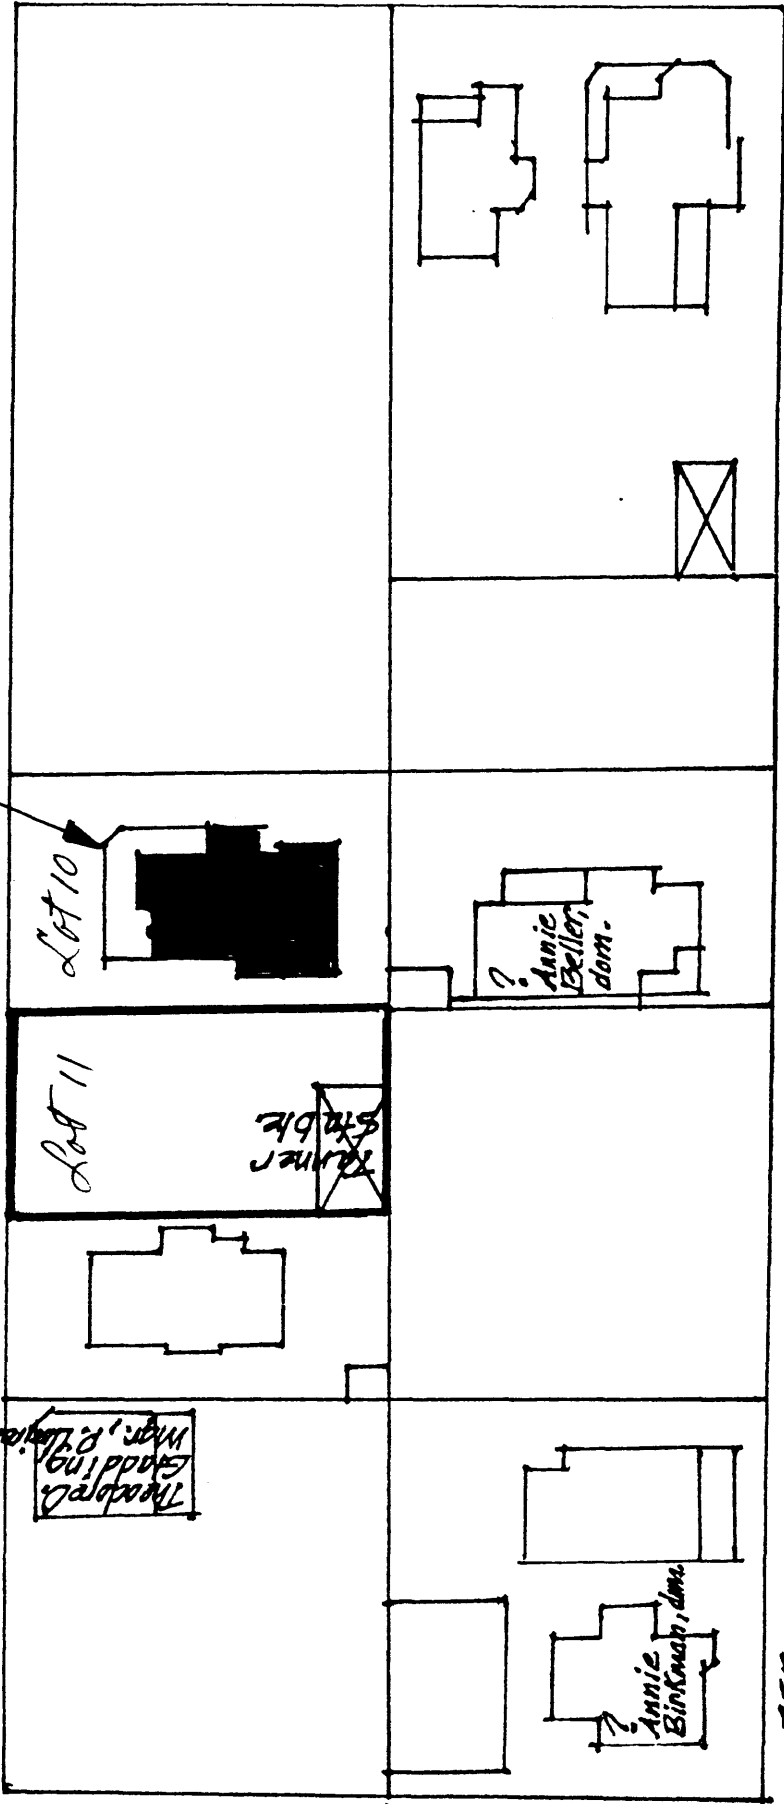
(3) 1889 SANBORN MAP (connected to 1898) showing 1893 residents IRVING

\*still existing structures

Property developed by Tanner on Northwest Johnson Street originally included Lots 10 and 11 of Block 8 of King's Second Addition to Portland. The original holding thus measured 100 by 110 feet, and a carriage house and stable occupied the westerly lot before it was sold off in 1905. In the front yard is an exceptionally handsome mature horse chestnut tree which probably was planted shortly after the house was built. Adjacent to the Tanner House on the west is the Colonial Revival house built in 1906 for Mary J. G. Smith, and on the east is the Italianate Sprague-Marshall-Bowie House--both properties recently restored and listed in the National Register.

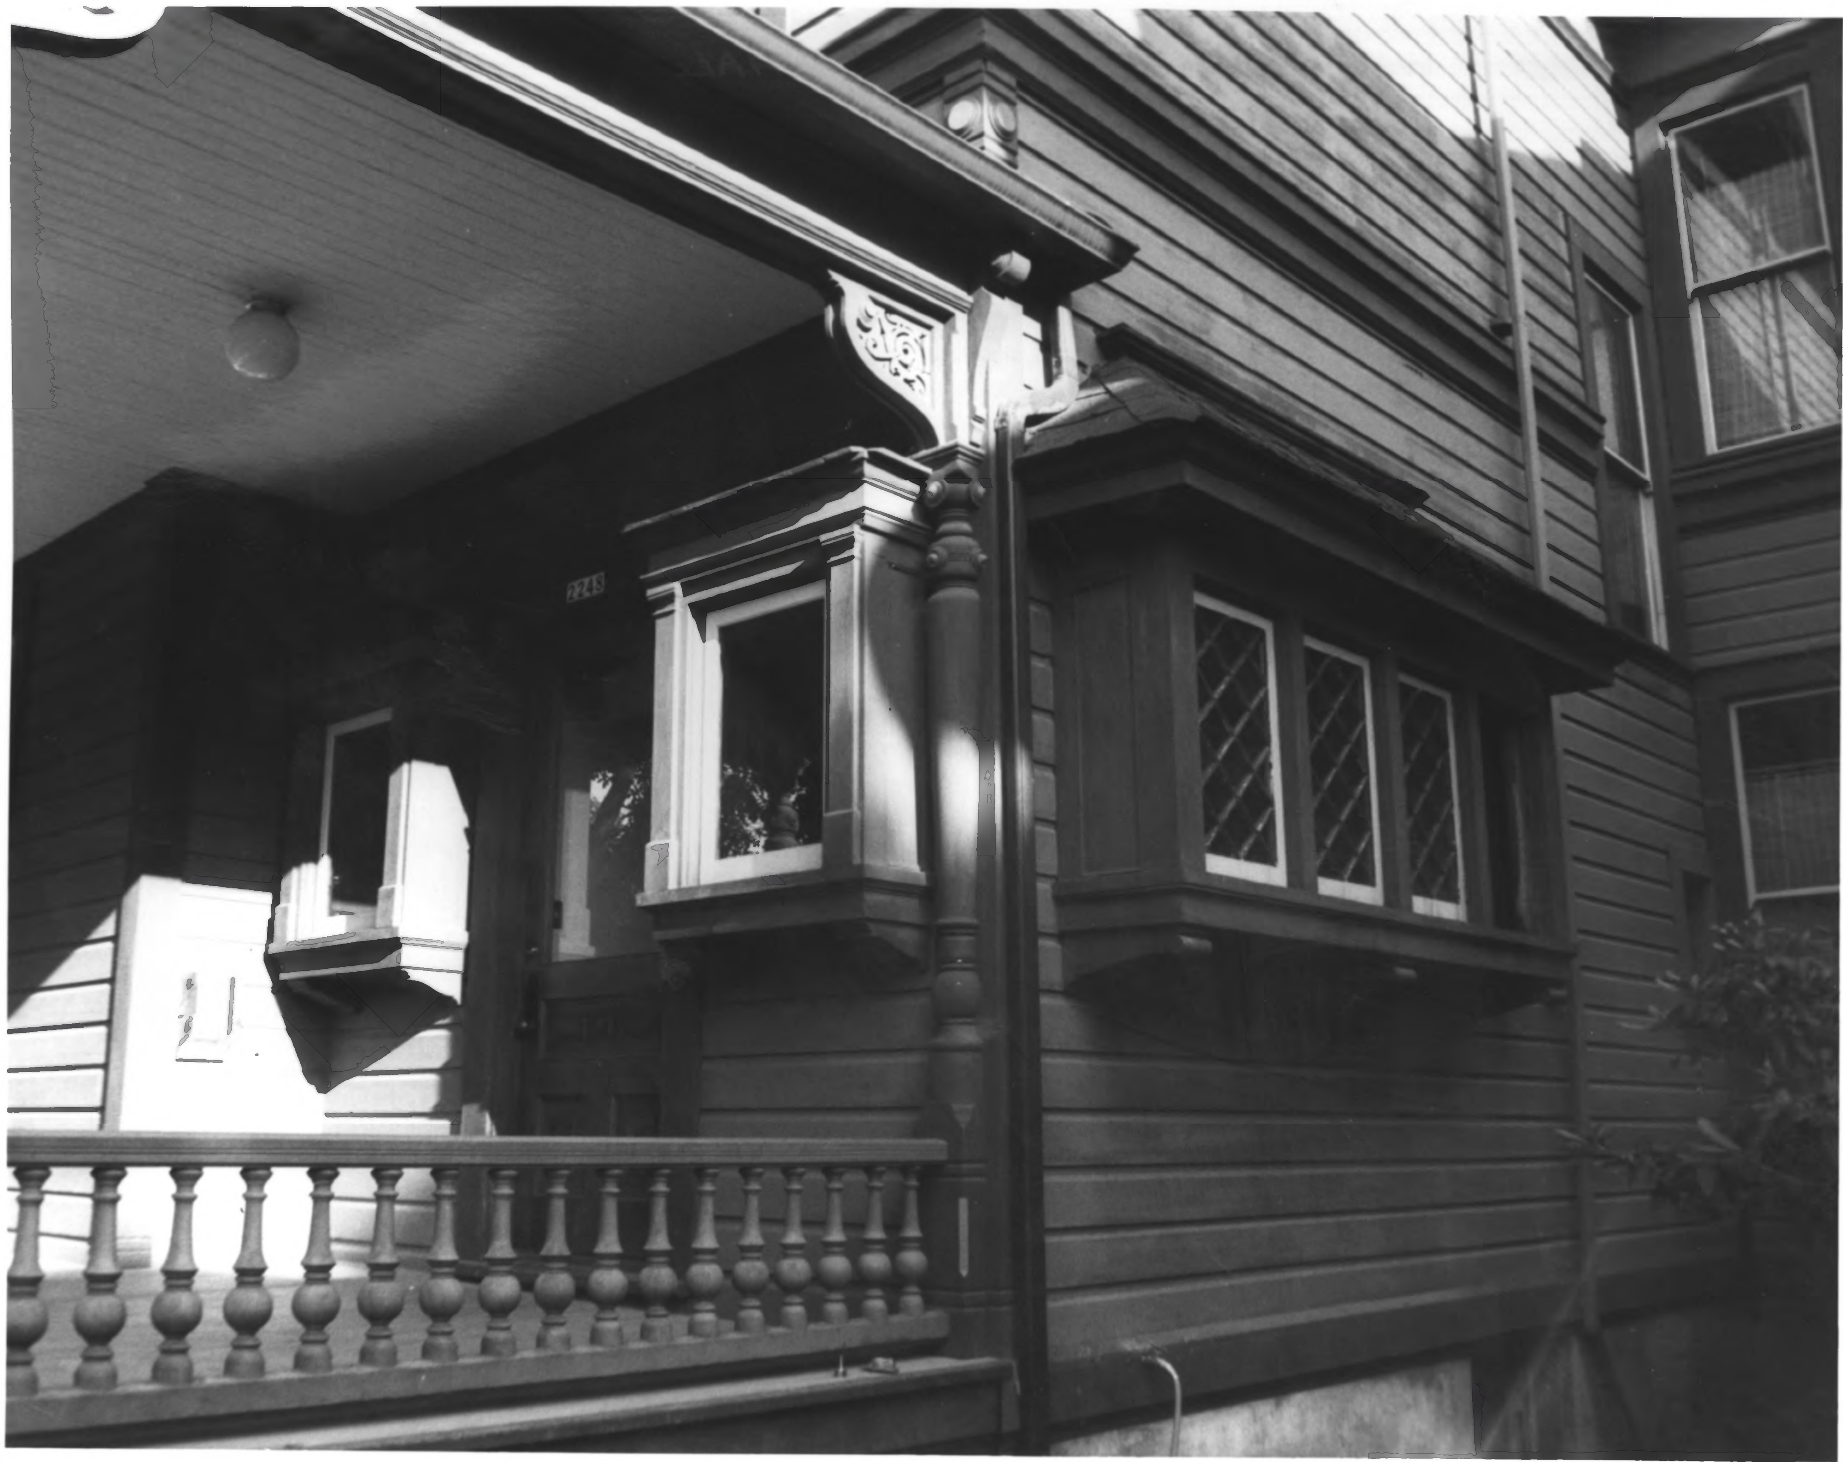
9. ADDED WINDOWS IN FRONT HALLWAY

3 of 10  
Detail of Craftsman style bay windows  
added to entry stairhall in 1905

During the last few years that Tanner occupied the house, ca. 1905, some alterations were carried out in keeping with the Arts and Crafts tradition. Three projecting window bays, one of which has diapered glazing, were added in the entry stairhall, and the settle may have been added at the base of the stairs. The wall between the stairhall and front parlor was opened by a portiere arch with columns. In the 1930s, the house was converted to rooming house use, the effects of which the current owner has reversed in a restoration program which was substantially complete in 1981. Among the recent modifications are the replacement of a vandalized chimneypiece in the sitting room by a wood burning stove, construction of a partition separating the entry stair-hall from front parlor, removal of the pantry partitions from the kitchen space, and addition of an upstairs bathroom.

The oak front door has a glass panel with one horizontal and two short vertical panels below. On both sides of the door, and on the west wall at the foot of the stairway, Craftsman-style bay windows were cantilevered from the wall in 1905. Those beside the front door contain one sash each, and the one on the west wall contains three. The latter window sashes with diamond pattern glazing, are being replaced with stained glass.

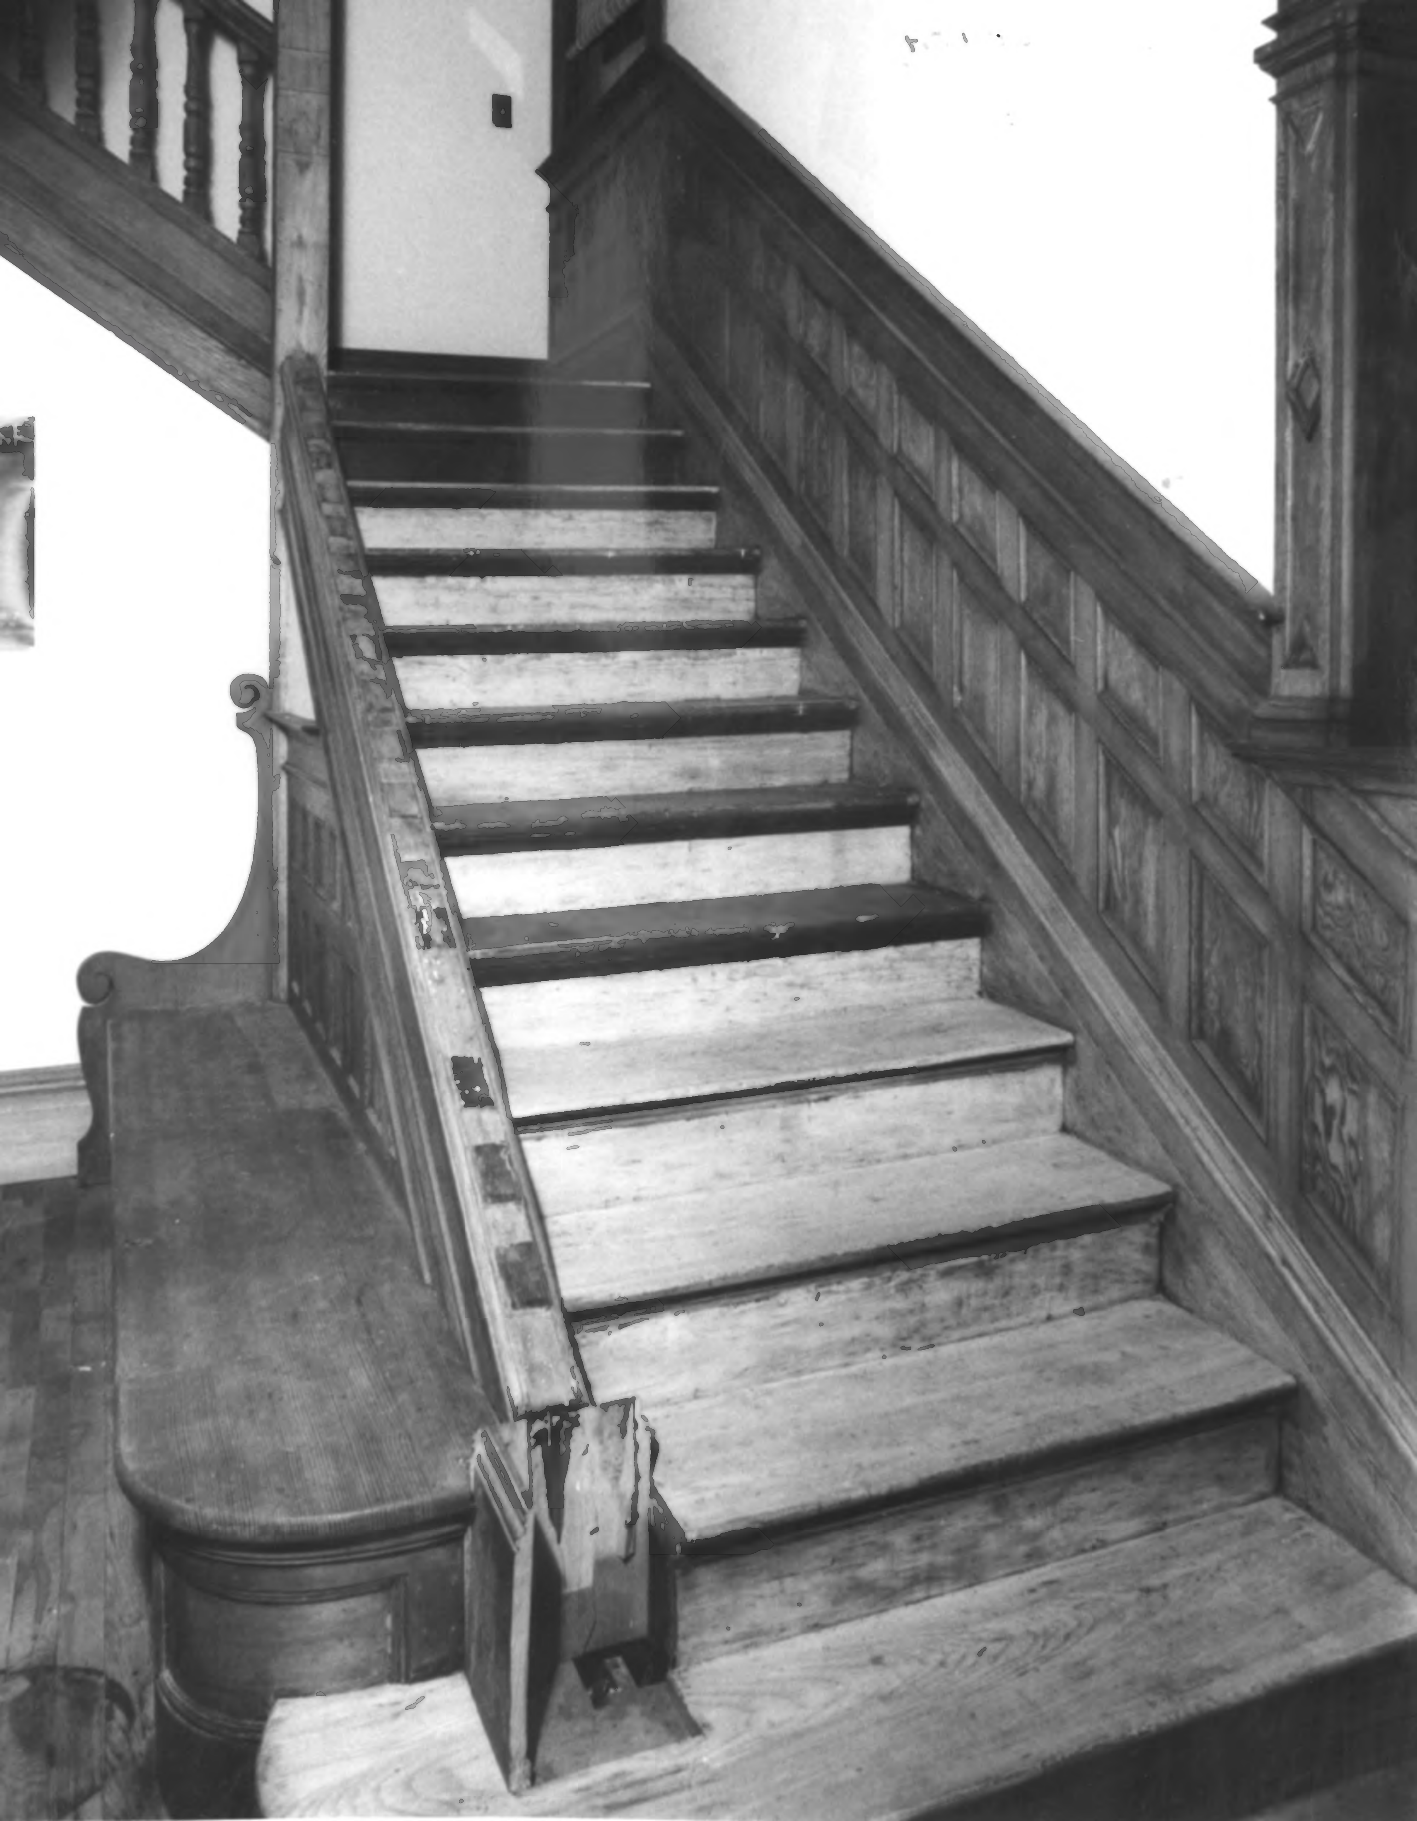
## 5. STAIRWAY

Entry stairhall. Stair railing is dismantled for repair (newel post was stolen).

The front stair has hardwood treads and pine risers with a shaped oak handrail with turned oak balusters and turned newell posts with square bases and square finials. The newell post at the foot of the stair was stolen and is being replicated for installation with the repaired railing.

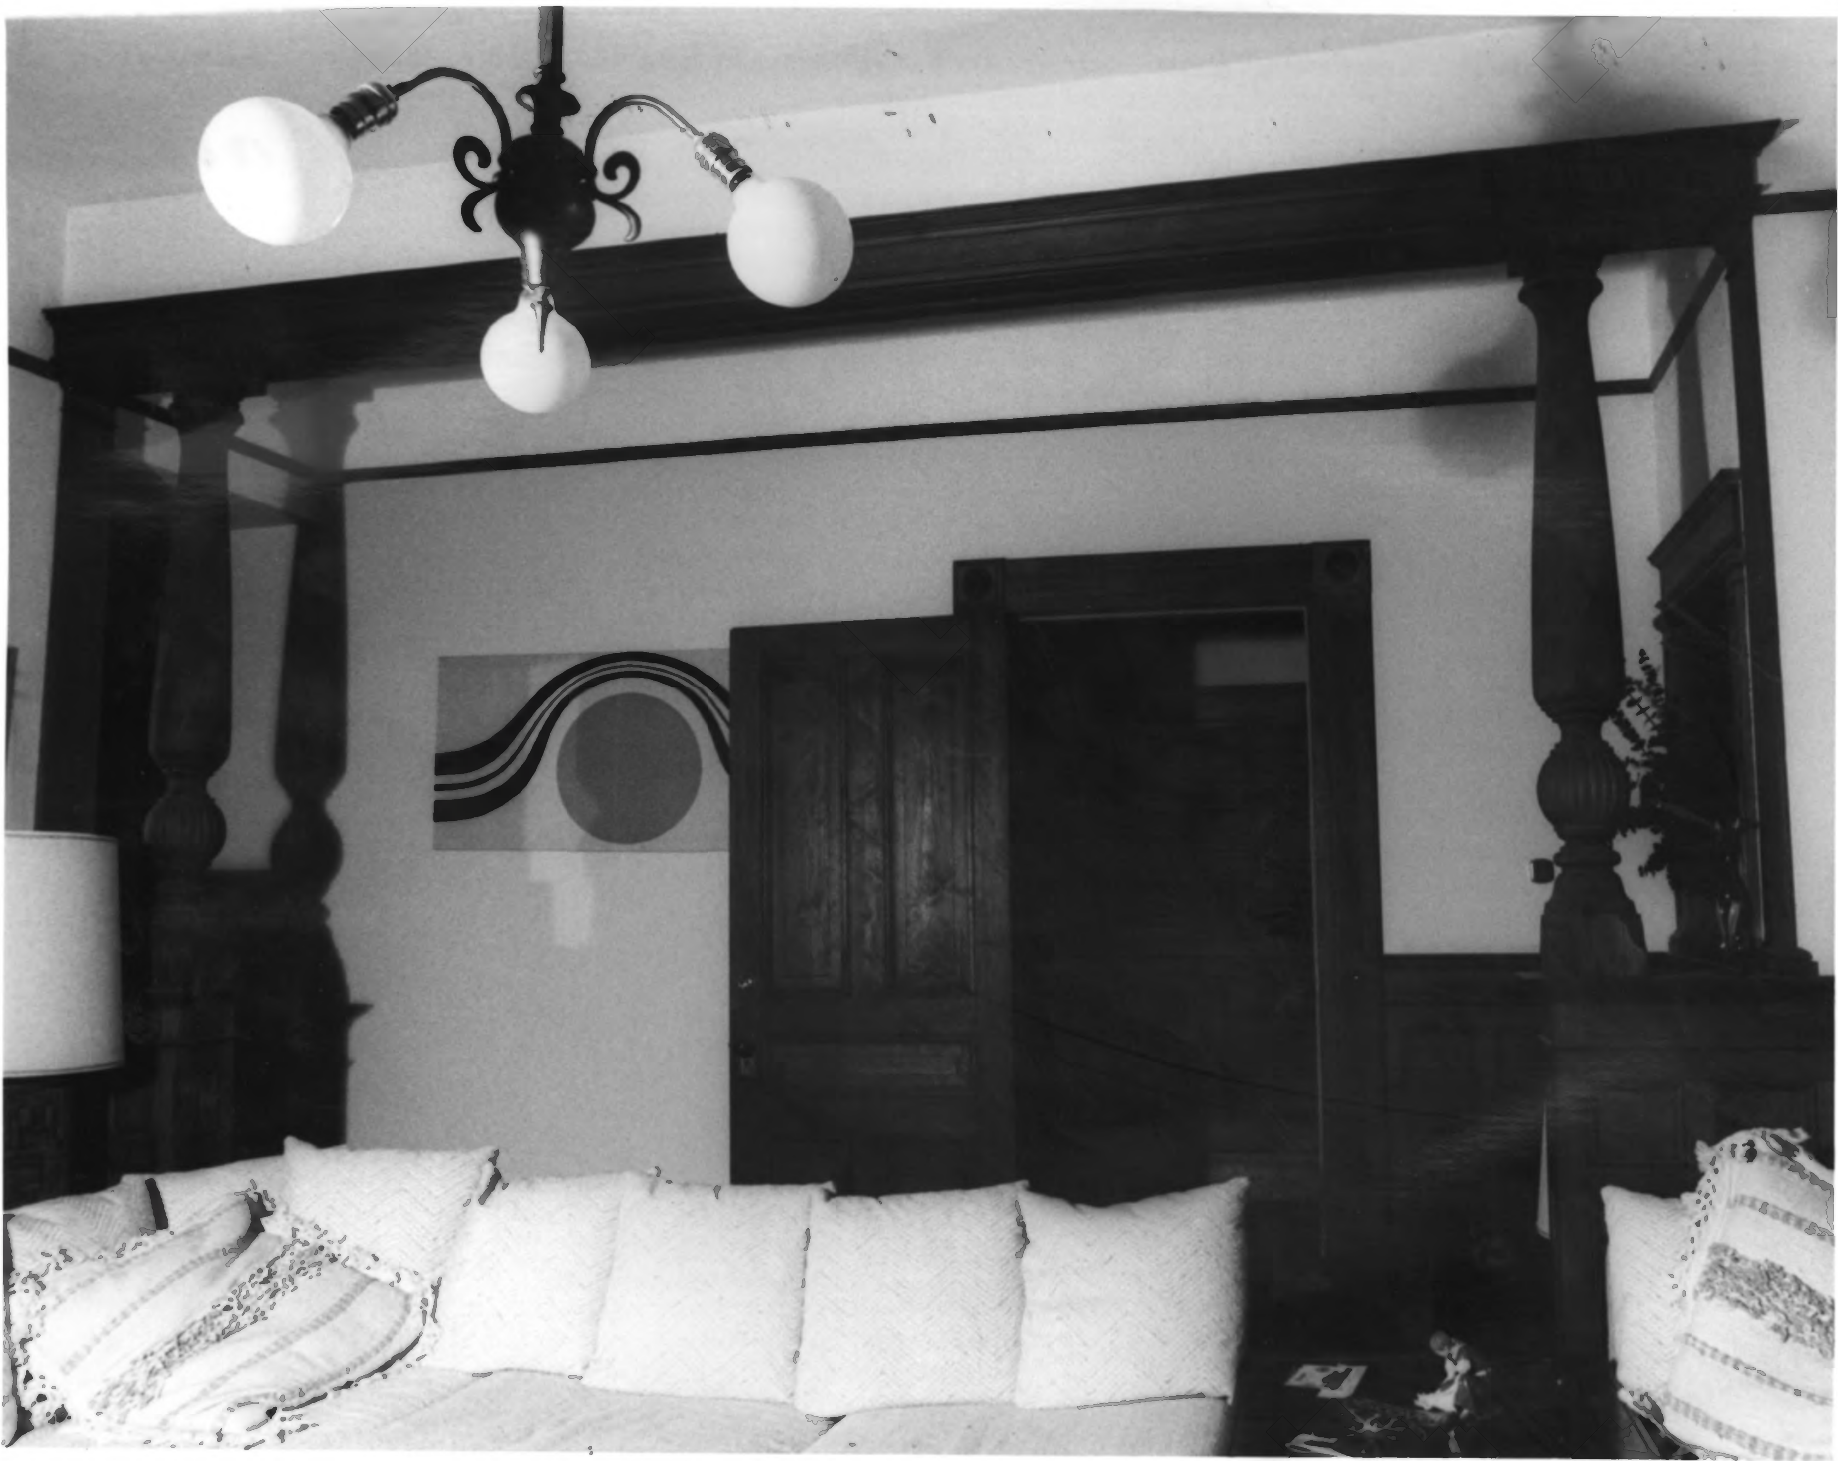
10. OPENING BETWEEN PARLOR AND FRONT HALLWAY SHOWING  
POST ETC ADDED 1905 AND DIVIDING WALL ADDED 1901.

Looking west from front parlor at re-  
cent replacement hall partition and  
entry stairhall beyond. The portiere  
arch replaced original sliding

pocket doors in 1905.

Sliding doors between the parlor and sitting room are 5'-0" wide 9'-0" high with seven panels each; two square over two tall over one horizontal over two short. The fireplace, placed diagonally across the southeast corner of the parlor, has a brick surround and basalt mantle with a niche above. The brickwork tapers towards the ceiling to a cast brick cornice. A brick belt course is situated midway between the mantle and ceiling. Whether this chimney piece was added in the minor remodeling of 1905 is unclear. In 1905, the parlor was opened to part of the original entry except for an 18"-high section of wall with wainscoting on each side. Turned columns are set atop of these wall sections. The opening is further framed with pilasters on either wall and paneled beam. A new dividing wall has been constructed in the entry as an energy conservation measure to separate the parlor from the stairhall. The door and trim in the new partition match the existing millwork.

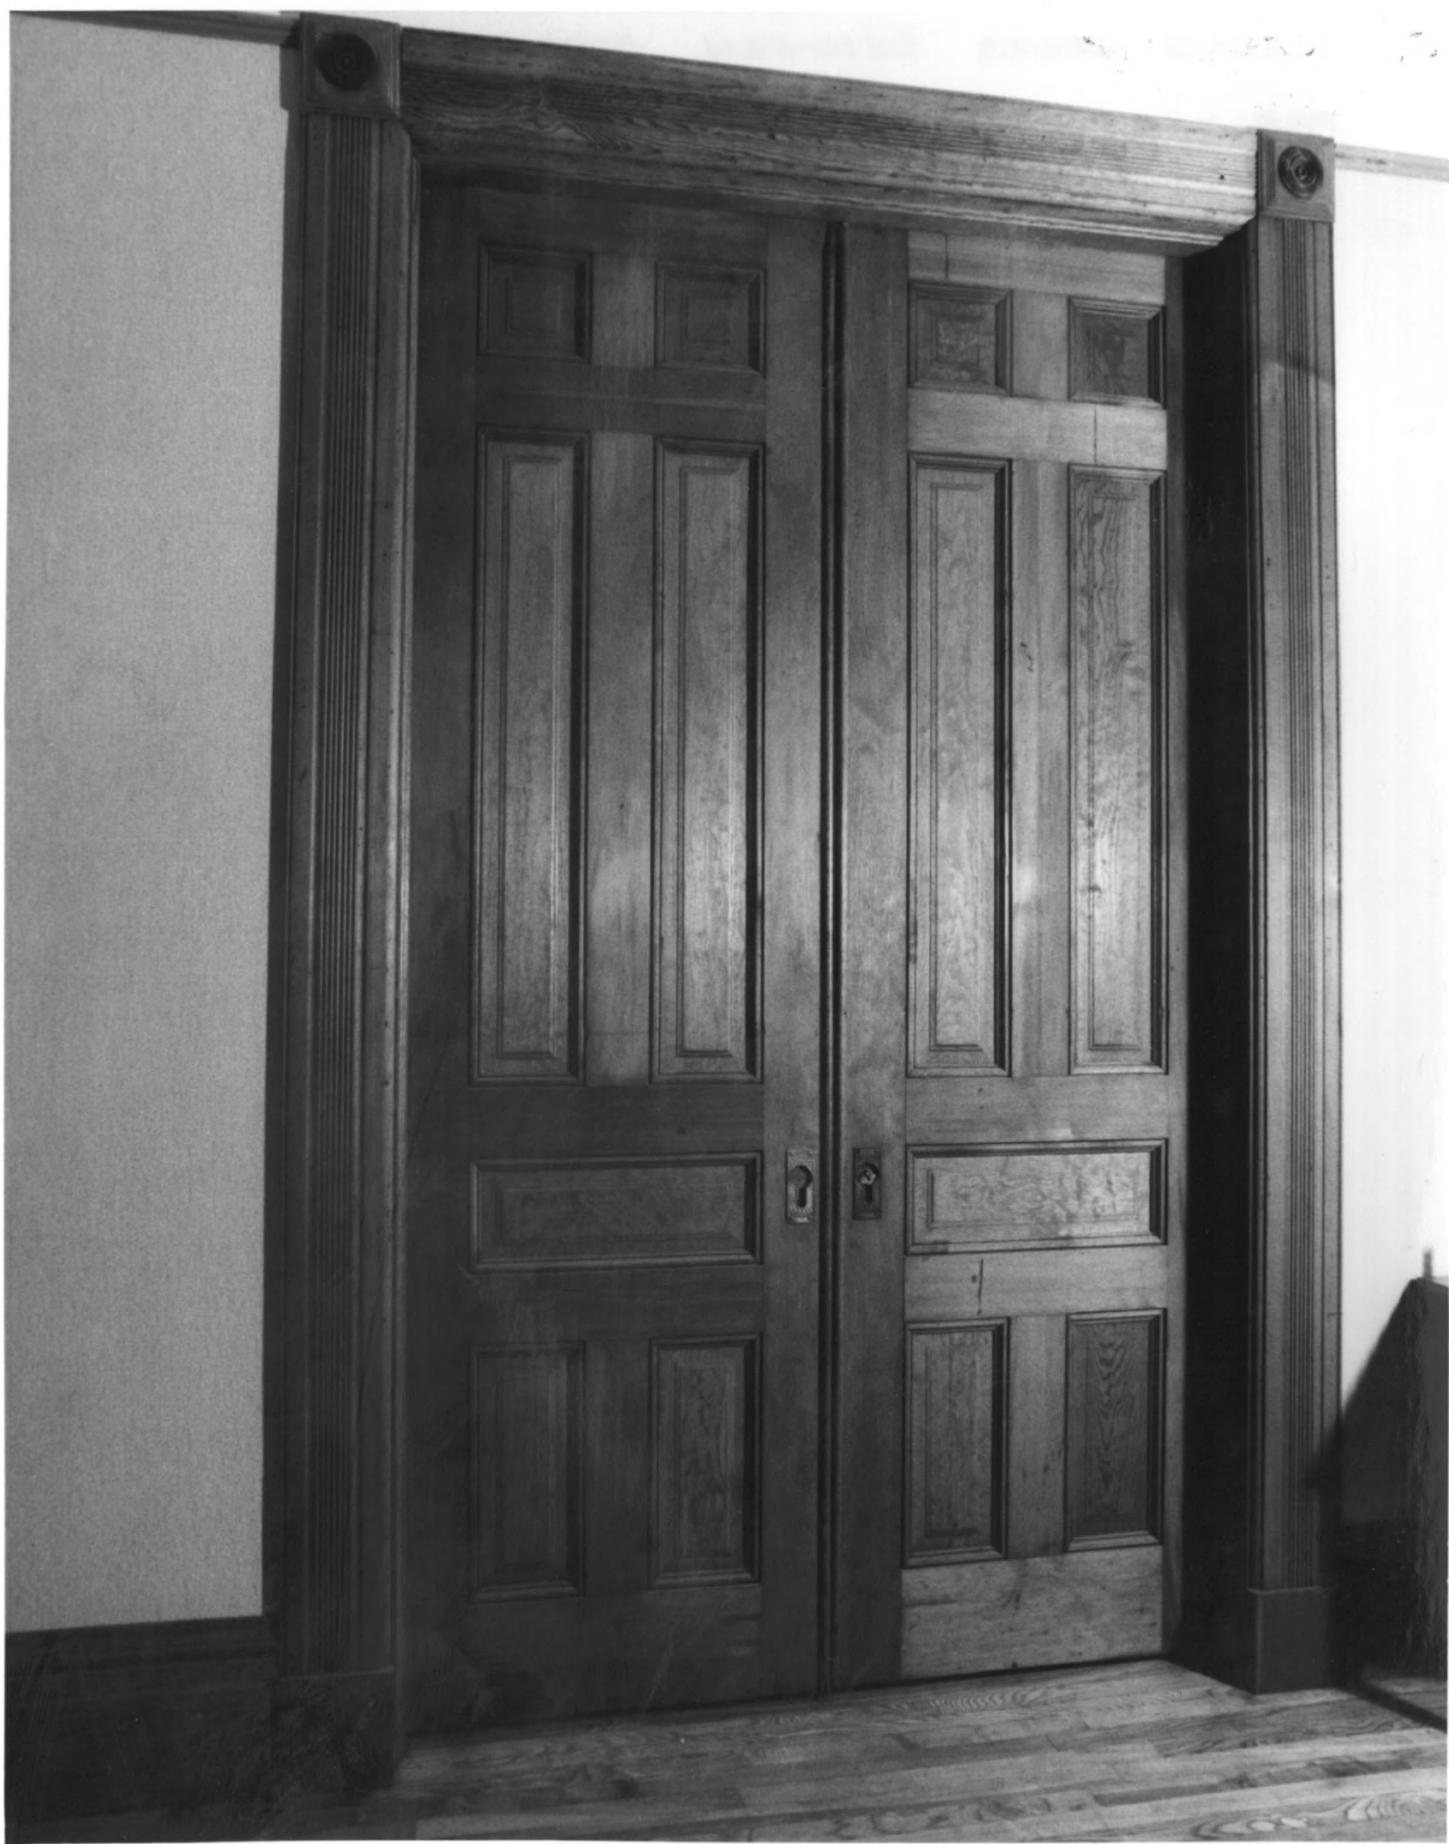
6. SLIDING DOORS BETWEEN SITTING ROOM AND  
PARLOR

Sliding pocket doors between front  
parlor and sitting room.

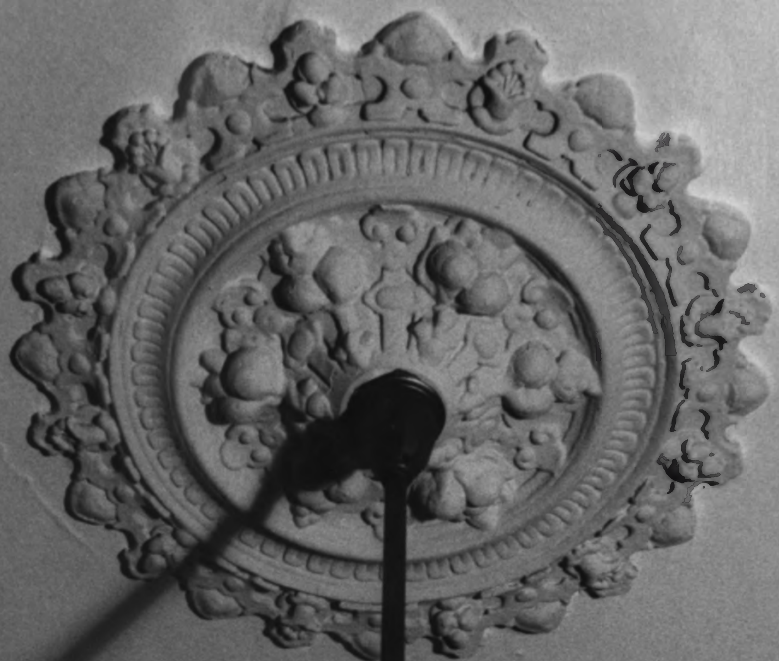
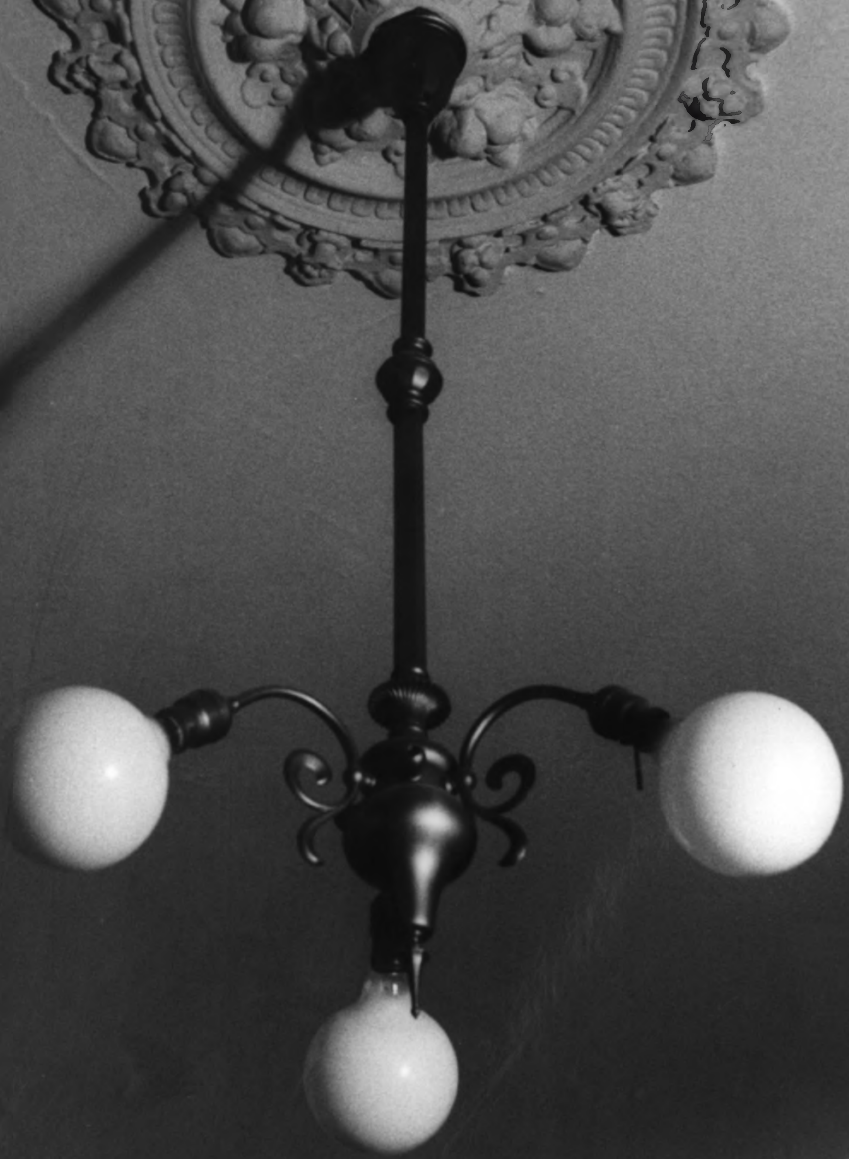
7. LIGHT FIXTURE AND MEDALLION IN DINING ROOM

9 of 10  
Plaster rosette and lighting fixture  
in diningroom.

Walls and ceilings throughout the first and second floors are finished with wood lath and plaster with a natural-finish picture mold. The entry hall, parlor, living and dining room as well as the second floor master bedroom have central ornamental plaster ceiling rosettes, originally for gas lighting fixtures. There is paneled wainscoting in the entry hall and stairwell as well as in the parlor. In the dining room, wainscoting consists of wide panels of burlled pine over 1x3" double beaded tongue-and-groove pine and oak. All flooring on the first and second floors is oak tongue-and-groove laid with a surrounding border, except in the kitchen, back hallway, and bathroom. Oak parquet flooring was added in the downstairs bathroom during the recent restoration.

The gas plumbing for the original lighting fixtures was still in place when the property was acquired by the present owner in 1975. Conversion to electric lighting had been made at the turn of the century. Three electric fixtures have been restored in the parlor, sitting

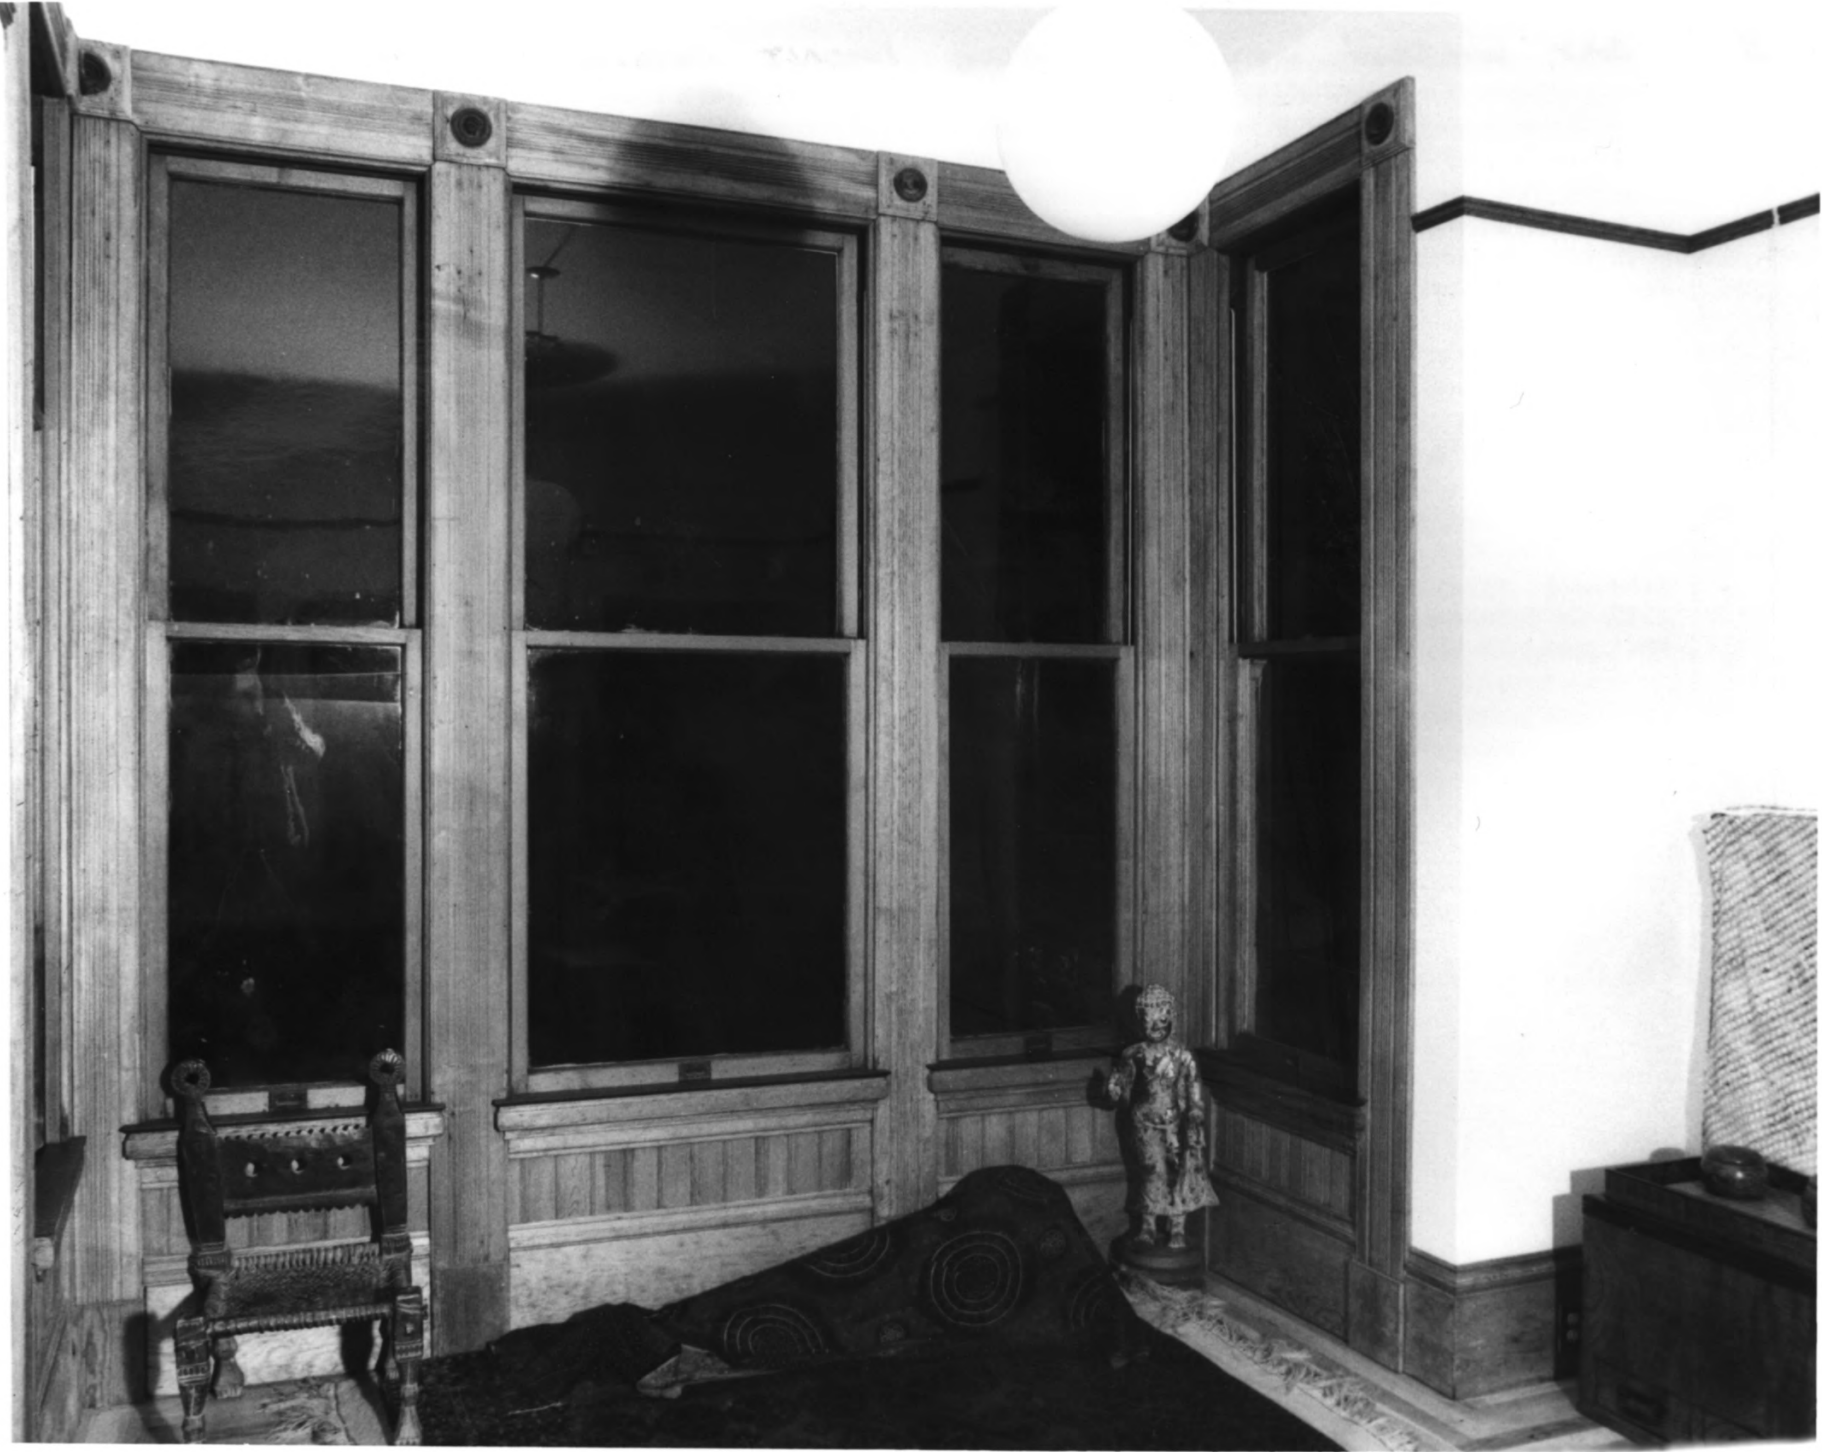
8 BAY WINDOW SECOND FLOOR FRONT MASTER BEDROOM

10 of 10  
Interior view of window bay, second  
story front bedroom.

The front stairway runs up the west wall to a landing and continues at right angles to the central second floor hallway. To the north is the master bedroom, above the parlor, containing a five-section rectangular bay window in the north wall. In the northwest corner, over the entry, is the dressing room with a double window in the north wall. Behind these rooms, on either side of the hallway, are two bedrooms, the one on the east with windows in the three sides of the square bay, the one on the west with windows directly above the dining room windows. There are two back bedrooms in the southwest and southeast corners with a bathroom and separate water closet between them. Both back bedrooms have two windows, one on each outside wall. In addition, between the west and southwest bedrooms, another bathroom was added in the space that originally contained the back stairway.
