Rim Drive Historic District  
Property Name

Klamath OR  
County State

# National Register of Historic Places Registration Form

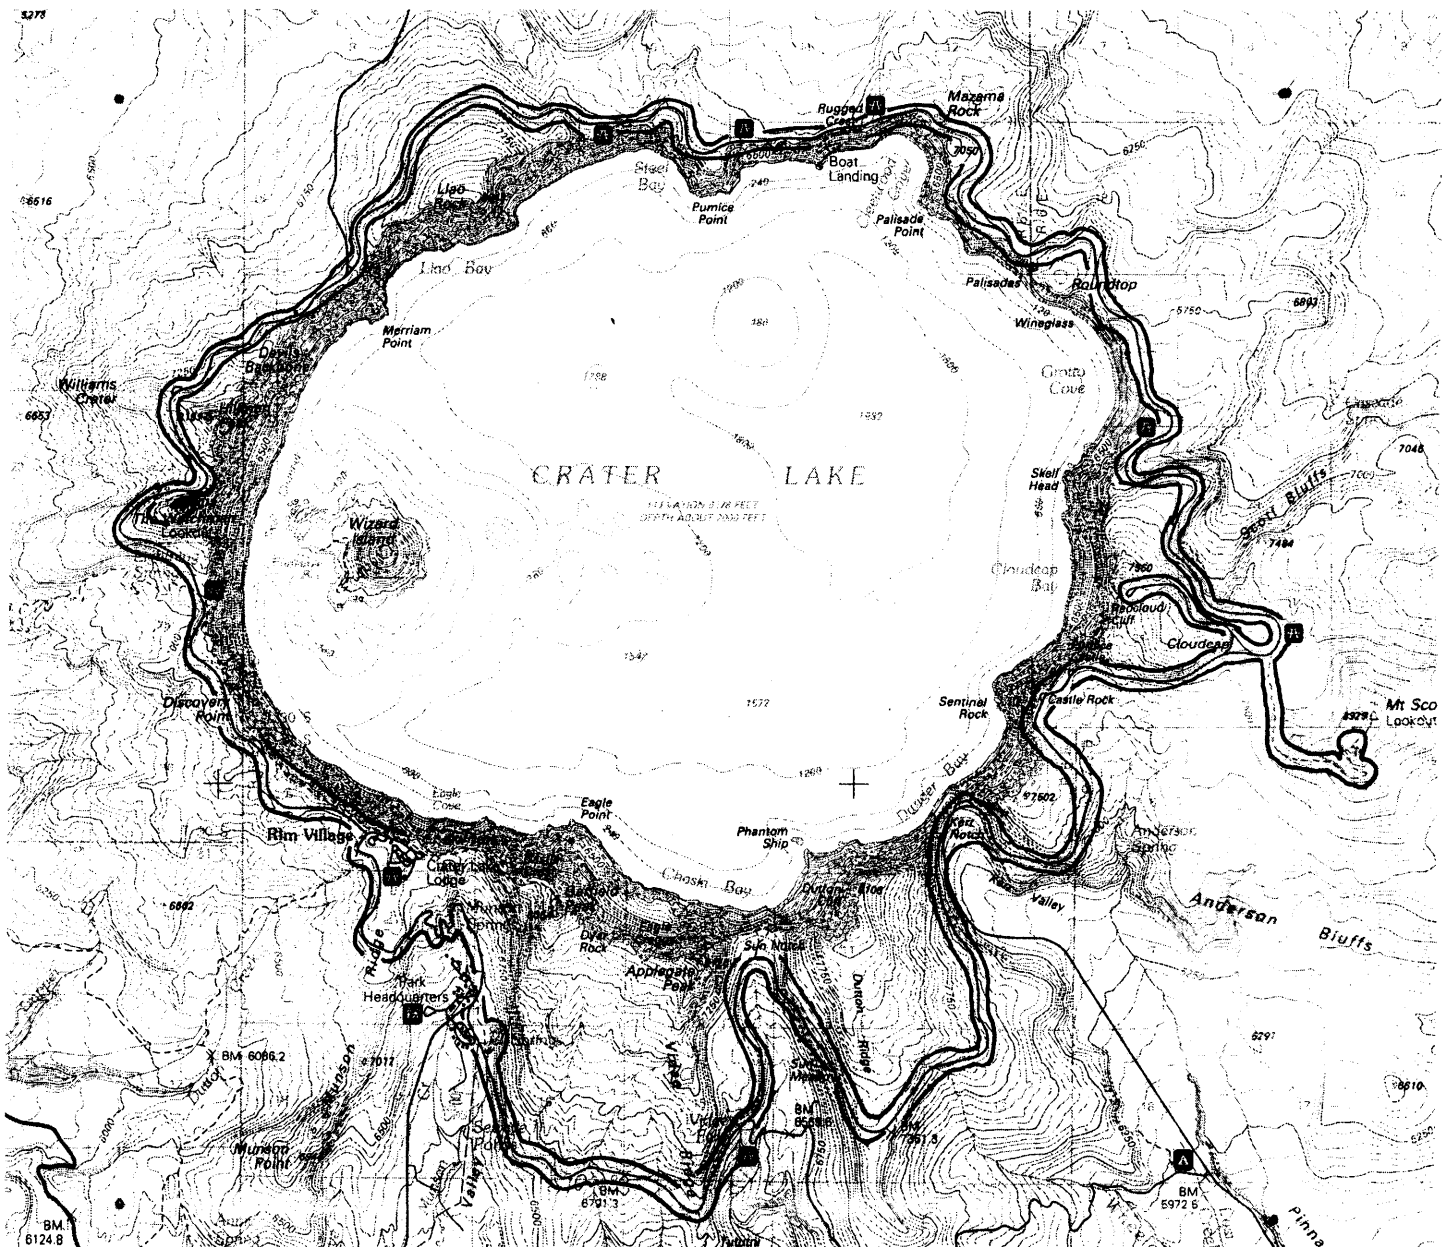
## BOUNDARY MAP

The boundary of the Rim Drive Historic District includes the road right-a-way of Rim Drive and its associated engineering features, including visitor amenities such as overlooks, pullouts, parking lots, and trails. Map not to scale. See Section 10 for a full boundary description.

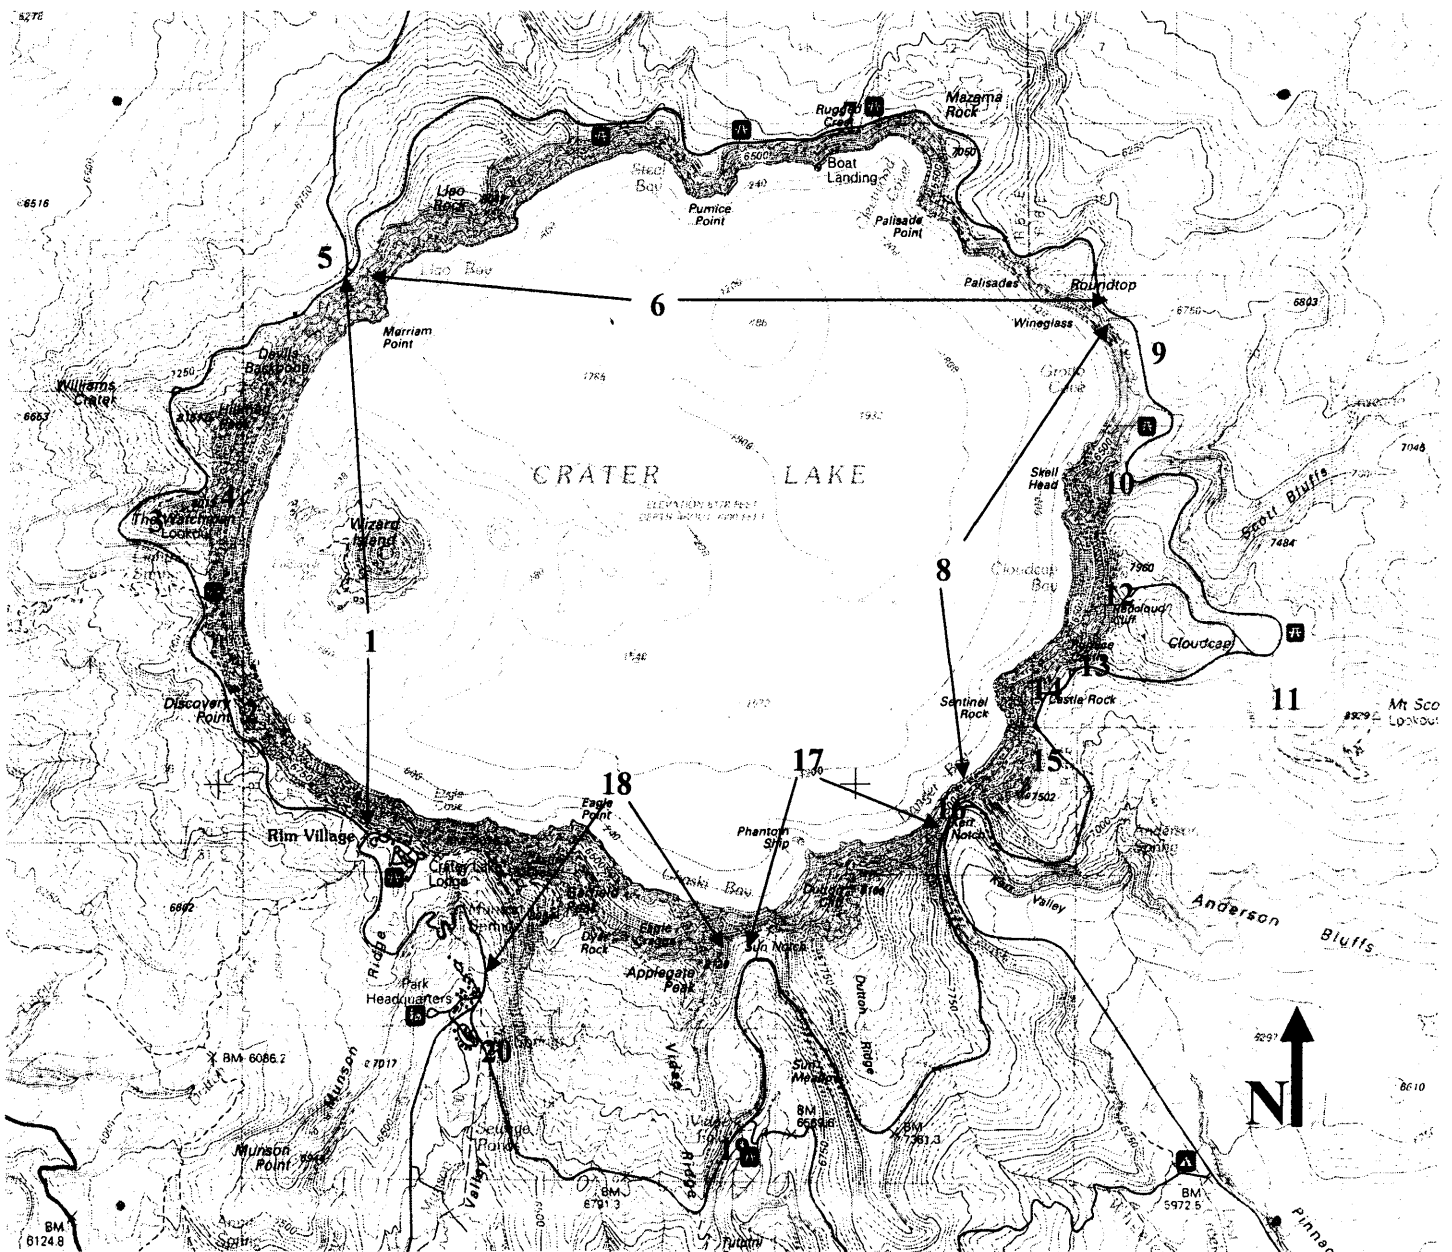
## RESOURCE MAP

Note: Resources 1, 6, 8, 17, and 18 are road segments whose length is defined by the arrows extending from the resource number. Please see Section 7 for precise descriptions of each resource.

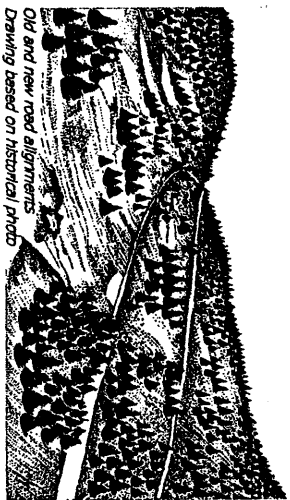
## First Rim Drive (1910 - 1919)

Old and new road alignments  
Drawing based on historical photo

Because of the exceedingly rough nature of the lava rock terrain around Crater Lake and the short working seasons it was a difficult task to build the Rim Drive of standard width, with a minimum number of curves and a gentle grade. The First Rim Drive (35.4 miles), completed in 1919, was a typical mountain road, rocky in some places, dusty in others and crudely surfaced most of the way.

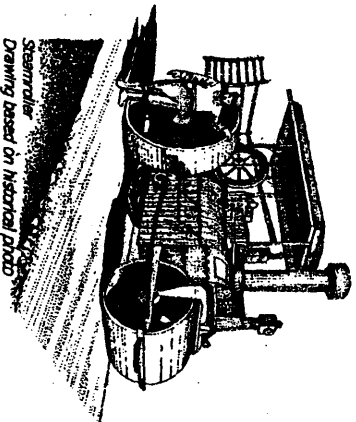
## Second Rim Drive (1928 - 1940)

In conjunction with the program for improvement and reconstruction of roads throughout the National Park system, the redevelopment of Rim Drive commenced in 1928. This program aimed to make the road system appropriate to modern standards. The Second Rim Drive followed the old route wherever possible in order to provide similar views of the lake and reduce construction costs. In an attempt to preserve the primitive picture of the natural setting, the new road was located so that it could not be seen from any point of the lake and, with a few exceptions, from any other point on the road. Special attention was paid to the protection of the landscape and the integration of the road within the natural context. Viewpoints, observation stations and parking lots became part of the road design. The construction of the Second Rim Drive involved blasting and hauling rock, grubbing, burning and clearing vegetation, grading and surfacing the road bed, building stone walls and planting native vegetation in the disturbed areas. The two-lane, two-way road was designed with an average width of 22 feet. The completed road had a paved bituminous surface from the Park Headquarters to Cloudcap, and an allied surface from Cloudcap back to the Park Headquarters. The completed length of the Second Rim Drive was 32.6 miles.

1. Circulation:  
The road and parking areas are separated from walkways and trails.

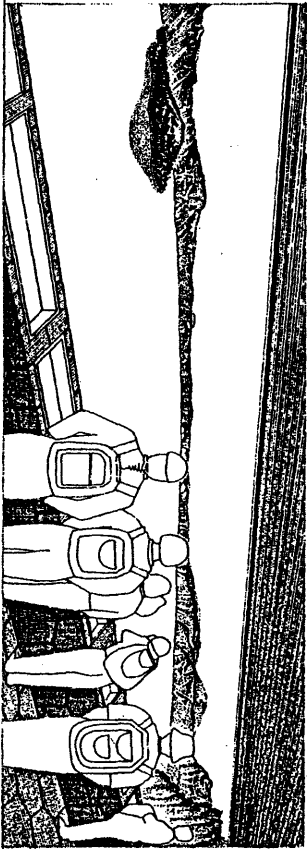
**Panoramic view to Crater Lake from the Shinnott Memorial.**  
Built on Victor Rock in 1930, the Shinnott Memorial is intended to be the main orientation point at the beginning of Rim Drive. It still affords a vantage point where visitors can go to hear about the lake from park staff.

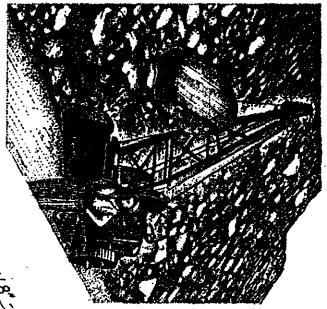
The Watchman quarry  
Drawing based on  
historical photo

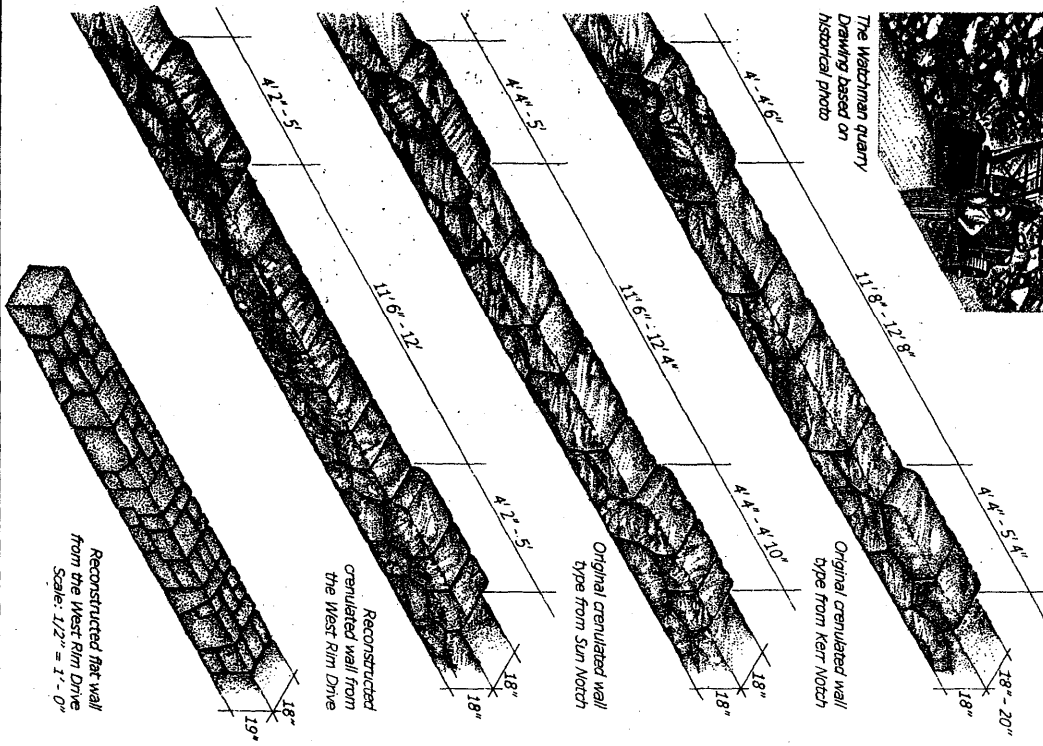
Roadside barriers were designed and constructed to provide safety for both motorists and pedestrians. Most of the original patterns of stone guardrails constructed between 1930 and 1938 can be found along the East Rim Drive. An extremely high level of craftsmanship, displaying special attention to composition and artistic layout can be seen in the area from Sun Notch to Kerr Notch. The walls are made of local andesite rock, most often obtained at the Watchman quarry. Though derived from a standard design, stonework patterns were intentionally irregular to better harmonize with the park setting. The original stone walls were built of huge, rough blocks with narrow, incised mortar joints. In order to provide variation and rhythm, the walls were broken by crenulations about every twelve feet. Most of the stone guardrails along the West Rim Drive have been reconstructed, and differ markedly in scale and pattern.

The barriers at the "Cornalis" observation station, erected in the 1970s, are the only modern wood rails. Wood reflection posts, usually in combination with stone walls, can be seen all along the Rim Drive. In a few places the old wood posts were used as vertical elements for standard "W" steel rails.

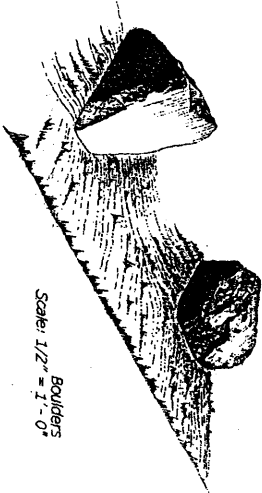
Boulders  
Scale: 1/2" = 1'-0"

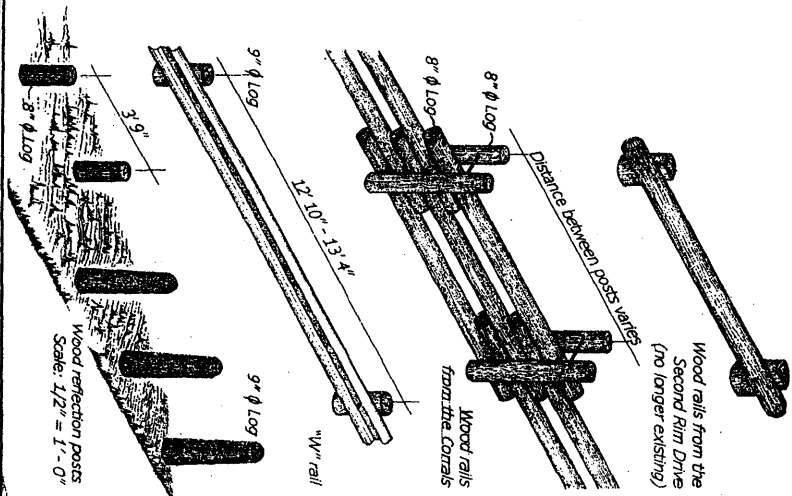
Rim Drive shoulders  
Drawing based on  
historical photo

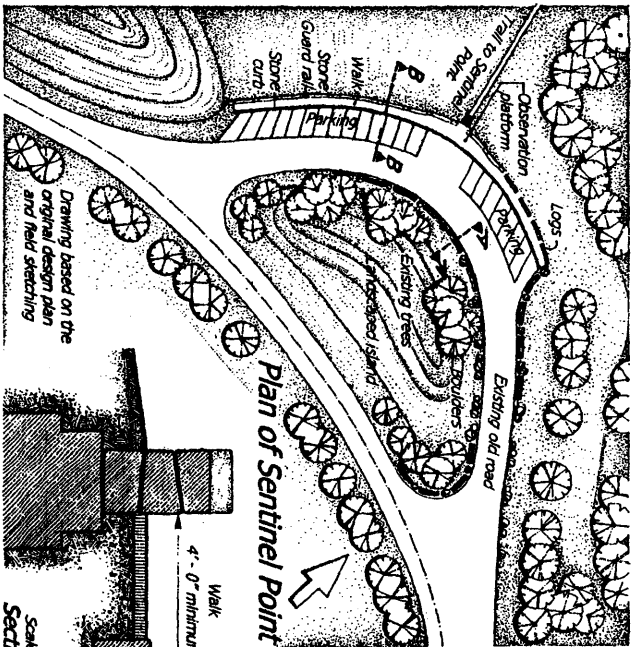
Plan of Sentinel Point

The unity in design of the Rim Drive and all its supporting elements is a major characteristic of the Rim system. Construction drawings prepared by the NPS Branch of Plans and Design in 1936 depict the design scale, form and materials of the observation stations. Designed as scenic overlooks, where visitors could leave their cars and enjoy the view, some stations were large enough to hold 50 cars, parked at an angle or perpendicular to the rim. The semi-elliptical pavilions were adjacent to the road and substantial in size, averaging 400-500 feet in length and 150-180 feet in width. Typically, the burntwood surface of the parking area was separated from that of the roadbed by an island plant bed. Within the paved area an attempt was made to separate pedestrian and vehicular circulation. A raised burntwood path, approximately 4 feet wide, was located as a promenade along the edge of the rim. The path was edged on the rim-side by a stone guardrail and on the parking side by a stone curb. At a promontory point, the path widened into a large gathering area 10 feet wide - the so called "observation platform". The numerous small scale features add a subtle level of detail to the constructed landscape. Most of them - drinking fountains, directional and interpretive signs, guardrails - were built of local stone or wood, designed with rustic forms to integrate with the surrounding natural setting. This harmonious relationship among the various elements within the Rim Drive system is a significant feature of this site.

Drawing based on the original design plan and field sketching

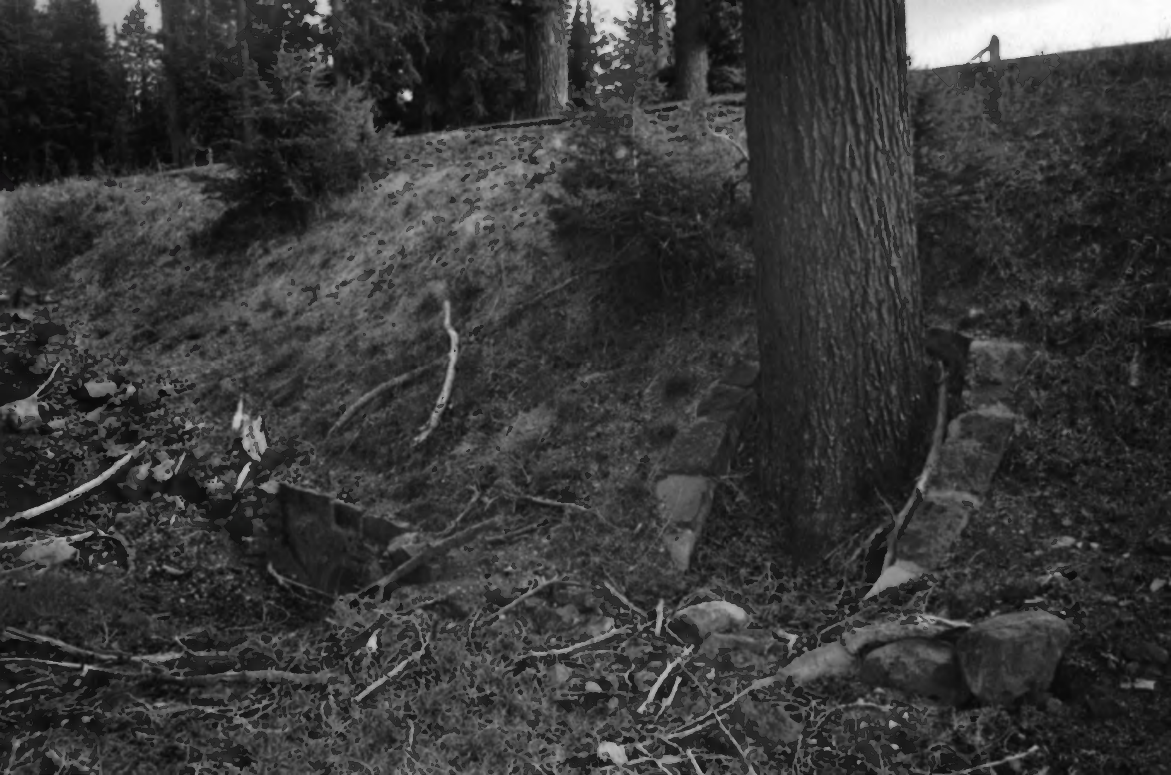
3. Culvert headwall (left) and masonry device to protect  
tree on fill (right) in road segment 7-A,  
Rim Drive Historic District  
Crater Lake National Park, Klamath County,  
Oregon

Segment A of Rim Drive maintains its original vertical and horizontal alignment, as well as cross drainage, masonry retaining walls and guardrail, and even some stone and mortar wells aimed at protecting trees on fill slopes. Some of the retaining walls and virtually all the masonry guardrail have been repointed and repaired. This is primarily due to the dominant slope orientation being southwest, but perhaps more importantly, the annual road opening done each spring with heavy equipment. Insufficient funding for masonry guardrail during original construction in 1931-32 resulted in CCC crews placing partially buried logs as safety barriers—devices that have since been replaced by newer masonry work during the 1960s. Consequently, two of the substations (3-A, the “Diamond Lake Overlook” at MP 5.1, and 3-C, “Glacial Evidence” at MP 5.6) have a patchwork appearance. Nevertheless, there is still a high degree of historic integrity as none of these alterations serve to destroy the sense of how Rim Drive is subordinate to a rugged volcanic setting, one where the idea of seeing Crater Lake from above and at some distance constitutes the main way of experiencing it.

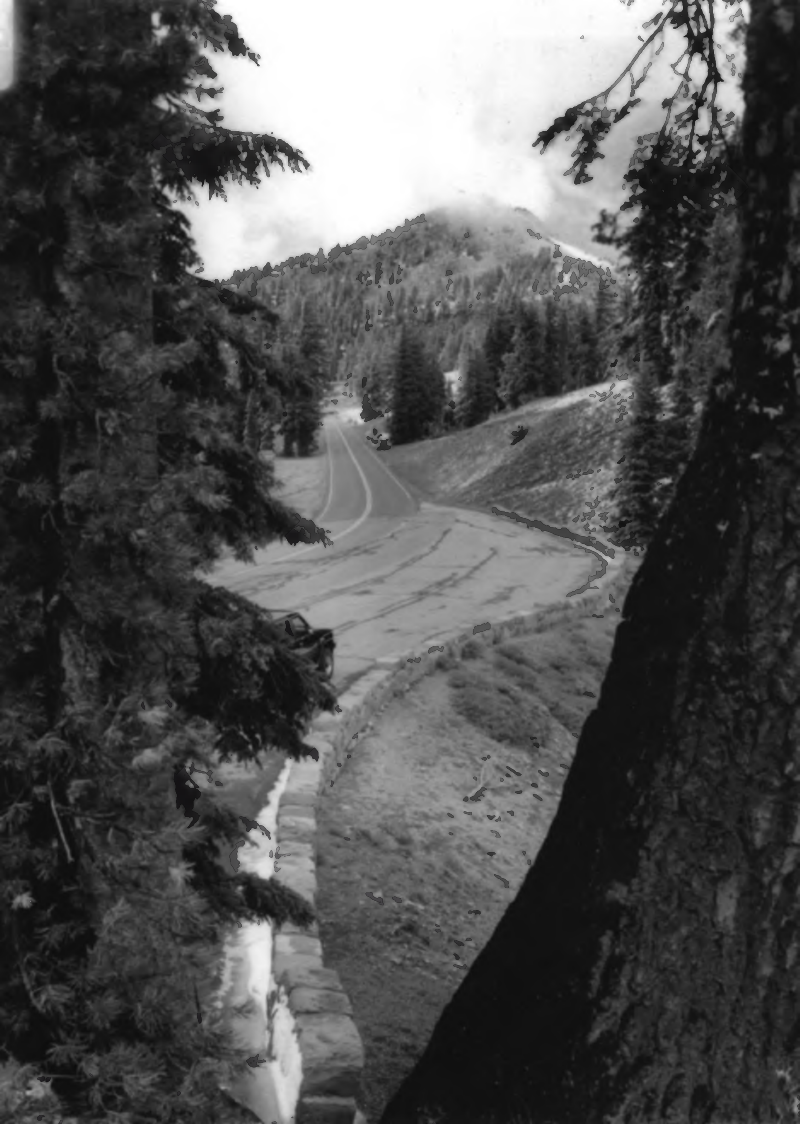
4. Substation 2-A delineated by  
masonry guardrail with road tangent  
and The Watchman in background,  
Rim Drive Historic District  
Crater Lake National Park,  
Klamath County, Oregon

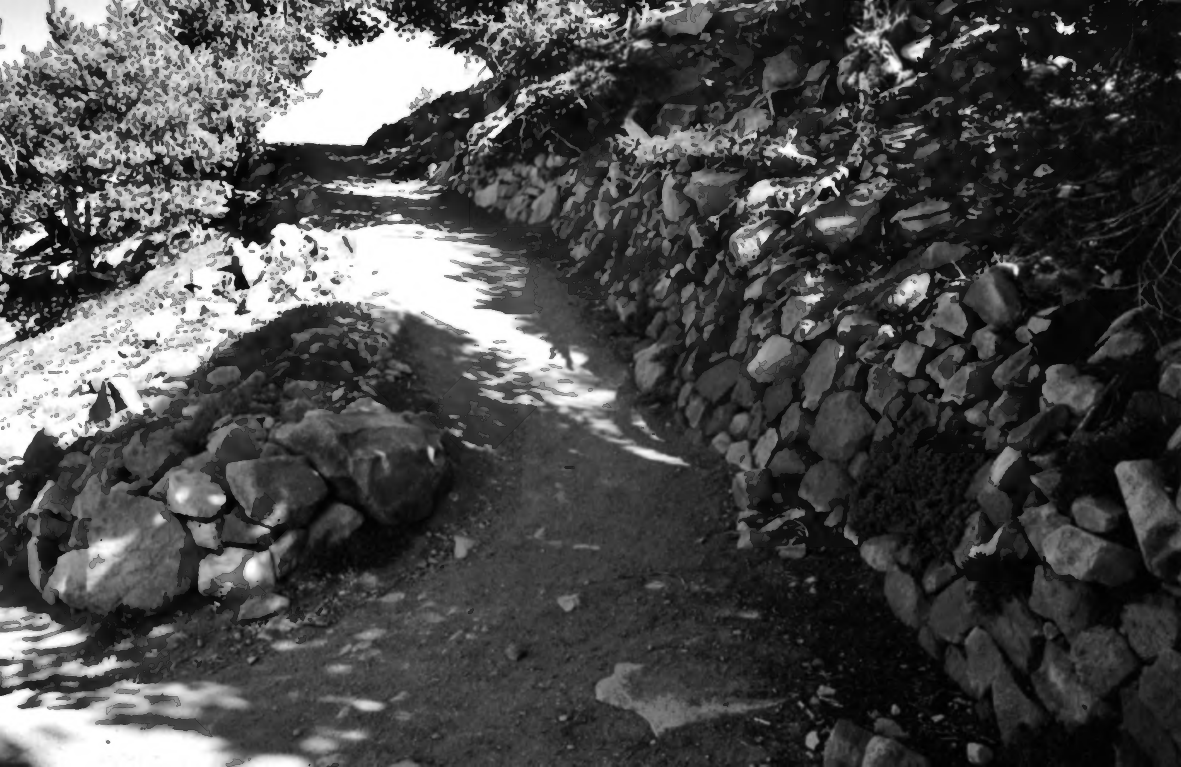
5. Dry laid retaining wall on Watchman Trail,  
Rim Drive Historic District  
Crater Lake National Park, Klamath County,  
Oregon

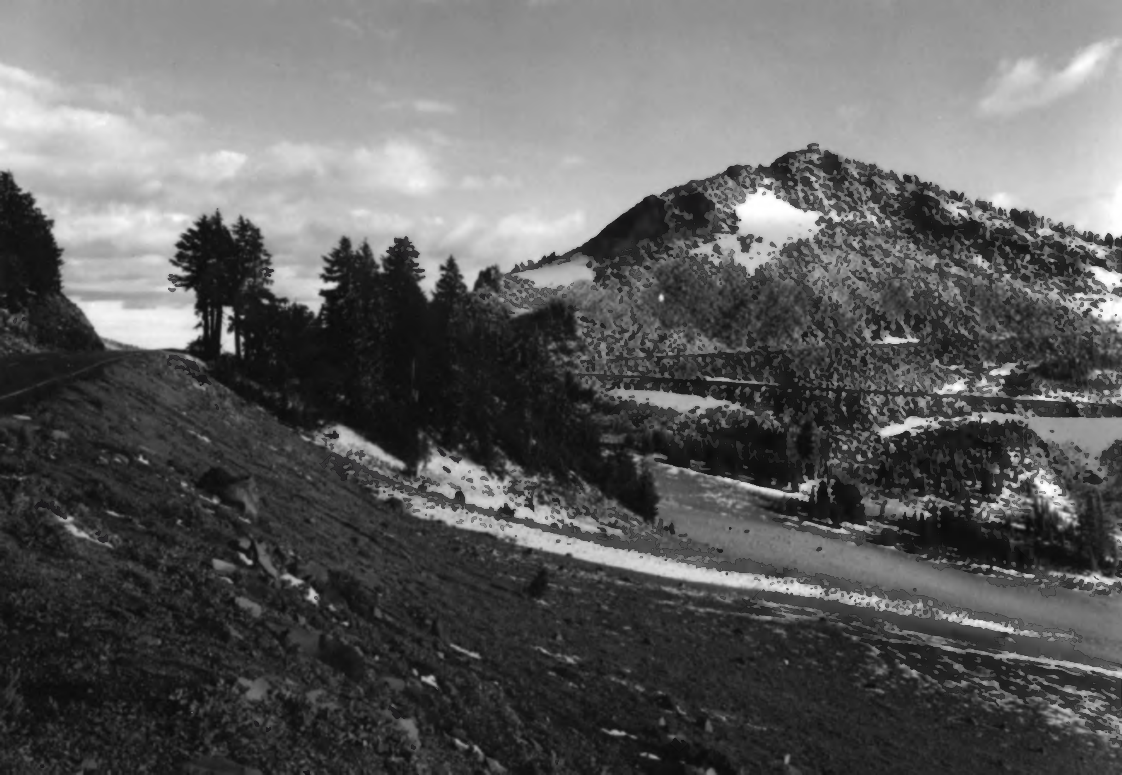
7. Watchman Lookout in the distance, with cuts for  
Watchman Trail (upper) and Rim Drive segment 7-A  
(lower) visible, Rim Drive Historic District  
Crater Lake National Park, Klamath County,  
Oregon

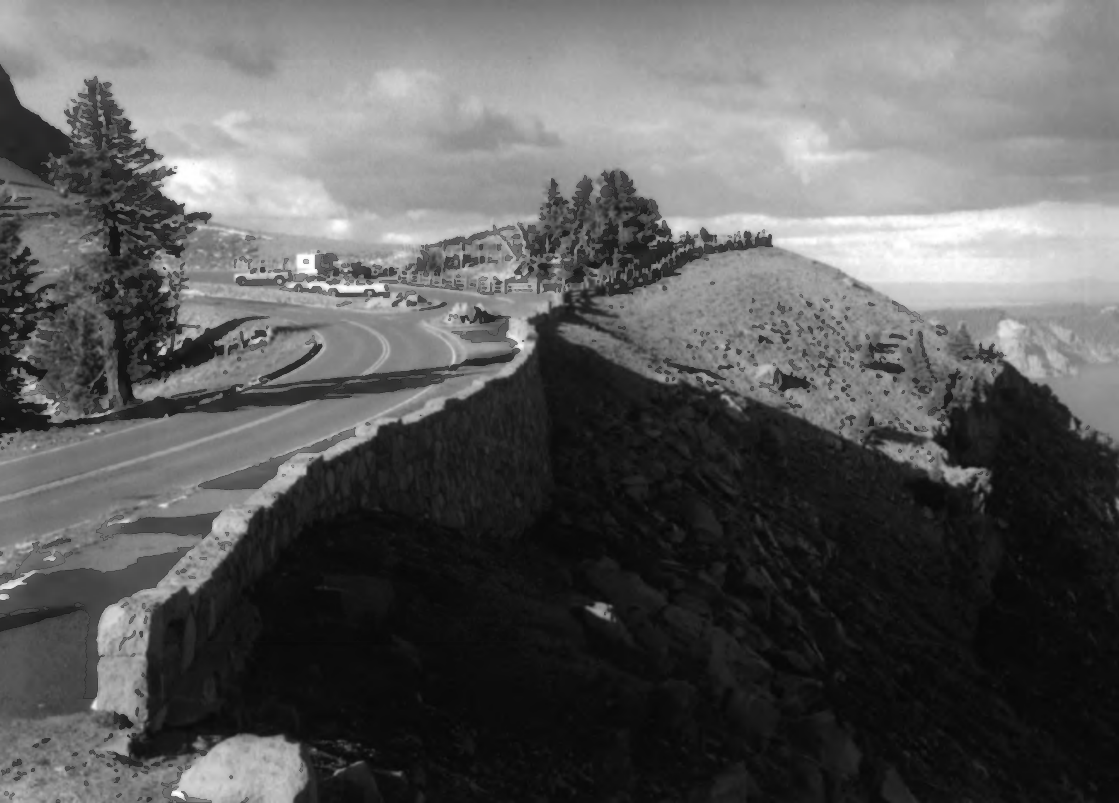
8. Watchman Overlook and parking area (noncontributing resource) with masonry retaining wall in foreground,  
Rim Drive Historic District  
Crater Lake National Park, Klamath County,  
Oregon  
#4

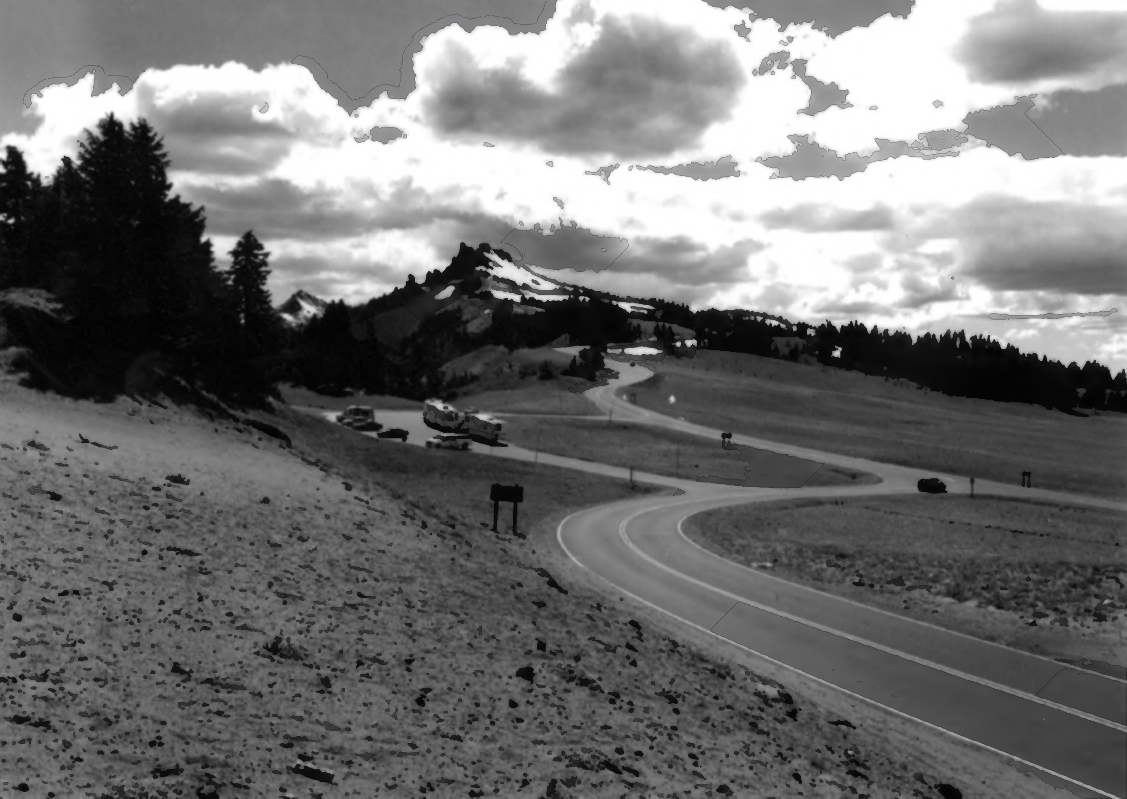
9. Intersection and parking lot at junction of Rim Drive and North Entrance Road (noncontributing resource), Rim Drive Historic District  
Crater Lake National Park, Klamath County,  
Oregon

Realignment of the Diamond Lake Junction occurred as part of rehabilitating the North Entrance Road from 1985 to 1987. A new "T" intersection replaced the original road wye and the new alignment gave precedence to a through route over continuation of the circuit. It also came with a new parking area, one intended to relieve pressure on the parking areas further south, which now consistently ranked second in popularity among all of the viewpoints on Rim Drive. According to the NPS justification for this project, the new parking area was to serve as part of a development that included hard surfaced walkways allowing for handicapped access to a pair of overlooks. These did not materialize, so the site quickly showed how foot traffic during the summer could negatively impact vegetation.

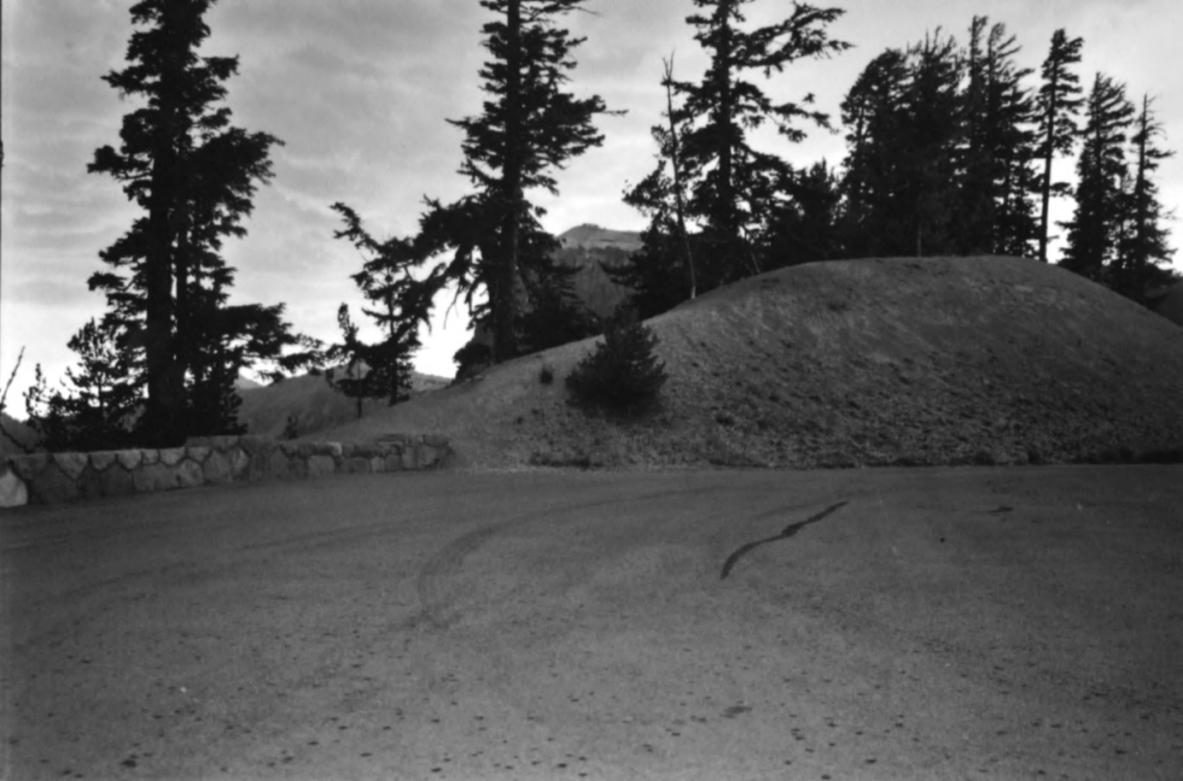
10. Graded bank slopes and masonry guardrail at Steel  
Bay parking area, Rim Drive Historic District  
Crater Lake National Park, Klamath County,  
Oregon

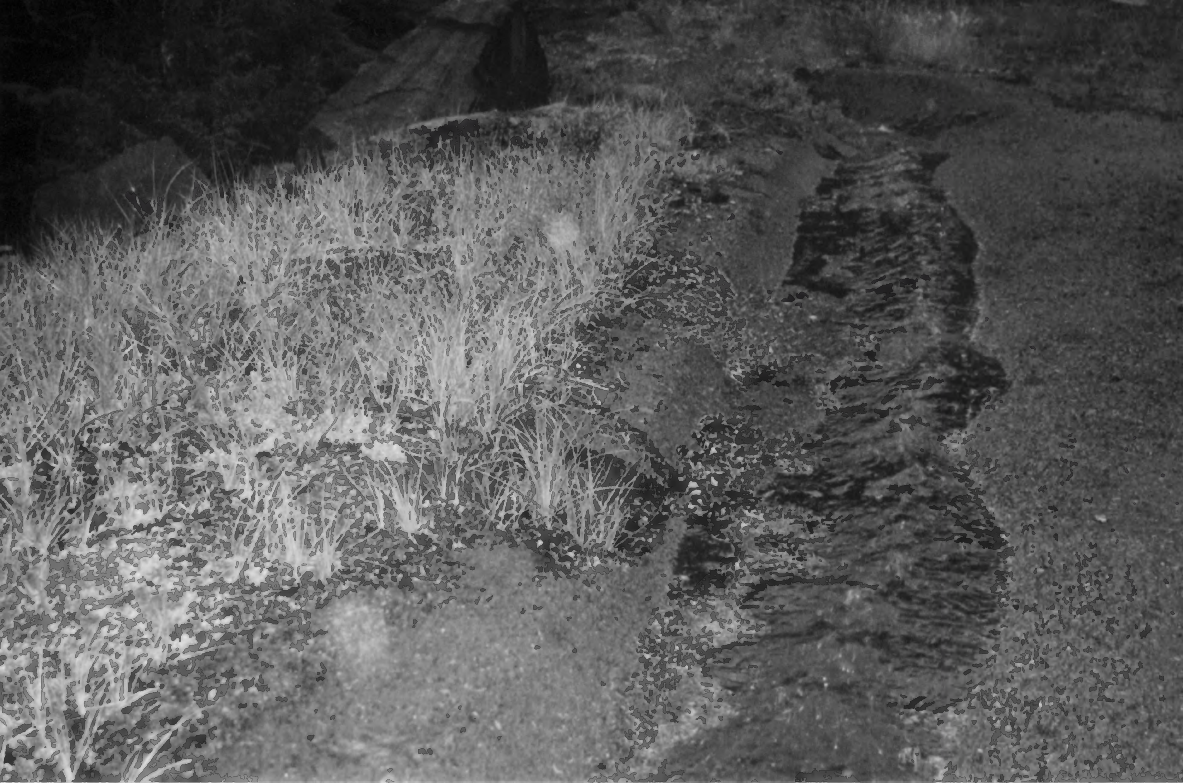
11. Rainwater flowing in paved ditch toward drop inlet  
in road segment 7-B, Rim Drive Historic District  
Crater Lake National Park, Klamath County,  
Oregon

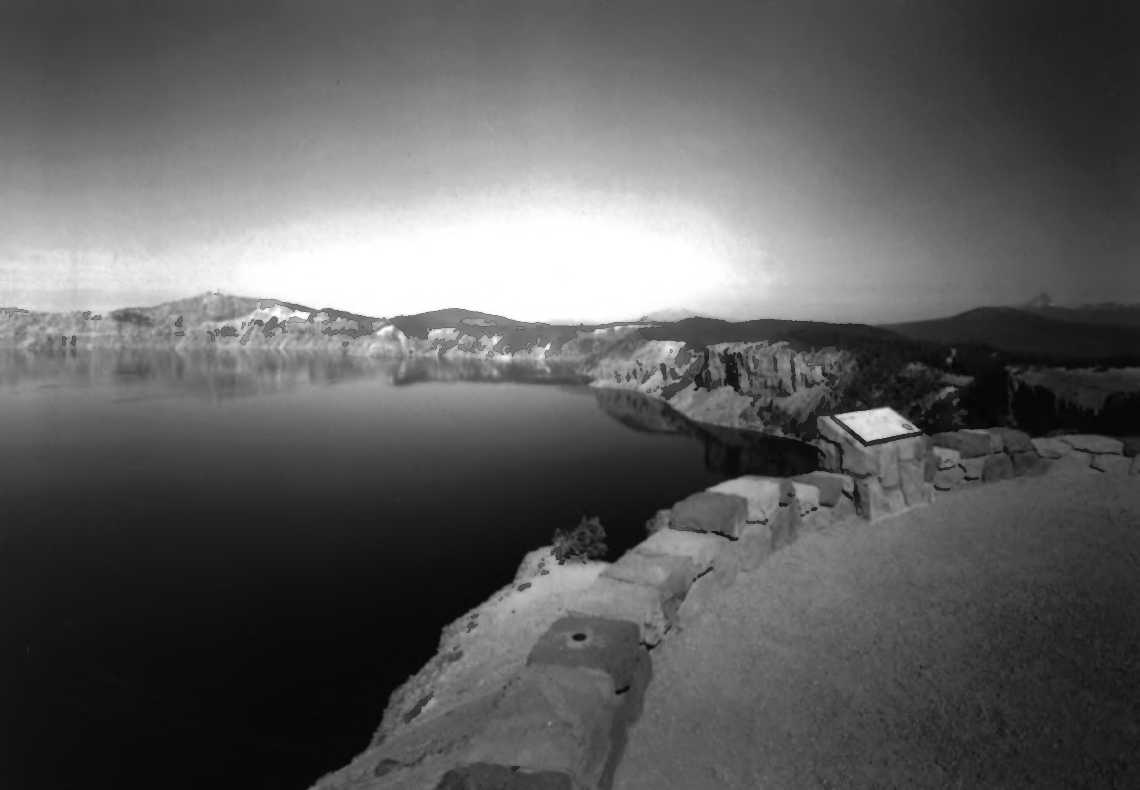
13. Walkway and parapet wall at Skull Head (observation station 6), Rim Drive Historic District  
Crater Lake National Park, Klamath County,  
Oregon

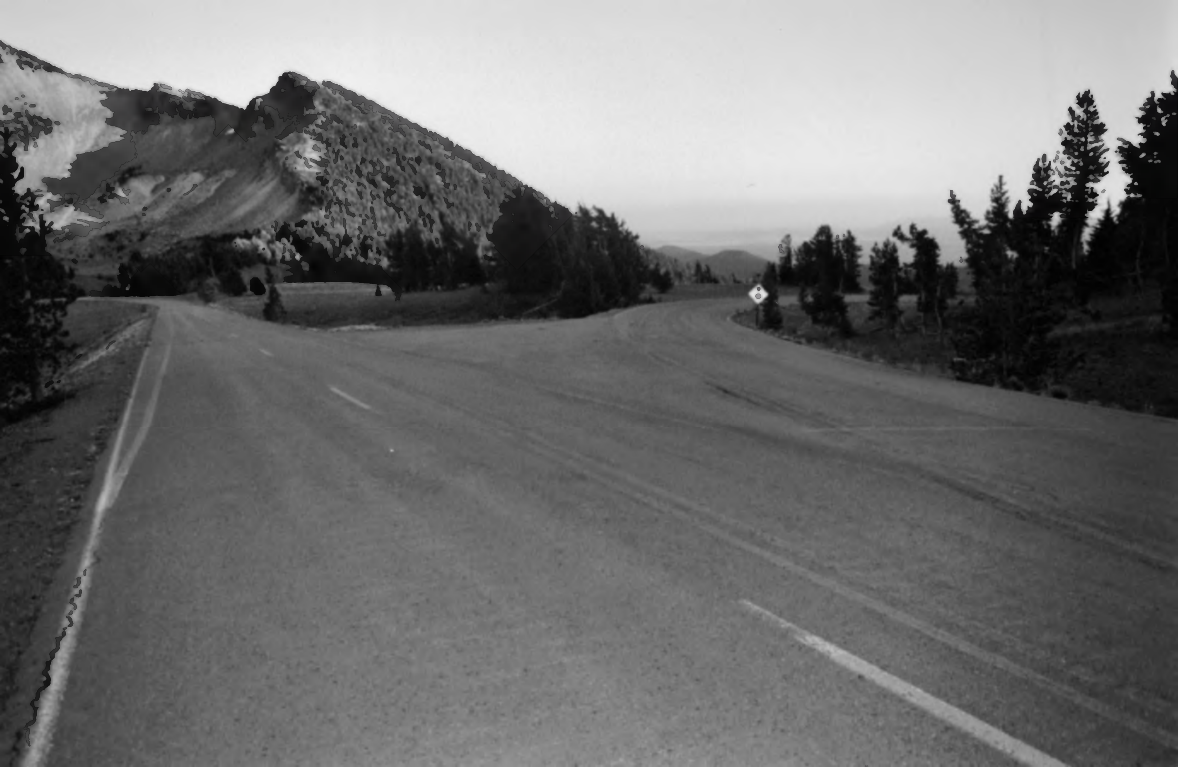
14. Road wye at junction of spur road to Cloudcap  
with Rim Drive segment T-C, Rim Drive Historic  
District

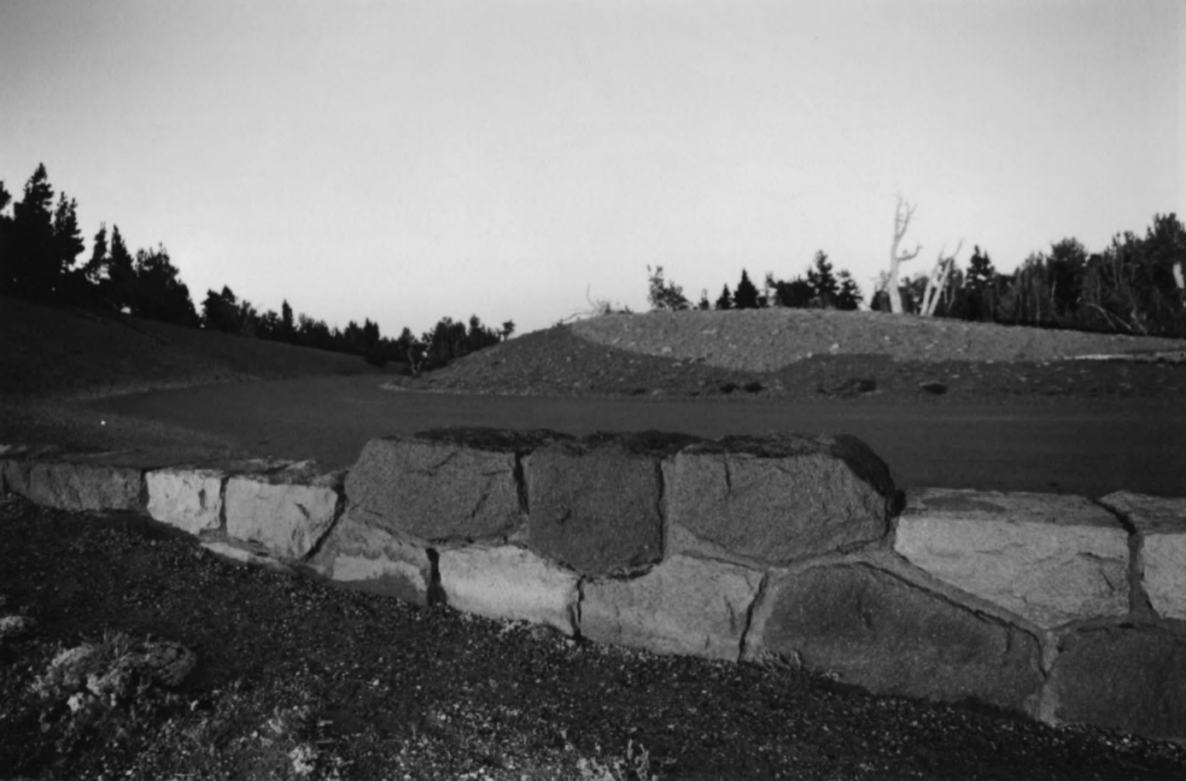
15. Masonry guardrail with bannisters used as a  
circulation device in background, Cloud Cap  
Parking Overlook (observation station 7) Rim Drive  
Historic District  
Crater Lake National Park, Klamath County,  
Oregon

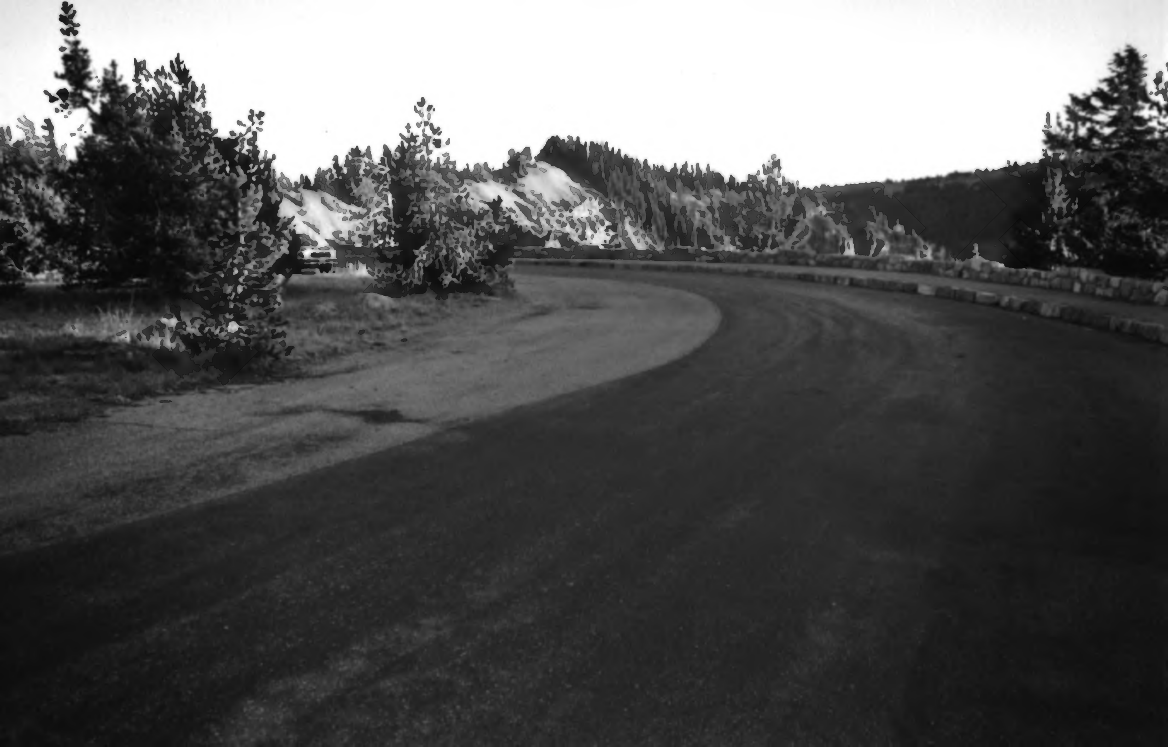
17. Planting bed, roadway, curb, walk, and masonry guardrail at Reflection Point Parking Overlook (substation 7-C), Rim Drive Historic District Crater Lake National Park, Klamath County, Oregon

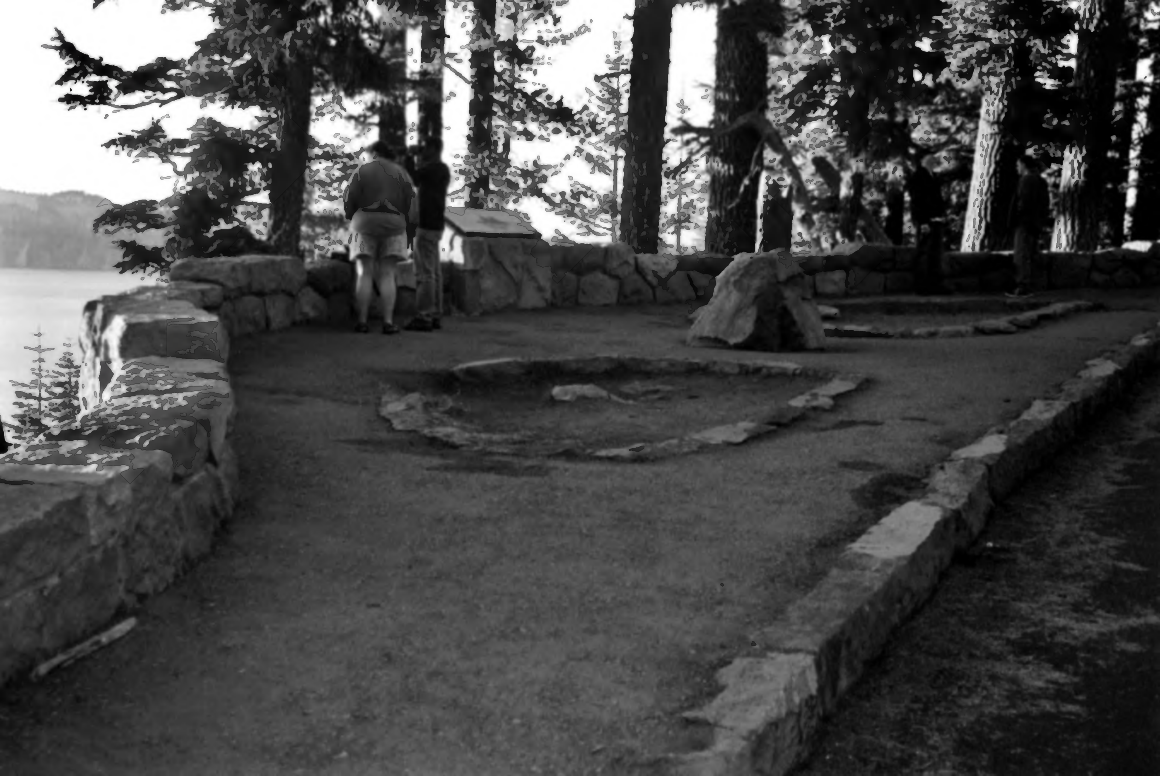
18. Parapet with planting beds, drinking fountain, and walk at Kerr Notch Parking Overlook (observation station 8), Rim Drive Historic District  
Crater Lake National Park, Klamath County,  
Oregon

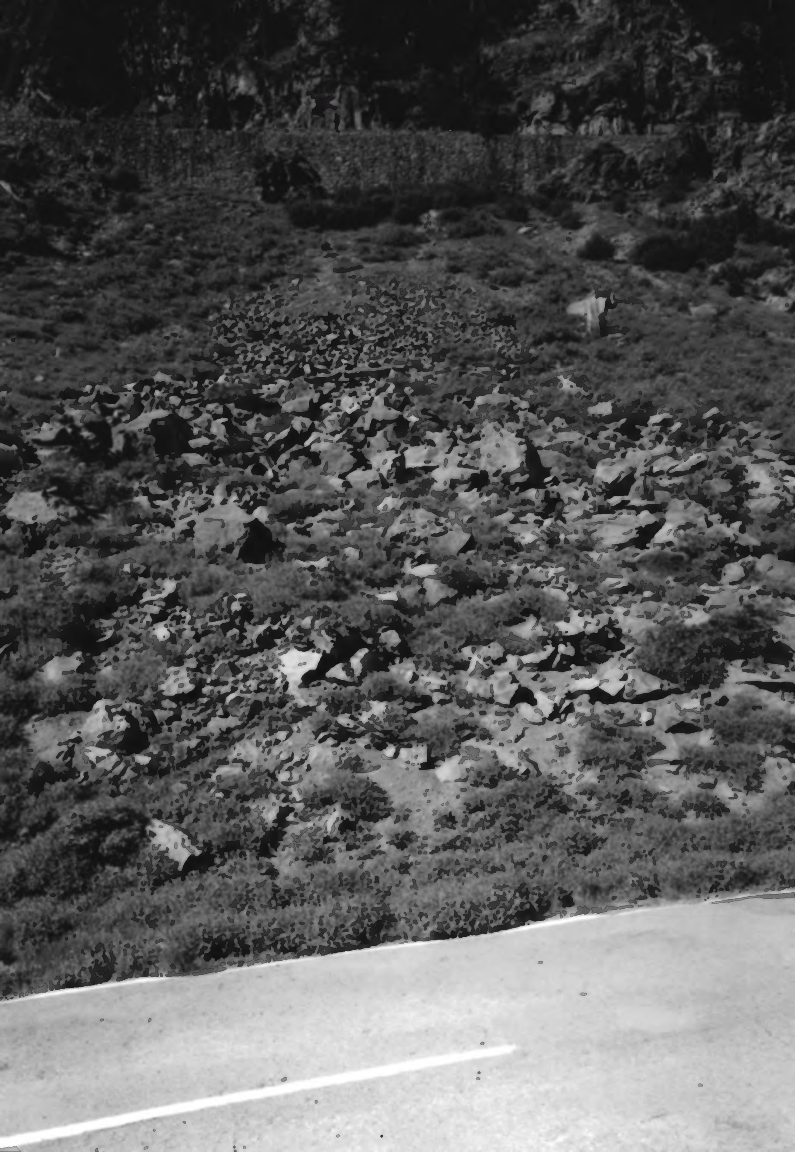
19. Retaining wall on the Dutton Cliff  
section of road segment 7-D, Rim  
Drive Historic District  
Crater Lake National Park, Klam-  
ath County, Oregon

Masonry guardrail has also undergone extensive repair on the west side of Dutton Ridge, about a half mile shy of the Sun Notch parking area. There remains, however, masonry guardrail in excellent condition where it was built away from steep slopes and rockfall areas. Several parking areas along this segment of Rim Drive still possess almost all original work and are located a mile or more south of Kerr Notch. One of the parking areas (there are no observation stations or substations in segment D) is situated high enough so that motorists who stop here can see Crater Lake to the north and portions of the Klamath Basin if they look south. Spectacular views of the basin and Klamath Marsh far to the east can be seen over the next mile or so to the road summit of Dutton Ridge where the southern panorama stretches to its widest point. The drive down the western side of the ridge to Sun Notch allows filtered views of Sun Meadow below the road and a ridgeline crowned by Applegate Peak to the west. None of the construction in this segment necessitated road obliteration because the old Rim Road followed an entirely different alignment located below Dutton Ridge where there is considerably less rockfall, but also far fewer vistas. The gradients encountered along the alignment of Rim Drive required designers to forsake paved ditches for cross drainage. They used stone masonry features called "spillways" instead to direct water coursing from seasonal springs and put it through culverts located underneath the road.

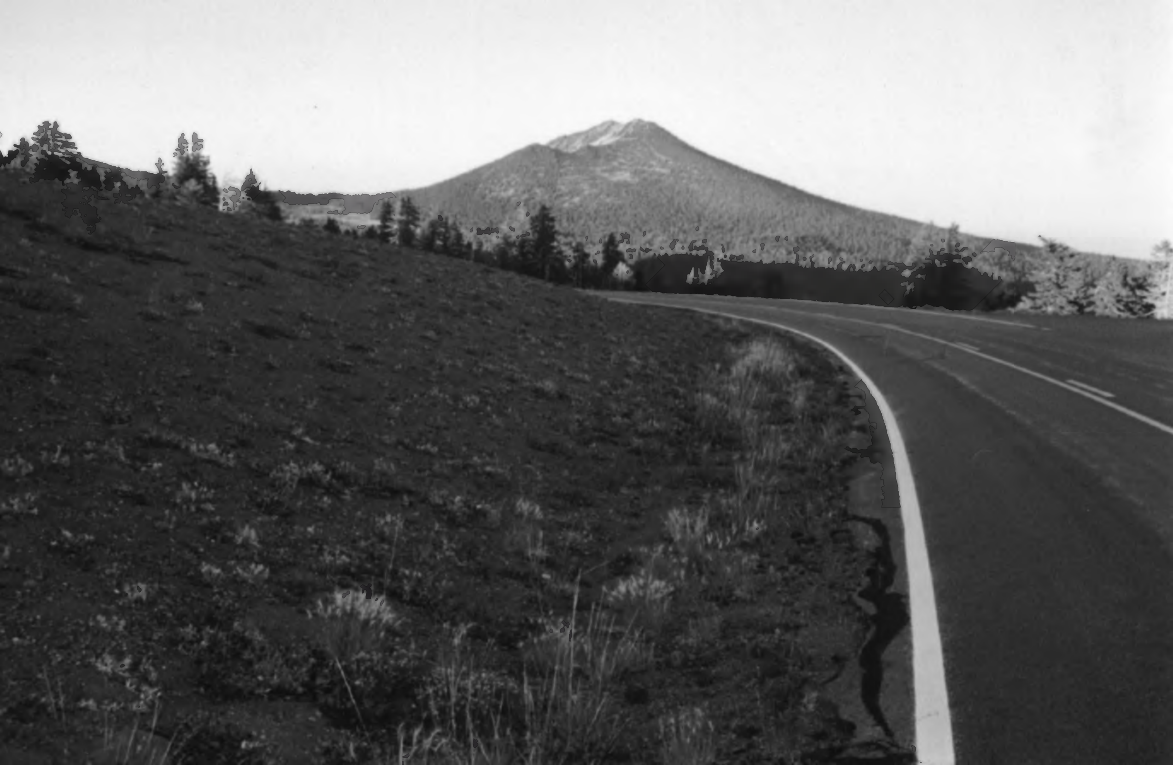
20. Rounded slopes on Dutton Ridge road summit,  
Mount Scott in background, Rim Drive Historic District  
Crater Lake National Park, Klamath County,  
Oregon
