Rim Drive Historic District  
Property Name

Klamath OR  
County State

# National Register of Historic Places Registration Form

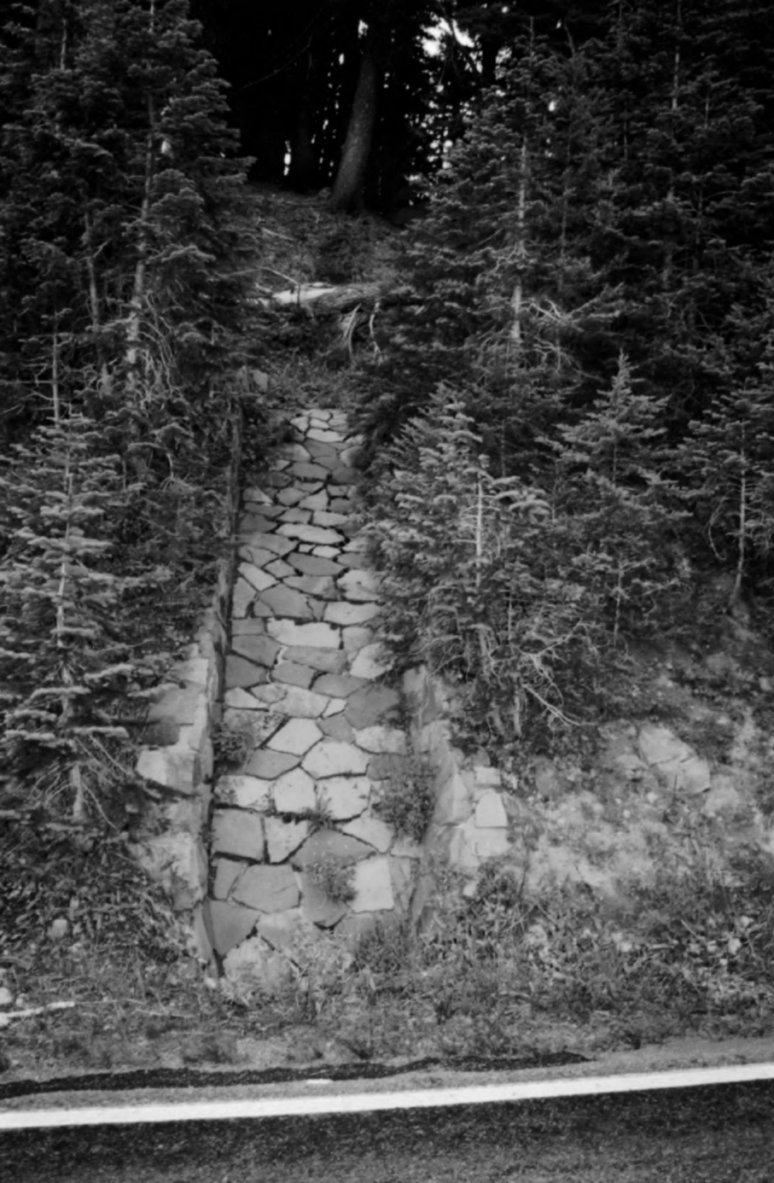
21. Masonry spillway for cross drainage  
along road segment 7-E, Rim  
Drive Historic District  
Crater Lake National Park, Klamath  
County, Oregon

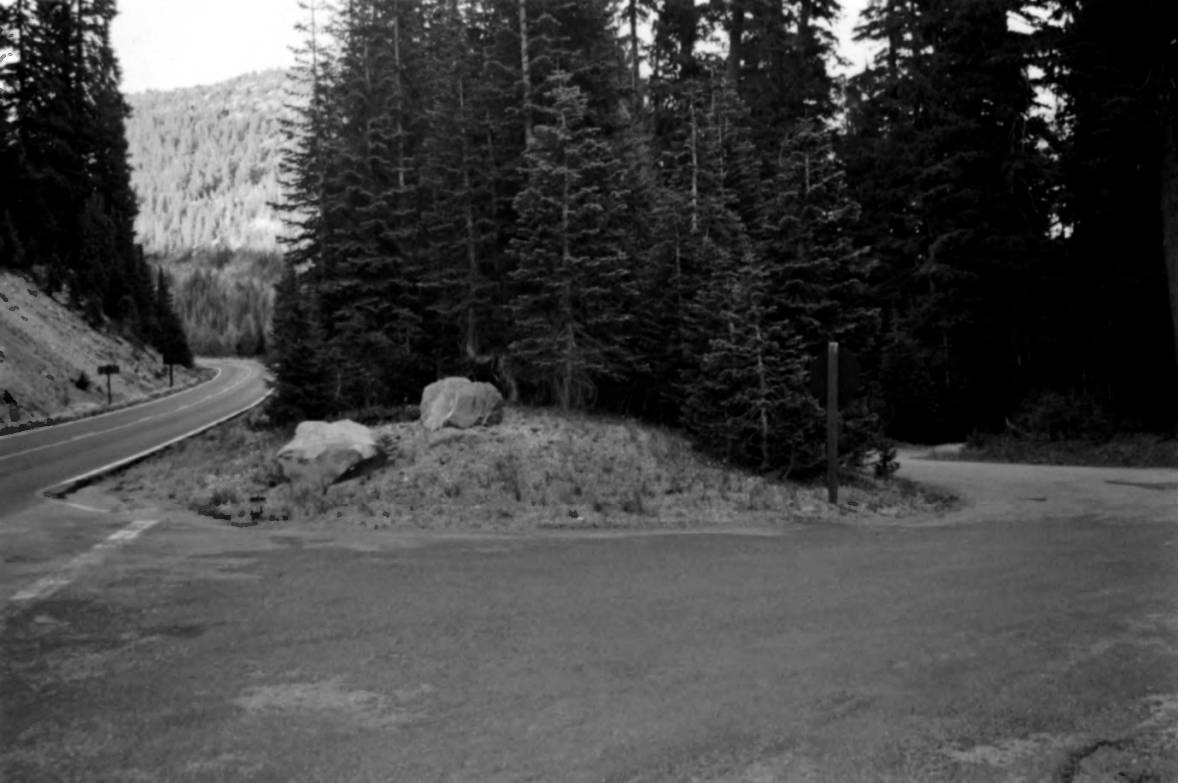
22. Banksloping used to separate Rim Drive (left) from  
Sun Creek Campground road near Vidau Falls  
parking area, Rim Drive Historic District  
Crater Lake National Park, Klamath County,  
Oregon

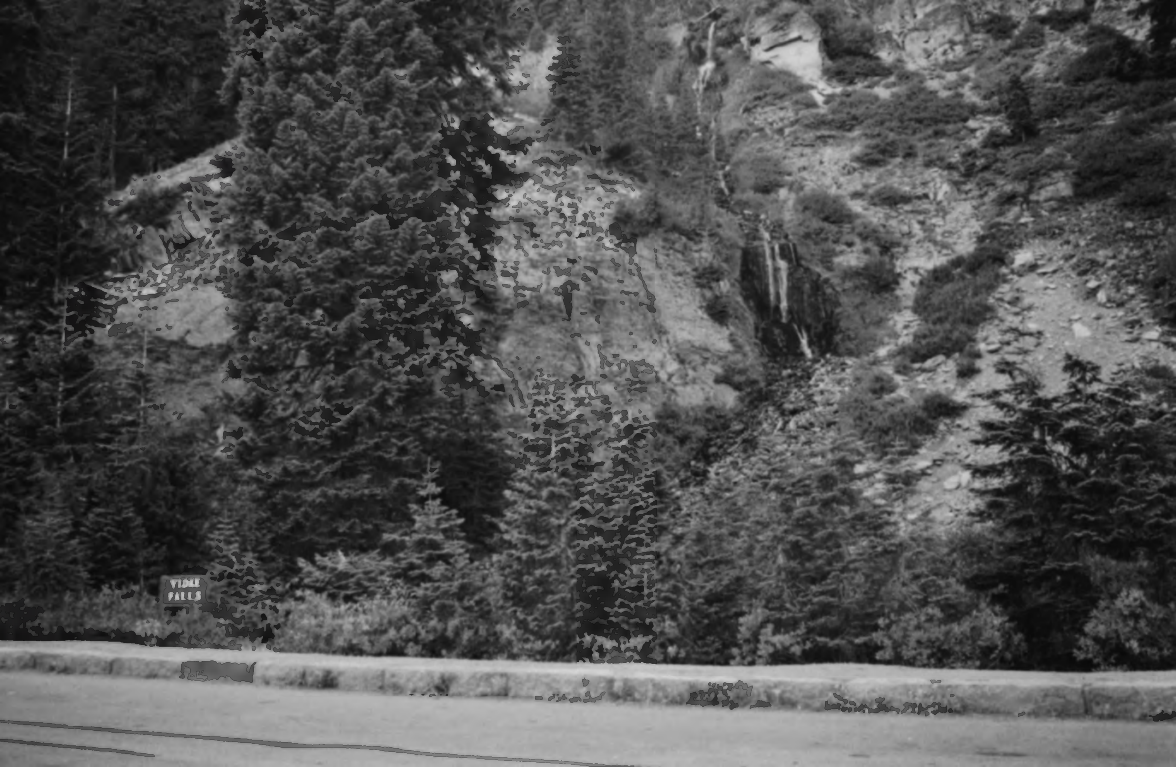
23. Part of Vidau Falls parking area with curb, original  
Civilian Conservation Corps sign, and plantings on  
fill, Rim Drive Historic District  
Crater Lake National Park, Klamath County,  
Oregon

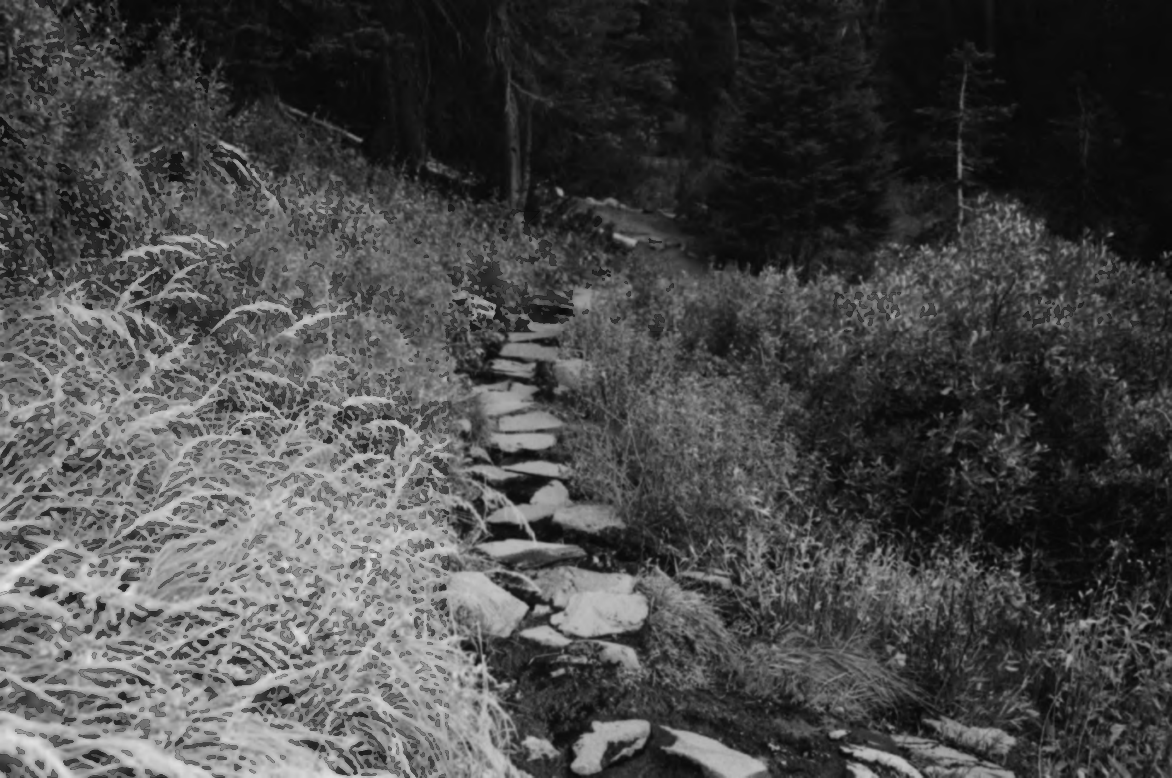
24. Stone steps on Castle Crest Wildflower Garden trail,  
placed to allow passage through wetland, Rim Drive  
Historic District

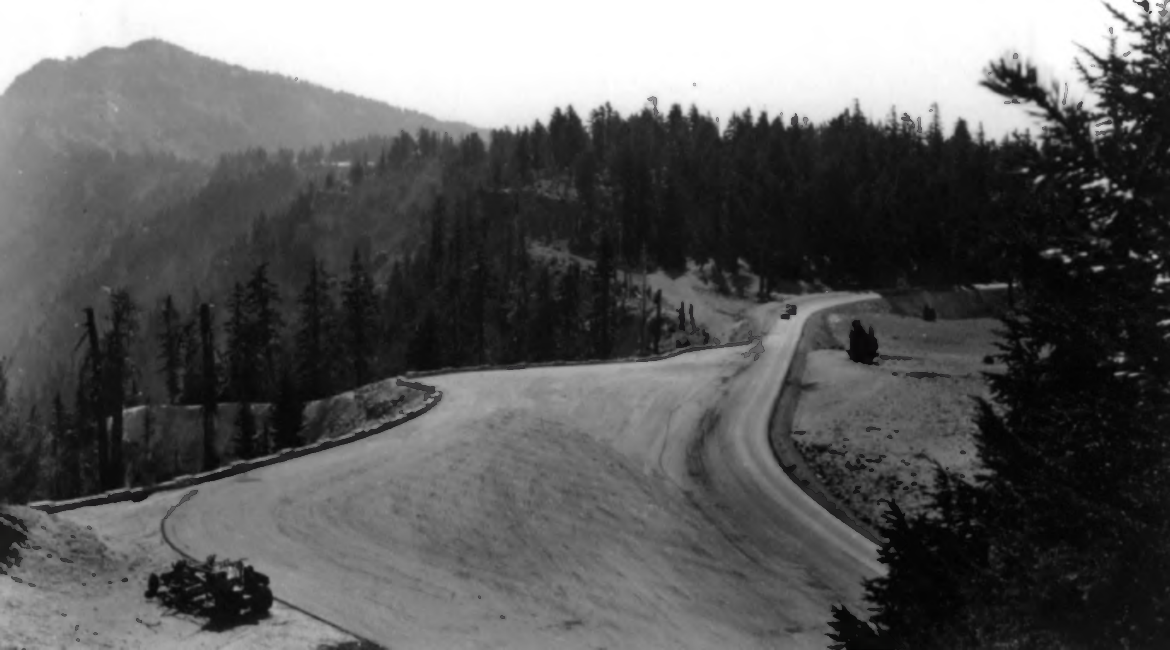
25. Paving Rim Drive (segment 7-A) at the Discovery Point  
Parking Area, Rim Drive Historic District (1935)  
Crater Lake National Park, Klamath County, Oregon

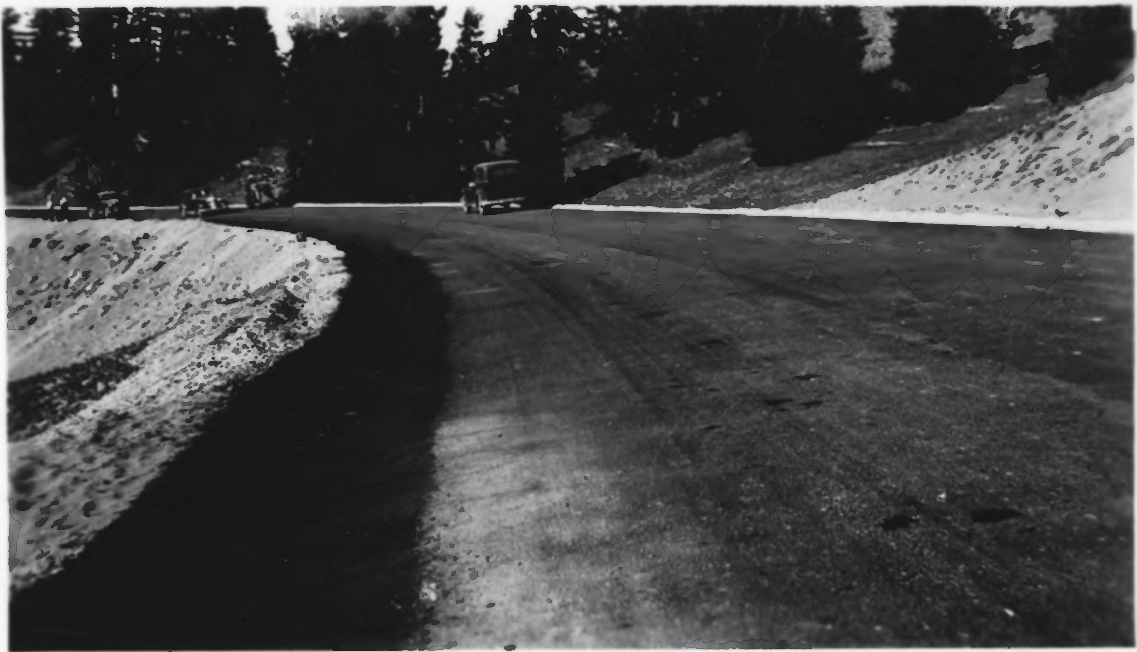
Rim Road-7B-CL-1938

28. Paving Rim Drive in segment 7-B, Rim Drive  
Historic District (1938)  
Crater Lake National Park, Klamath County,  
Oregon

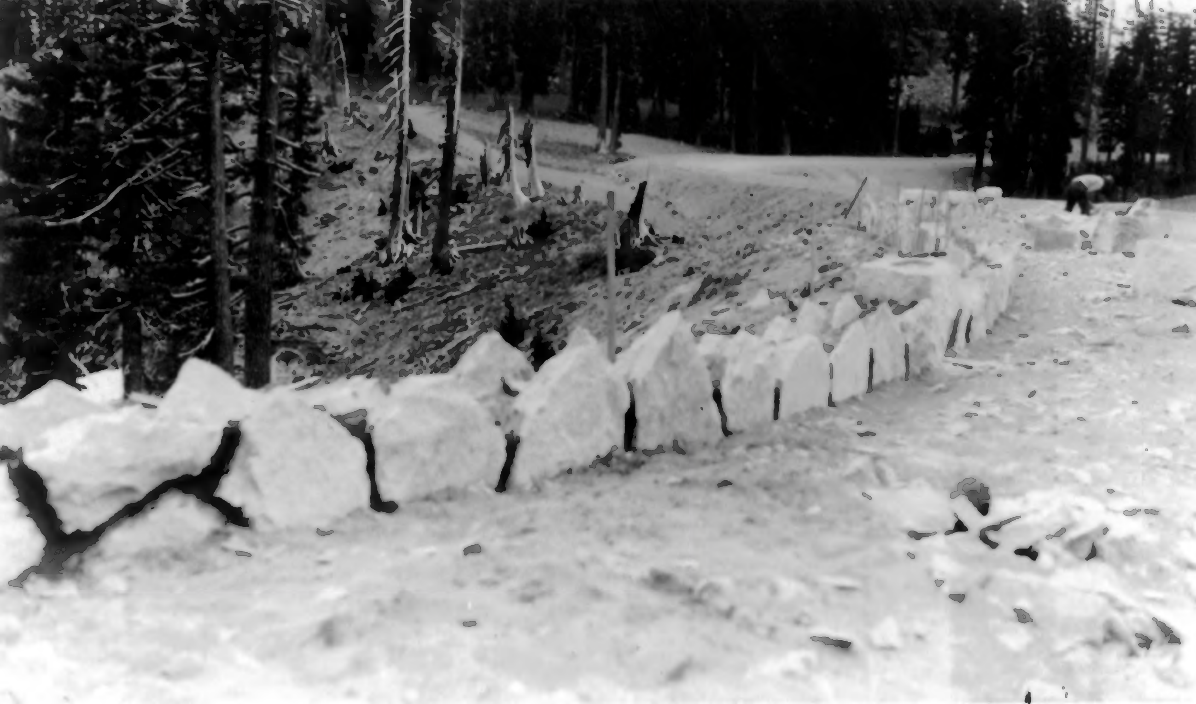
29. Building masonry guardrail near Pumice Point  
(observation station 5), Rim Drive Historic District  
(1934)

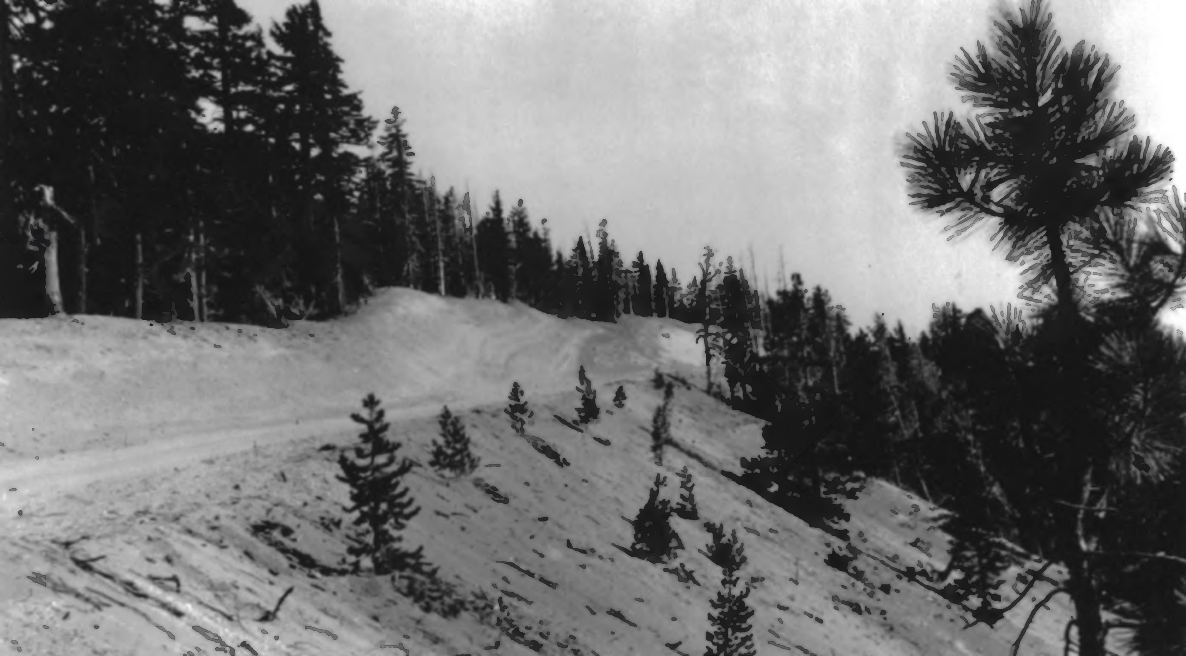
30. Trees planted to stabilize fill along road segment  
7-B, Rim Drive Historic District (1935)

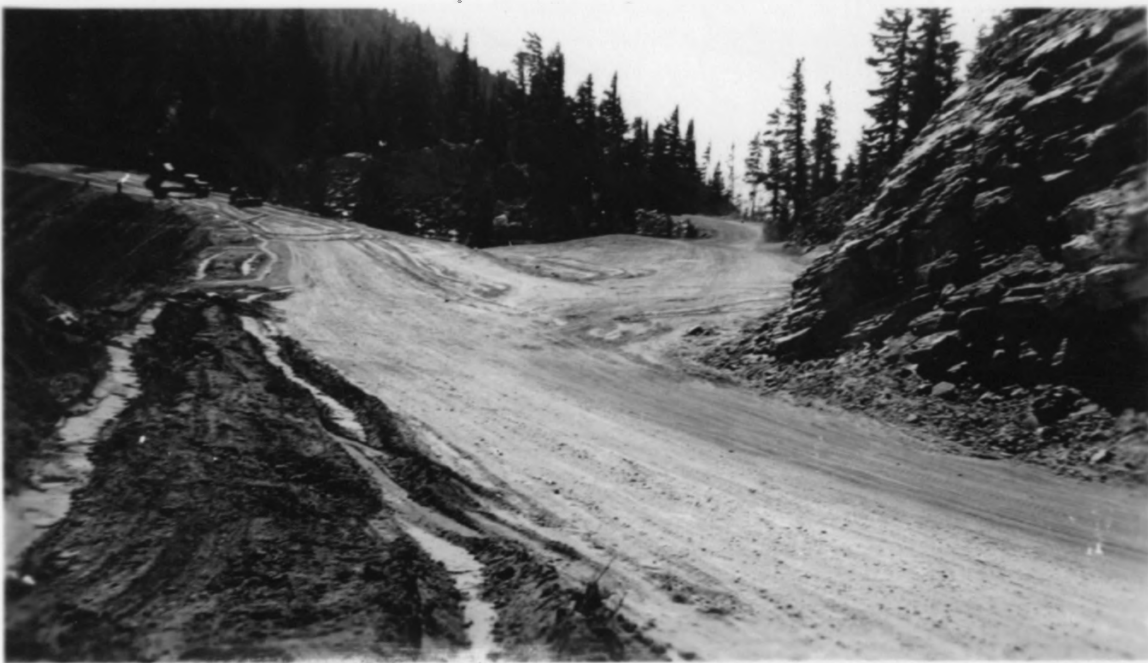
Rim Road (7B) - CL-1935

31. Portion of road segment 7-B at left, in relation to  
a piece of the old Rim Road (center right) during  
rough grading, Rim Drive Historic District (1935)  
Crater Lake National Park, Klamath County,  
Oregon

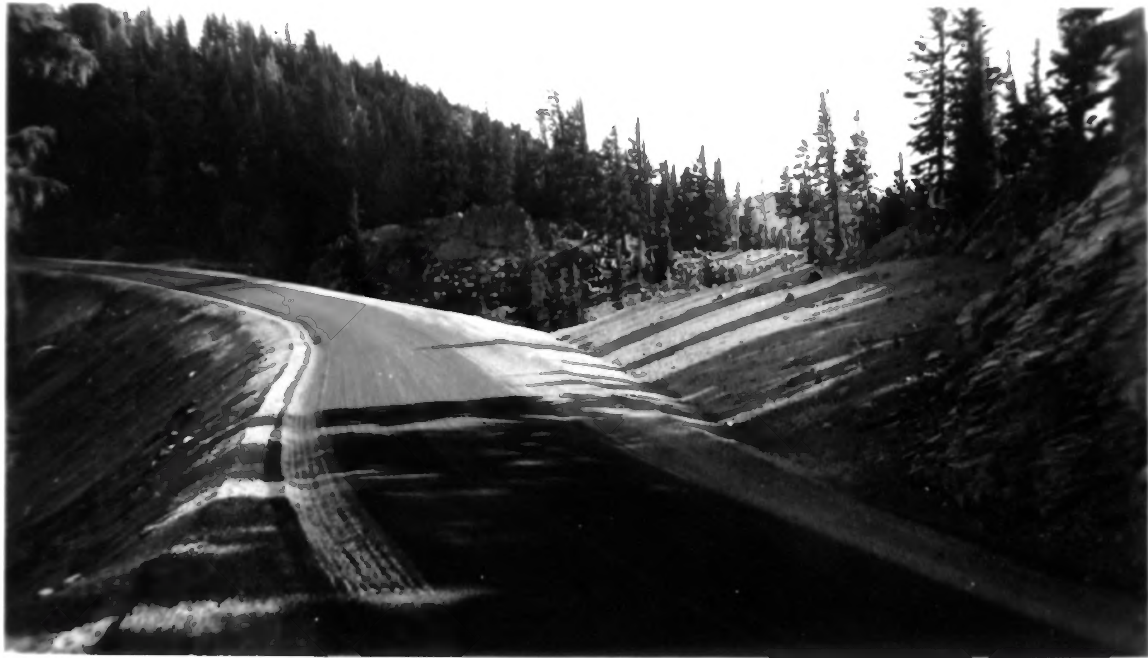
Rim Road-7B-CL-1938

32. Paved section of road segment 7-B after obliterating evidence of the old Rim Road, Rim Drive Historic District (1938)

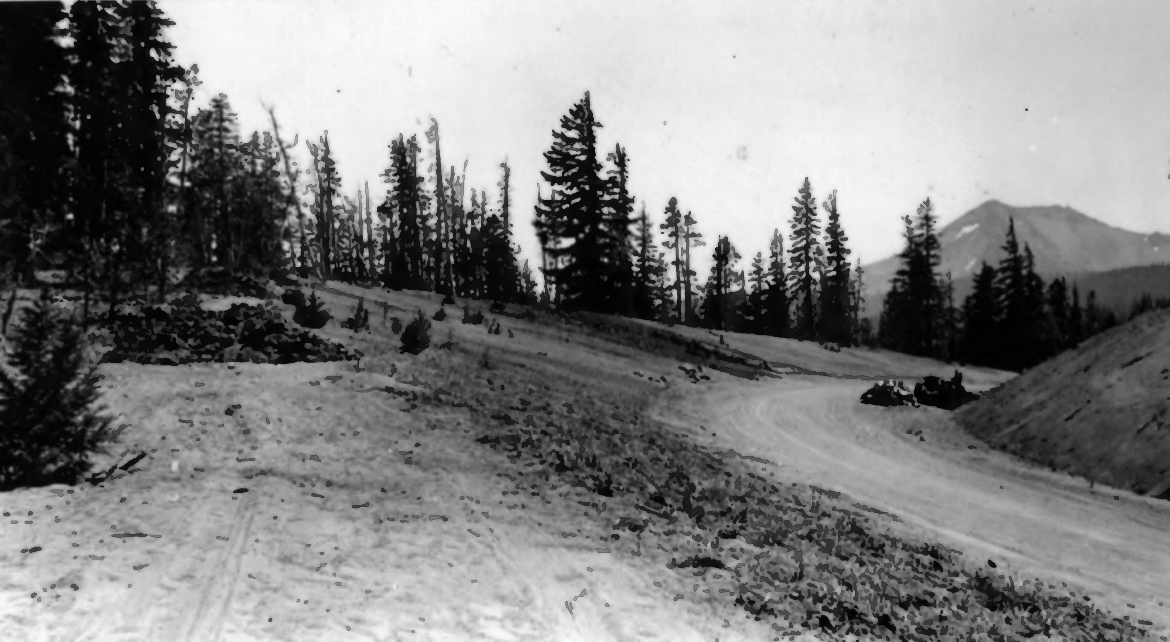
33. Planting daylighted slopes as a landscape treatment  
in road segment 7-C, Rim Drive Historic District  
(1935)

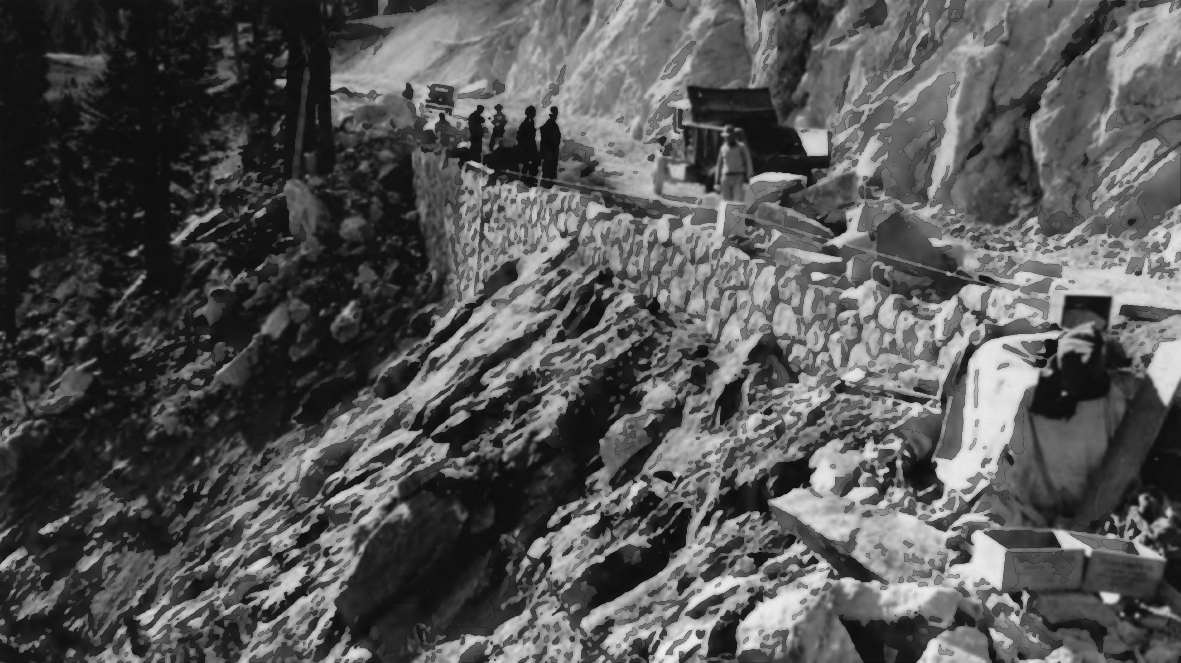
34. Crew building a retaining wall for the Scott Bluffs  
parking area, Rim Drive Historic District (1934)  
Crater Lake National Park, Klamath County.  
Oregon

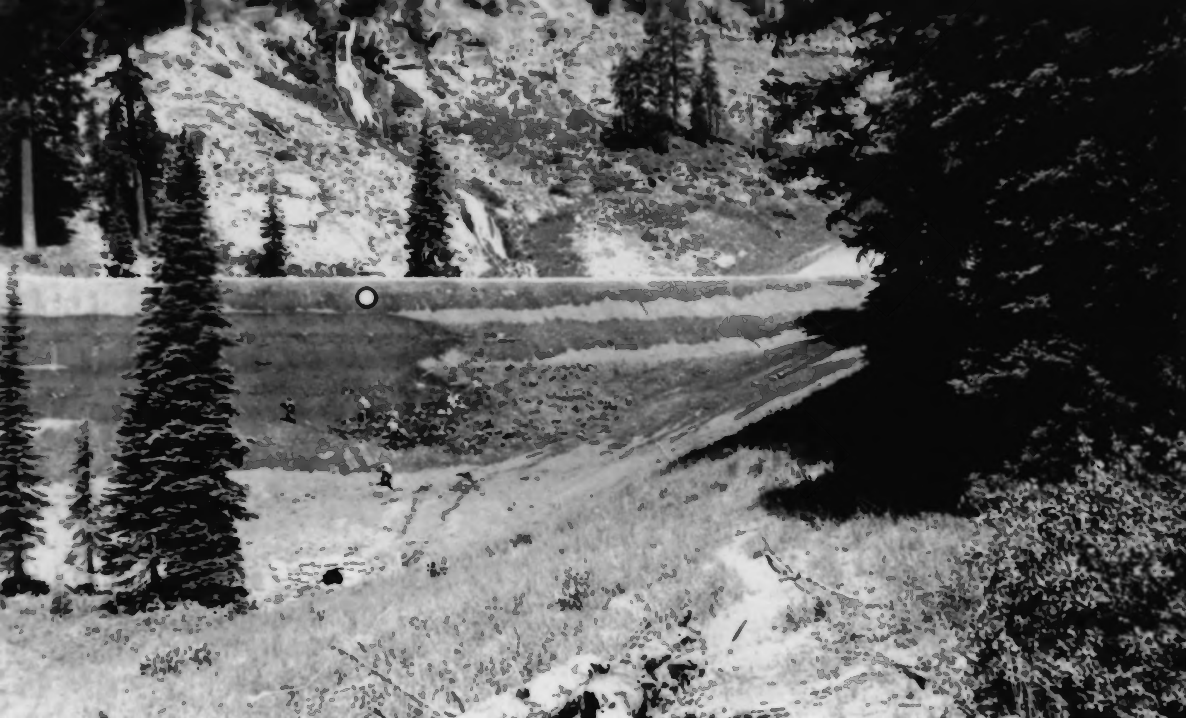
36. Crew planting the fill below Vidoe Falls, Rim  
Drive Historic District (1939)  
Crater Lake National Park, Klamath County,  
Oregon

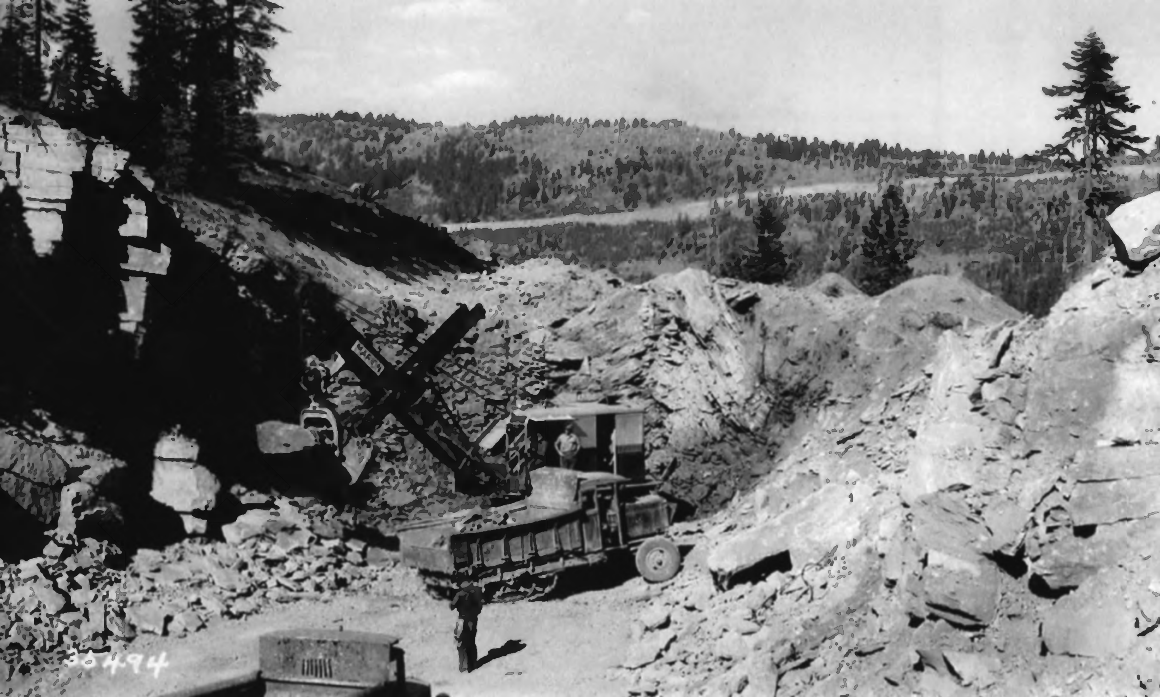
0494

37. Excavation with a steam shovel in road segment 7-E,  
with Dutton Ridge in the background, Rim Drive  
Historic District (1938)

In some respects, finally paving segments 7-C1, 7-D, and 7-E in 1960 represented the last act of road construction begun almost three decades earlier.<sup>118</sup> In the interim, the BPR supervised laborers hired by the NPS in 1952 to address active slides at Anderson Point in segment 7-C1 by stabilizing slopes, but the engineers also oversaw the building of roughly 100 lineal feet of masonry guardrail to replace an earlier safety barrier along this section. The NPS also wanted to counteract the rock fall that repeatedly damaged, and in some cases, destroyed masonry guardrail on a section of road located along Dutton Cliff in 7-D1. It thus let a contract in 1966 to repair some of the guardrail and retaining wall, in conjunction with establishing some additional cross drainage in this section of road.<sup>119</sup> On the other side of Dutton Cliff, in segment 7-D2, continual slides and rock fall led to repair and rebuilding of some masonry guardrail along this so-called "Sun Grade" section in 1985. Cuts made as part of the original grading contract remained subject to erosion and raveling, however, particularly where the slope face remained wet.<sup>120</sup>
