**NATIONAL REGISTER OF HISTORIC PLACES
INVENTORY -- NOMINATION FORM**

DEPRESSION-ERA BUILDINGS

NAME: Paulina Lake Guard Station

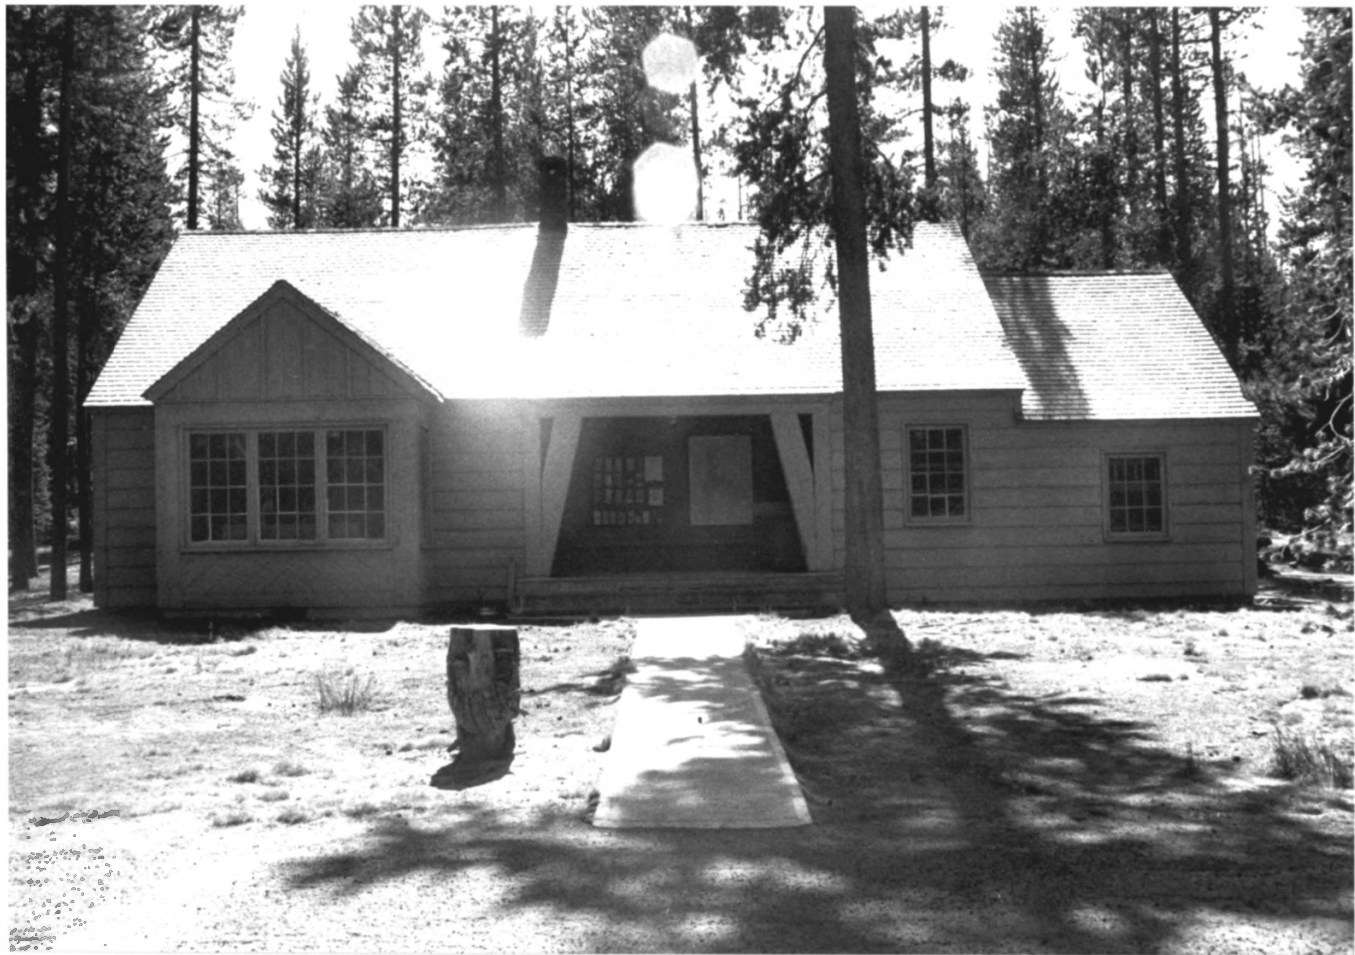
- 1) Name of Property: Paulina Lake Guard Station #1019
- 2) City and State: Vicinity of Bend, Oregon
- 3) Photographer: Carl M. Davis
- 4) Date: July 1984
- 5) Negative Location: USDA Forest Service, Regional Office, Recreation Unit, CRM files.
- 6) Description: Looking west at main elevation of Guard Station
- 7) Photograph Number: 01-03-1019

Paulina Lake Guard Station #1019: 1938; rectangular, 1 story, wood-frame, poured concrete foundation, wood-shingled medium gable roof, projecting offset gables, left on front elevation, light on rear elevation, gabled garage abuts right gable end, inset, stone interior chimney, arched cap, off center on ridgeline. Horizontal clapboard covers exterior walls to eave-level, vertical board and batten on all gable ends. Nine-and-twelve-light sashes in divisions of two with mullions. Mullion Window of three divisions of fifteen lights each in off-set gable, front elevation. Main entry, center, main facade, recessed in anterior wall; flagstone platform enclosed on three sides; entry surrounds formed by heavy squared timbers, flush with walls, heavy squared straight timber brackets, angled placement, extend from platform surface to lintel. Rear entry recessed, extreme left corner, rear elevation. Hinge-opening two-leaf garage doors off-center on exposed gable end of abutting garage. No decoration. No obvious structural or material alterations to exterior.
