Vinsonhaler Blacksmith ShopMalheurProperty NameCounty

NATIONAL REGISTER OF HISTORIC PLACES REGISTRATION FORM

_____ 1. Name of Property historic name: Vinsonhaler Blacksmith Shop other names/site number: 2. Location street & number: 122 Good Avenue not for publication N/A vicinity N/A city or town: Nyssa code: OR county: Malheur state: Oregon code: 045 zip code: 97913

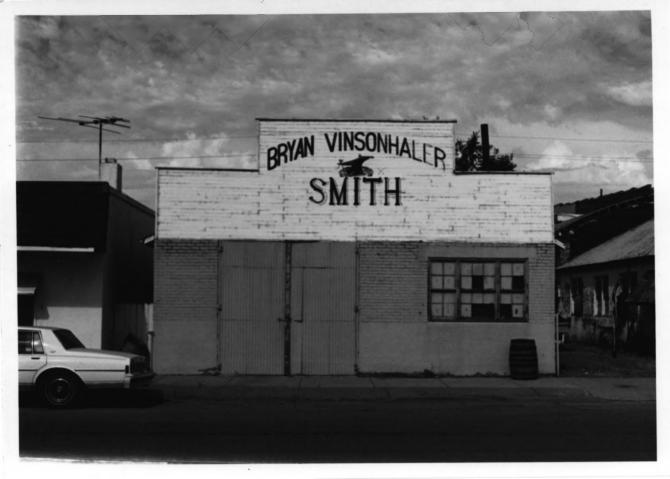
PHOTO 5 OF 5 2. LATE 19405

- 4) Date: c. late 1940s
- 6) Looking northeast at north side of the 100 block of Good Avenue
- 7) 5 of 5

The south facade facing Good Avenue presents a wood false front which rises above the height of the gable roof. The false front is lower on the each end and steps to a higher center section. The signage at the false front reads "BRYAN VINSONHALER" which is painted in black lettering in a gentle arch. Beneath this name is painted a blacksmiths anvil. Below the anvil is the word "SMITH" in larger lettering. A photo from the late

1940s displays the name in the same location with "BLACKSMITHING" beneath and the words "WELDING and HARDFACING" at the bottom.

The south entrance of the shop is a pair of large swinging doors which reach the top of the brick, approximately ten feet. The doors are covered with corrugated metal siding. The late 1940s photo depicts the doors as wood with cross bracing at the top and bottom of each door. Three strap hinges per door extend half the width of each door. These entrance doors are offset to the left with a triple set of windows to the right. The windows are arranged with a large 6/6 double hung window in the middle and a 4/4 double hung window at each side.
